**CONCEPTUAL SITE MODEL  
FOR  
FARWELL MILL OIL RECOVERY  
SITE  
LISBON, MAINE  
ANDROSCOGGIN COUNTY**

**PREPARED FOR:  
MILLER INDUSTRIES, INC.  
LISBON FALLS, MAINE**

**MARCH 2009**

**CONCEPTUAL SITE MODEL  
FARWELL MILL OIL RECOVERY SITE  
LISBON, MAINE**

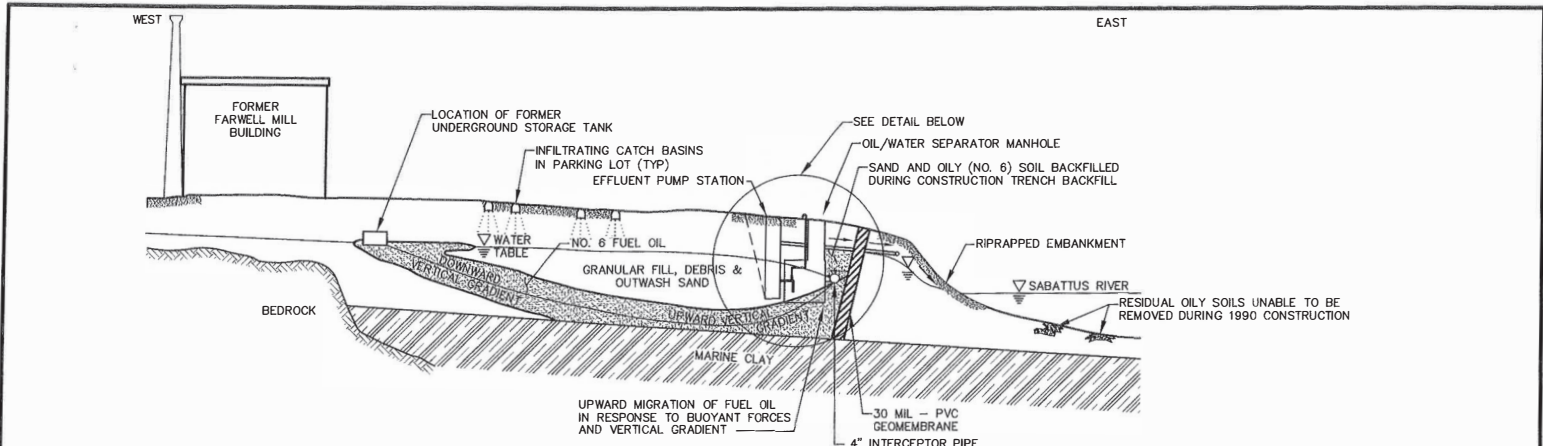
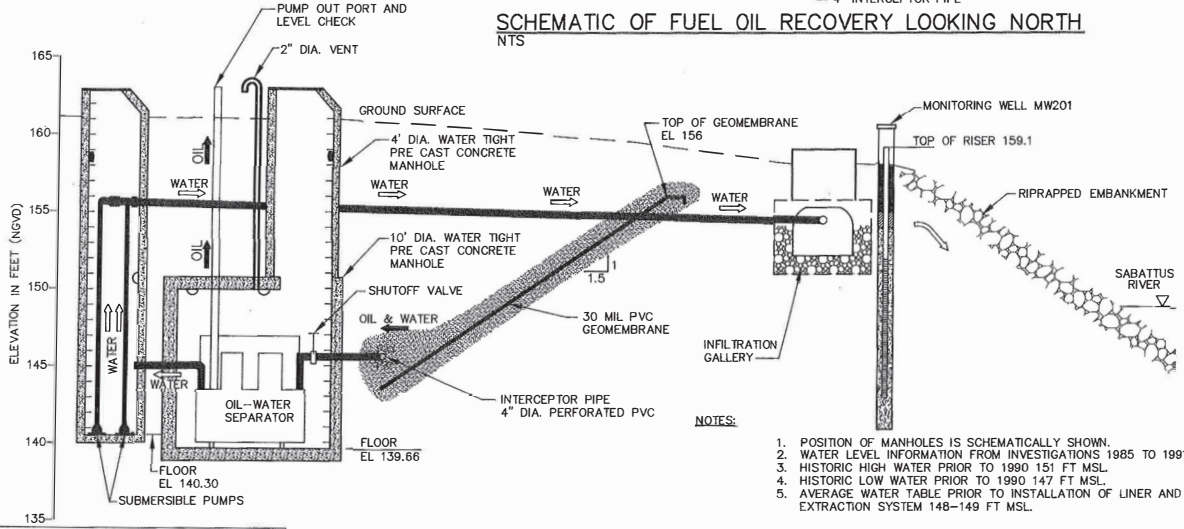
FIGURE 3  
SYSTEM CROSS SECTION  
SCHEMATIC (1999 - 2007)  
FARWELL MILL PROPERTY  
LISBON, MAINE

System Groundwater Model. During the subsurface oil recovery system operations from 1990 until 2007, the groundwater flow rate through the system (from the effluent discharge of the oil-water separator) ranged from 20 gallons per minute (gpm) at the start up of the system to approximately 11 gpm during 2006 and 2007. The direction of flow appears to be controlled by groundwater flow and the topography of the bedrock. The presence of the 30-mil PVC geomembrane prevents oil migration to the Sabattus River to the east and the presence of a native marine clay base or a bedrock base prevents oil migration vertically. Annual sampling and testing results for DRO from the downgradient groundwater monitoring well (MW-201) during the system's operation from 1991 through 2007 were well below the MEDEP limit of 15 ppm. Figure 3 provides a cross-section schematic of the site hydrogeology and the subsurface oil recovery system in operation from 1990 until 2007.

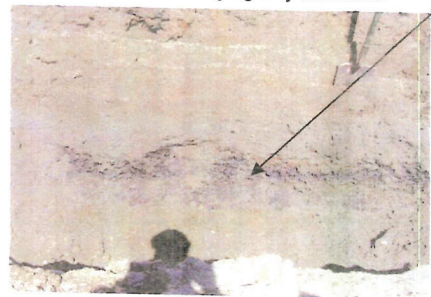
All three test pits (designated as TP-1, TP-2 and TP-3) showed the presence of No. 6 fuel oil in the coarse backfill material under the 4-inch perforated PVC infiltration pipe. Within all three test pits, No. 6 fuel oil was not observed in the natural soil (a silty fine sand) under the coarse backfill, adjacent to the coarse backfill, or in the fine sand above the coarse backfill. Although the coarse backfill was visibly stained with No. 6 fuel oil, it was loose and appeared to be porous.

Within each test pit, a cross section of infiltration pipe was cut out for inspection, and the remaining pipe was repaired with a coupling. The pipe on the west side of the distribution box appeared to be Schedule 35 PVC, and the pipe on the east side of the distribution box appeared to be Schedule 40 PVC. Both pipes contained circular 1/2-inch diameter perforations on the bottom of the pipe spaced approximately 6 inches apart. The cross section of pipe extracted from TP-1 was completely filled with silty sand. The cross sections of pipe from TP-2 and TP-3 were clear (no silt, or sand were present), and the 1/2-inch perforations on the bottom of the pipe were open. Both sections from TP-2 and TP-3 showed evidence of No. 6 fuel oil and some orange (presumably iron) deposits on the interior of the pipe. Photos of the pipe cross sections from TP-1 and TP-2 are shown below:

1. Because the western portion of the infiltration pipe is filled with silty sand, hire an environmental contractor to clean the interior of the infiltration trench piping (using a jetting tool) and the interior of the distribution box.
2. After the infiltration system is cleaned, conduct a clean water test of the infiltration system to determine if future operations would cause overflow of the distribution box to the Sabattus River. This test would consist of discharging approximately 300 gallons of clean water into the distribution box at a rate similar to the rate the sump pump's discharge rate (10 to 15 gpm), and observing the on-site monitoring well and the banks of the river to see if any seeps break out through the rip rap.

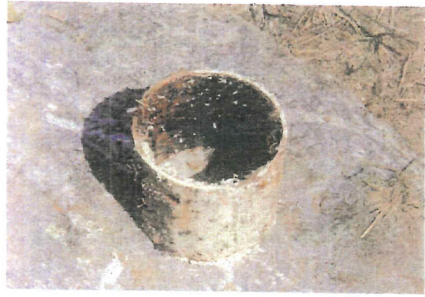
Photo 1. Infiltration pipe in test pits TP-2 and TP-3 not blocked.

- a. Figure 1 shows the locations of the three test pits completed on May 22, 2007. Test Pit 1 revealed that the northwest end of the infiltration pipe was filled with a silty sediment. Test Pits 2 and 3 showed no sediment in the infiltration pipe, and showed the perforations in the bottom were open. The coarse backfill under the infiltration trench contained visible No. 6 staining and concentrations of DRO above MEDEP Baseline 2 standards of 50 to 100 mg/kg. Observations of the fine silty sand under the coarse backfill did not contain any visible staining of No. 6 suggesting that the No. 6 fuel oil in the coarse backfill is not mobile and was not the cause of the sheen on the River on April 25, 2007.

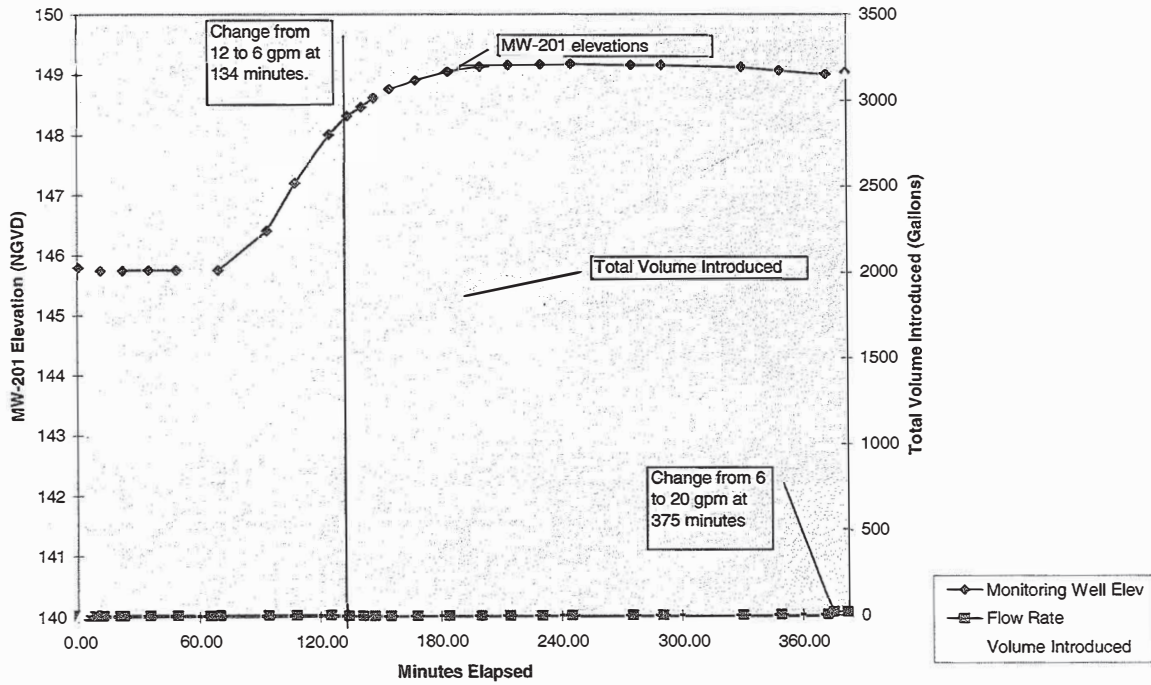
# Farwell Mill Infiltration Test

- b. The clean water test was conducted on August 17, 2007. Clean water was obtained from the hydrant at the entrance to the lower parking lot for Farwell Mill. Flow rates were adjusted using a ball valve and measured continuously using a rod guided flow meter. Water was introduced into the infiltration system distribution box through a garden hose. Water levels were monitored at the distribution box and in MW-201 to assess the impact on groundwater fluctuation. The 4-foot diameter and 10-foot diameter vaults were also monitored to ensure no water was flushing back through the check valves into the vaults. Attachment D contains summaries of the data collected. Water was introduced to the infiltration system at a rate of 12 gpm for approximately two hours. The water level in the distribution box and in MW-201 was constant for 1 hour and 10 minutes. For the remaining 50 minutes of discharge at this flow rate, the water level in MW-201 increased by 2.2 feet, suggesting the pore spaces had been saturated. During this initial flow rate, (1 hour and 49 minutes in the test) a steady seep emerged from the riprap on the embankment, indicating a preferential pathway for groundwater flow was present. The infiltration flow rate was decreased to 6 gpm, and the water levels in MW-201 stabilized, but the seep on the embankment continued for the duration of the test (an additional 4.5 hours). A dye test was conducted by

introducing dye into the distribution box 4 hours and 5 minutes into the test. The dye was never observed at the seep.

The persistence of the seep and the rapid rise of the water table after 1.5 hours of infiltration at 12 gpm (as indicated by MW-201 elevation changes) indicate that a new infiltration trench will be needed to accommodate the current flow rate.
