20 December 2019

Project Number: 3611191238

**Subject: Vulnerability Assessment and Resilience Planning, Town Dock, Castine, Maine
Penobscot Bay Working Waterfront Resiliency Analysis
State of Maine, Department of Marine Resources**

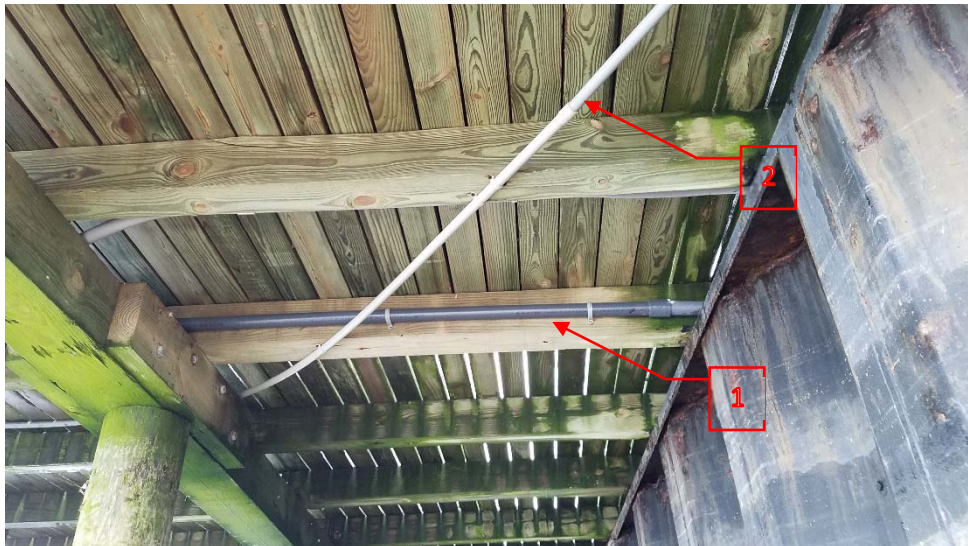
Photograph No. 6:

View of underside of pier and condition of timber framing.

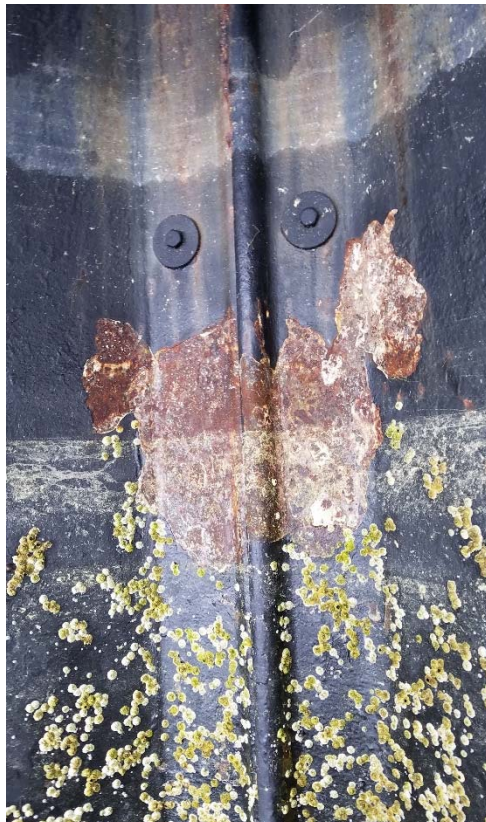
Photograph No. 8:

Typical view exhibiting condition of sheet pile wall at face of wharf.

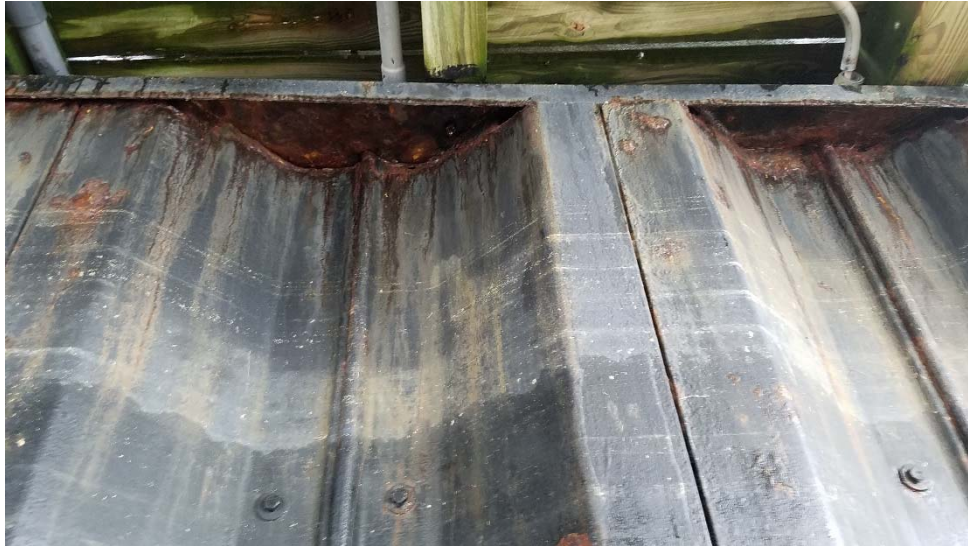
Photograph No. 9:

Close-up at top of sheet pile wall showing header angle or channel.

Signs of apparent surface corrosion. Extent of corrosion must be determined by intrusion means.

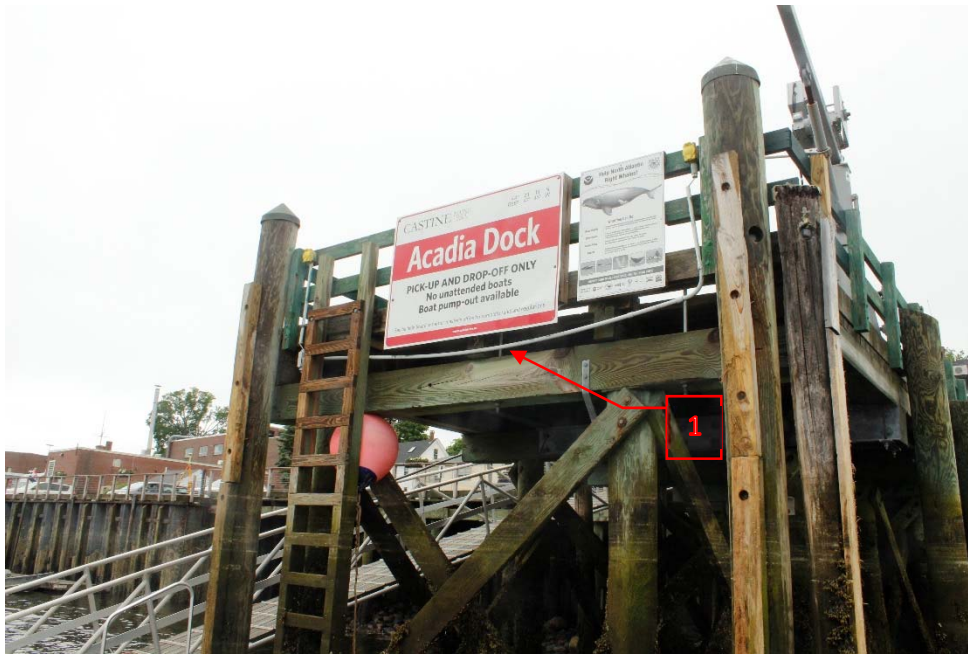
Photograph No. 15:

View facing west at pier.

1. Electrical utilities noted at exterior of pier.

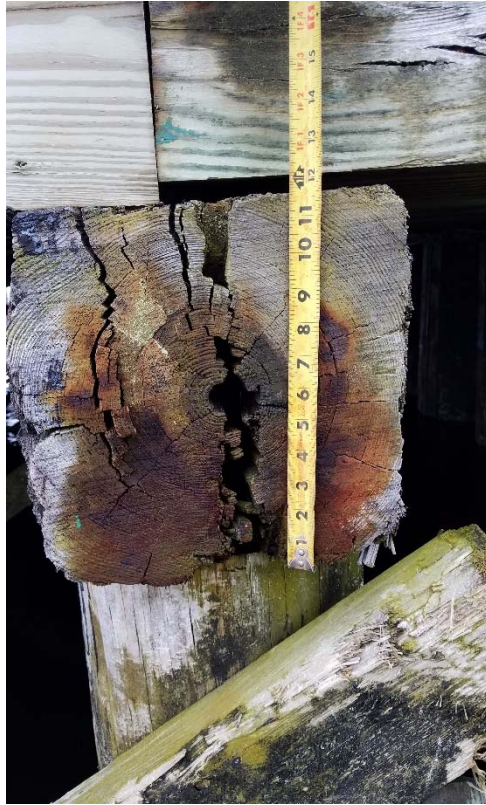
Photograph No. 19:

Severe splits and/or checks in the timber cross section.

Condition noted in photo is located at adjacent pier structure south of site of interest (See previous photograph) and considered out of scope. However, due to the serious extent of deterioration we have noted here with regard to the potential for substantial damage during wave action of the Present Day scenario for the Base Flood Elevation. See data in Tables 2 & 3 and Appendix C of the report.

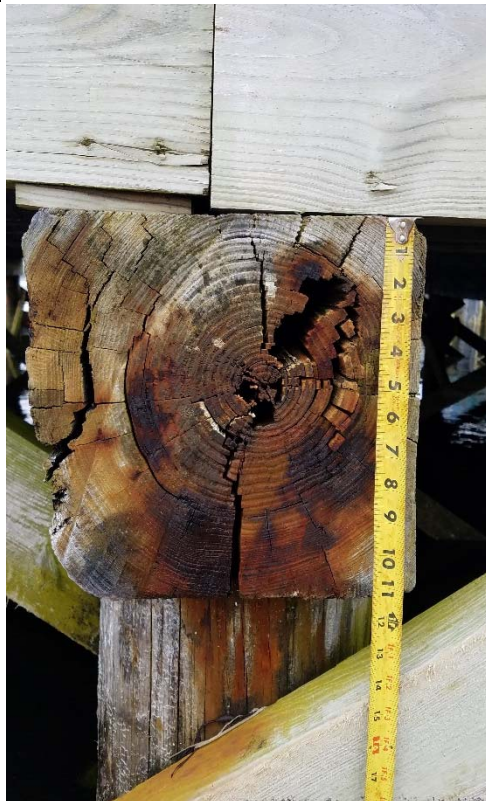
Photograph No. 20:

Additional location of severe splits and/or checks in the timber cross section (adjacent site).

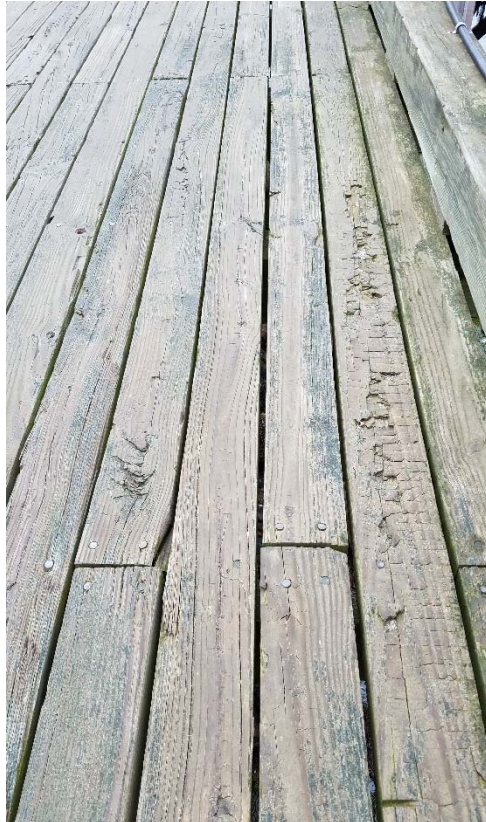
Photograph No. 23:

Close-up of condition of deck timber.

Moderate deterioration with signs of weathering and minor delamination.

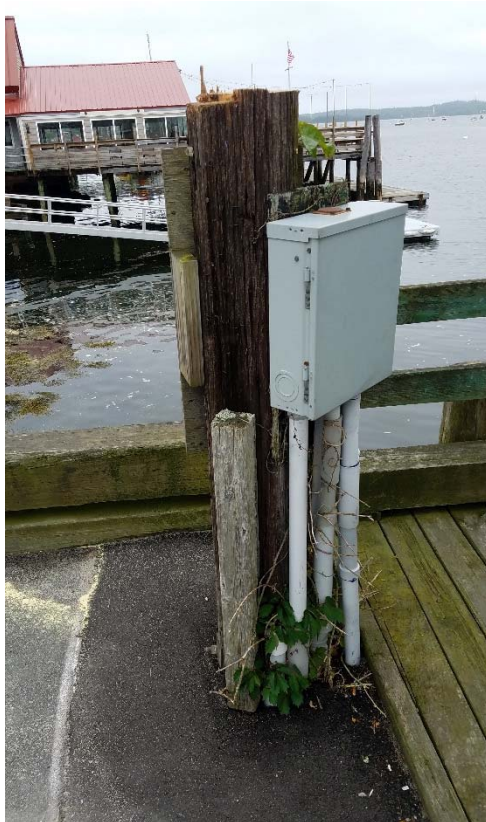
Photograph No. 27:

Electrical equipment near office. Some equipment appears to be waterproof, however the cabinet construction should be verified.

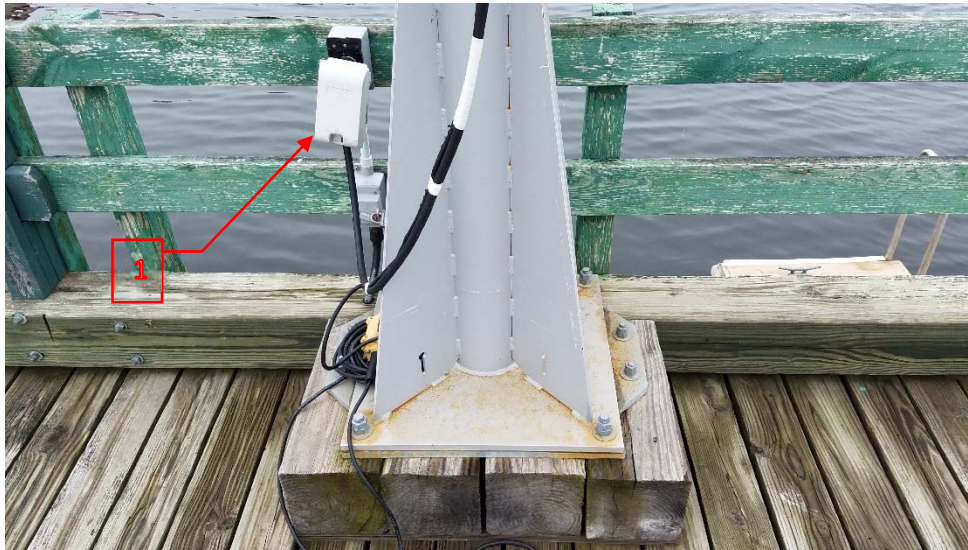
Photograph No. 29:

Close-up of deck hoist attachment to deck.

Outlets should be raised above DFE and/or weatherized to prevent damage to system.

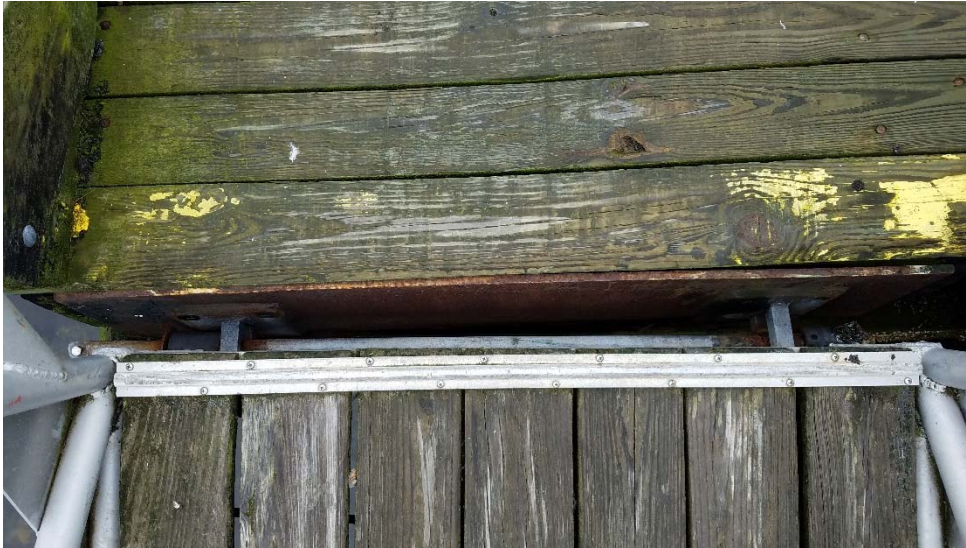
Photograph No. 31:

View of gangway attachment to wharf via metal header.

Signs of corrosion noted at header and rod/pin steel.

- Clean and coat all corroded steel framing members and replace corroded hardware. Confirm that all members are positively connected and the substrate is in decent condition to resist the intended design loading
- Confirm the gangway attachments are sufficient to resist the design loading and repair or replace as needed.
- Moor all floats to independent float piles or using mooring chains/ropes anchored to the seabed.

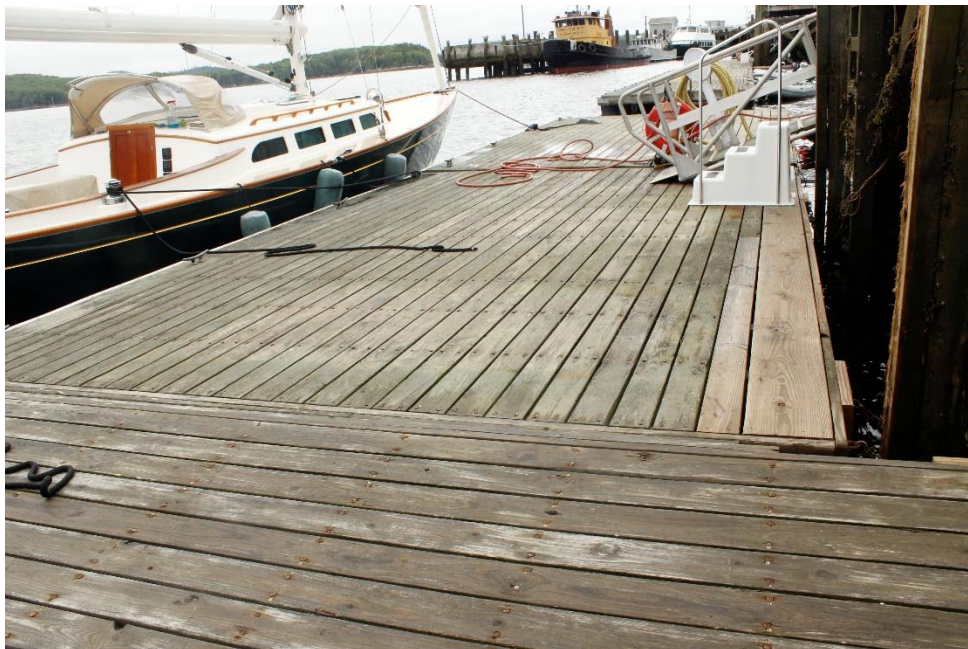
Photograph No. 34:

Closer view of floating dock. Condition noted as decent. pontoons appear to function as intended.

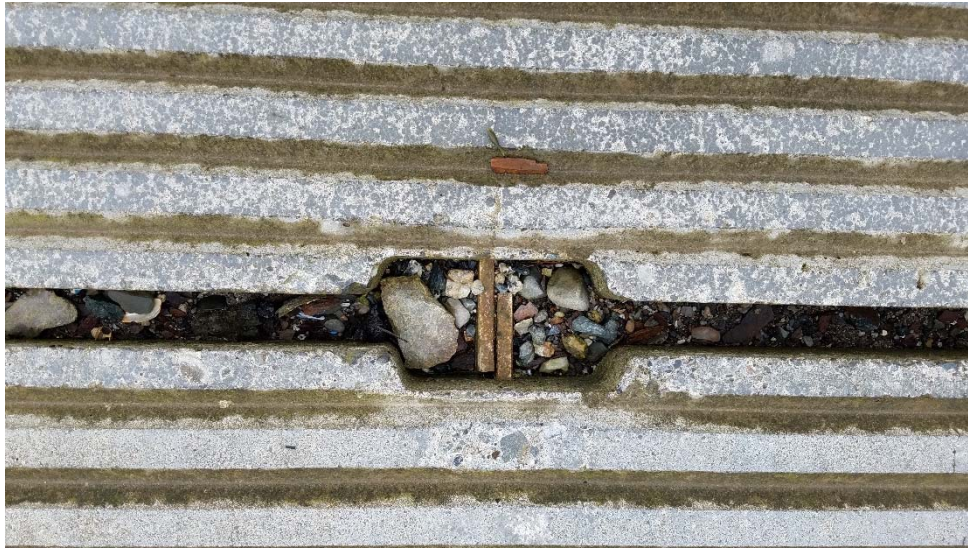
Photograph No. 39:

Close-up of panel connection at boat ramp. Embedded steel with minor corrosion.
