Pavement Condition Report

BETHEL REGIONAL AIRPORT (OB 1)

To assist individual airports to effectively maintain their pavement infrastructure and help improve airport pavement conditions statewide, the Maine Department of Transportation (MaineDOT) contracted with DuBois & King, Inc. (D&K) to provide pavement evaluation surveys at local airports. Assisting D&K on this effort was Applied Research Associates, Inc. (ARA). This report documents the pavement condition at Bethel Regional Airport (OB1) in November 2018.

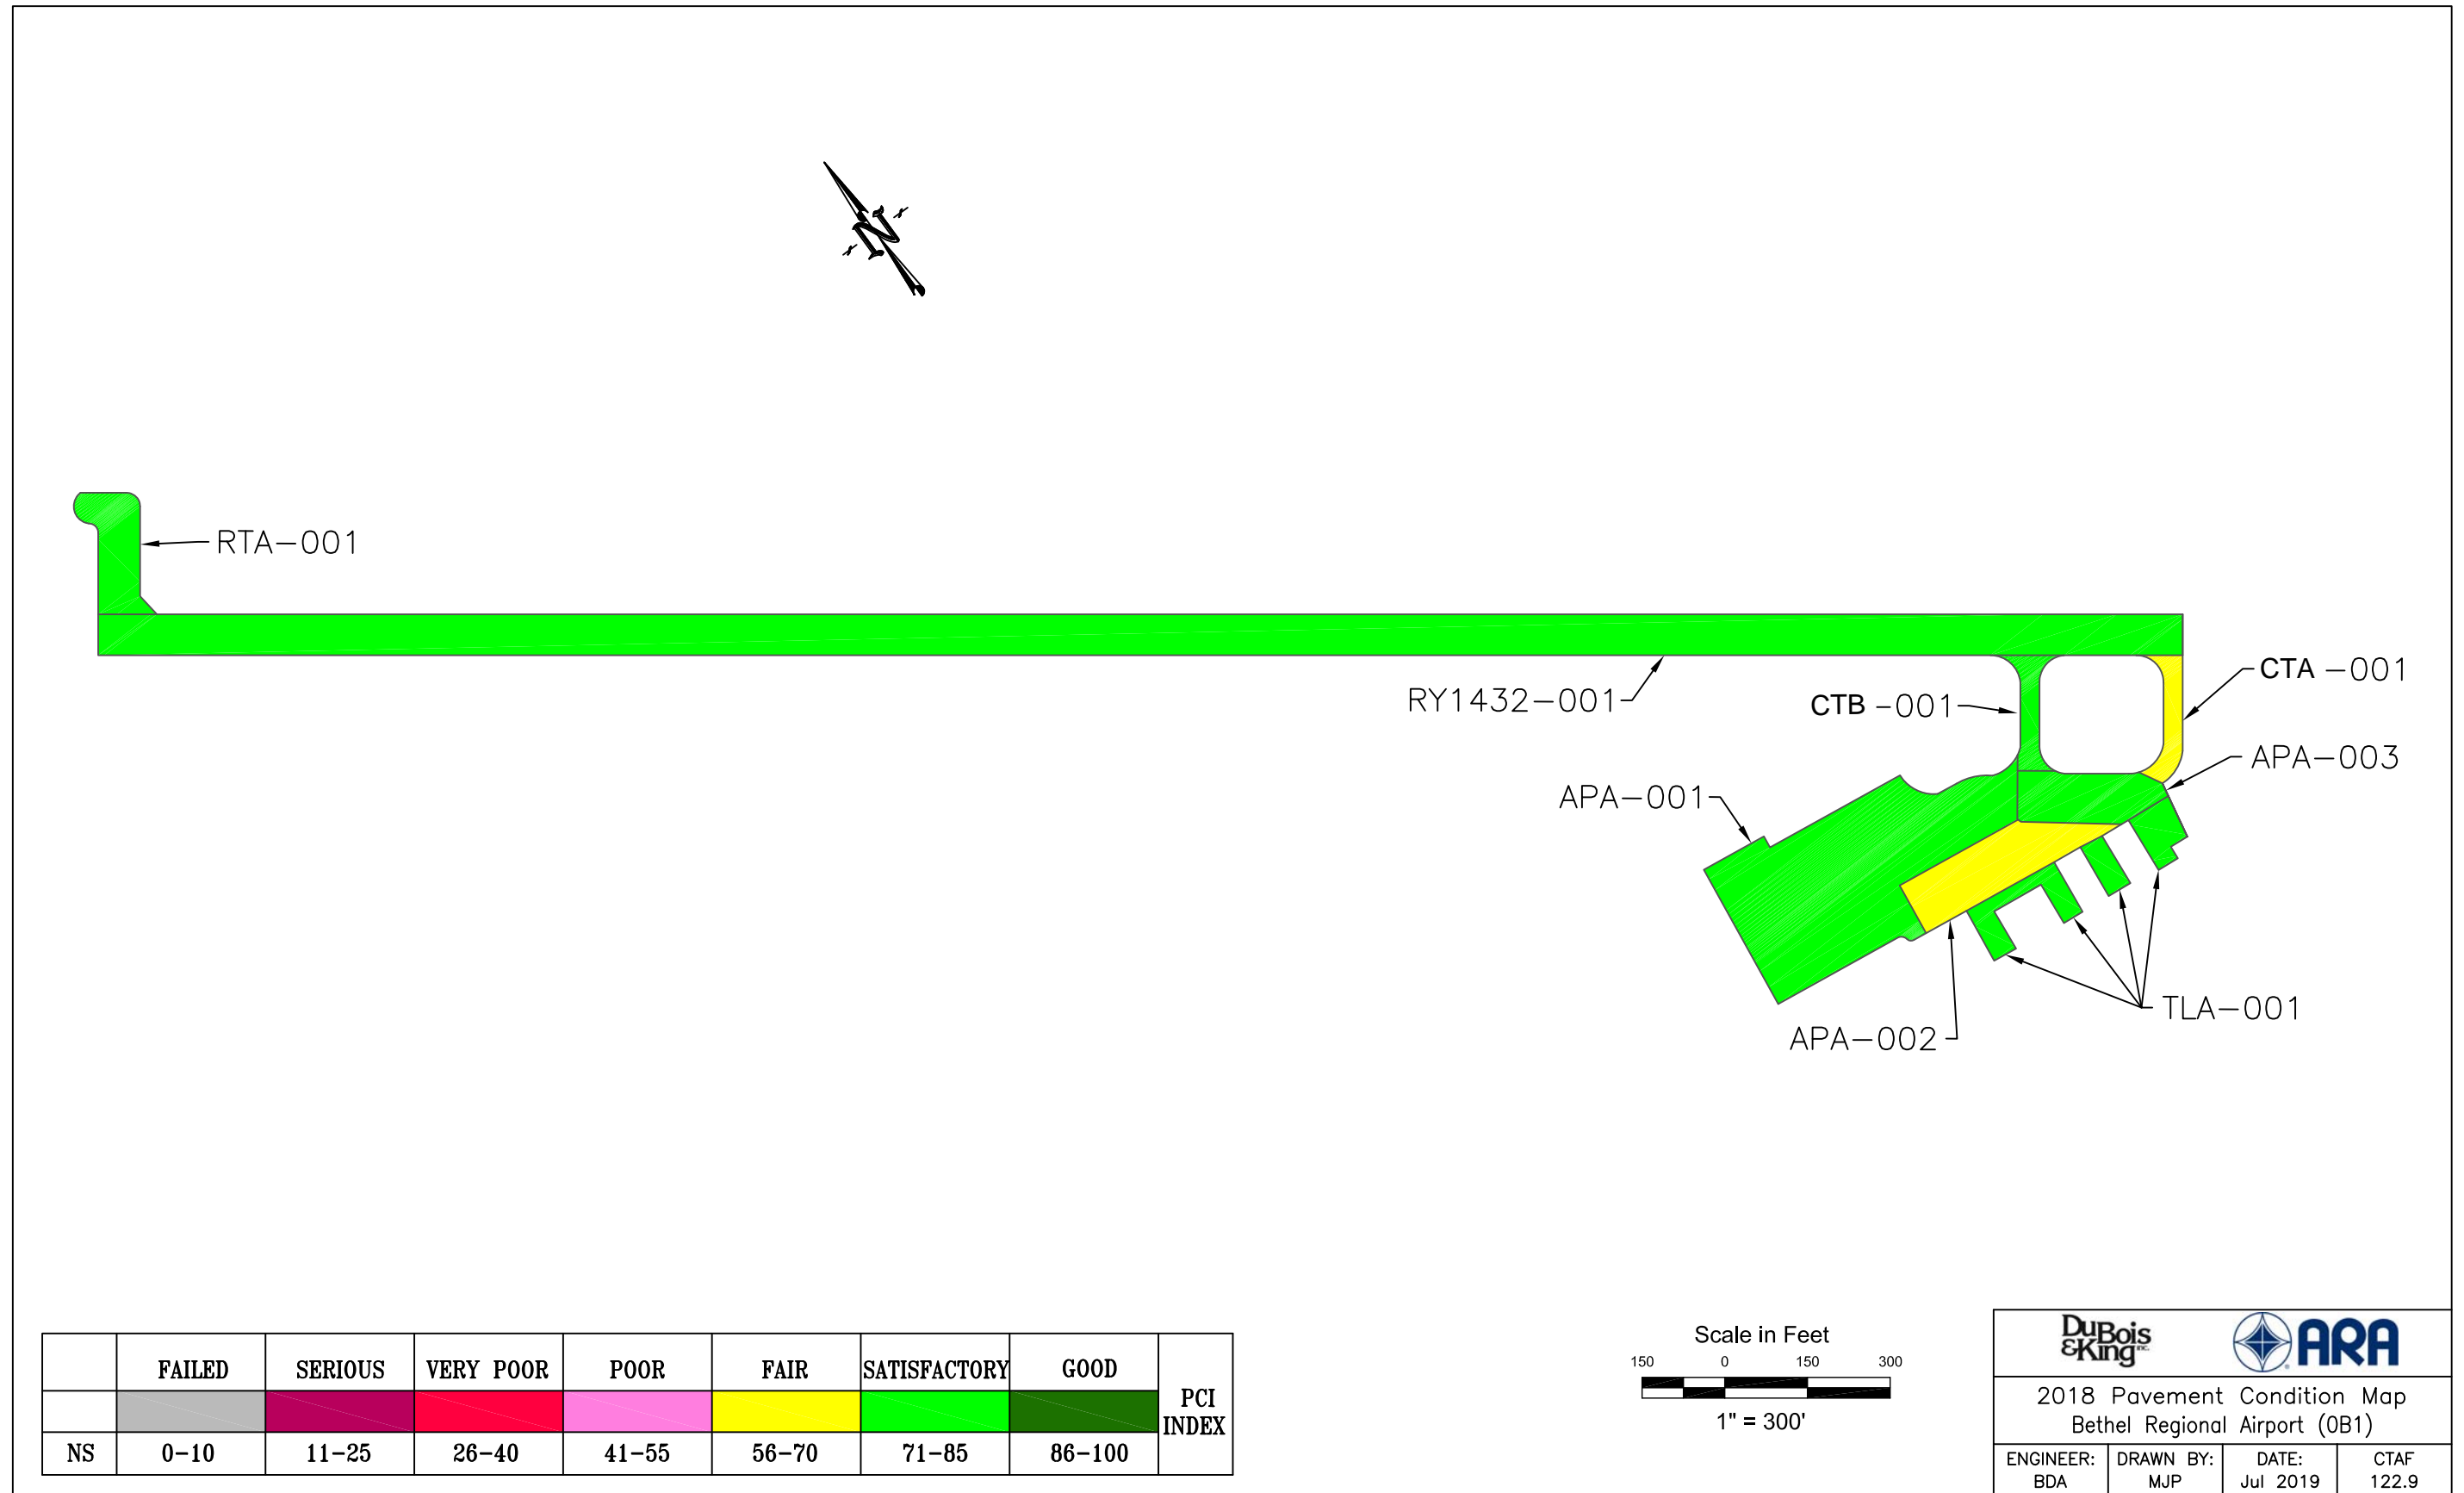
2018 Pavement Condition Map
Bethel Regional Airport (OB1)

The average inspected Pavement Condition Index (PCI) for all the airfield pavements at OB1 was 74. Runway 14-32 had an average inspected PCI of 71, which is above the MSL of 70. Taxiways had an average inspected PCI of 74, taxilanes had an average inspected PCI of 73, and aprons had an average inspected PCI of 79. A comparison of the average PCI values at OB1 to the statewide average PCI values, by branch use, is shown in the figure below.

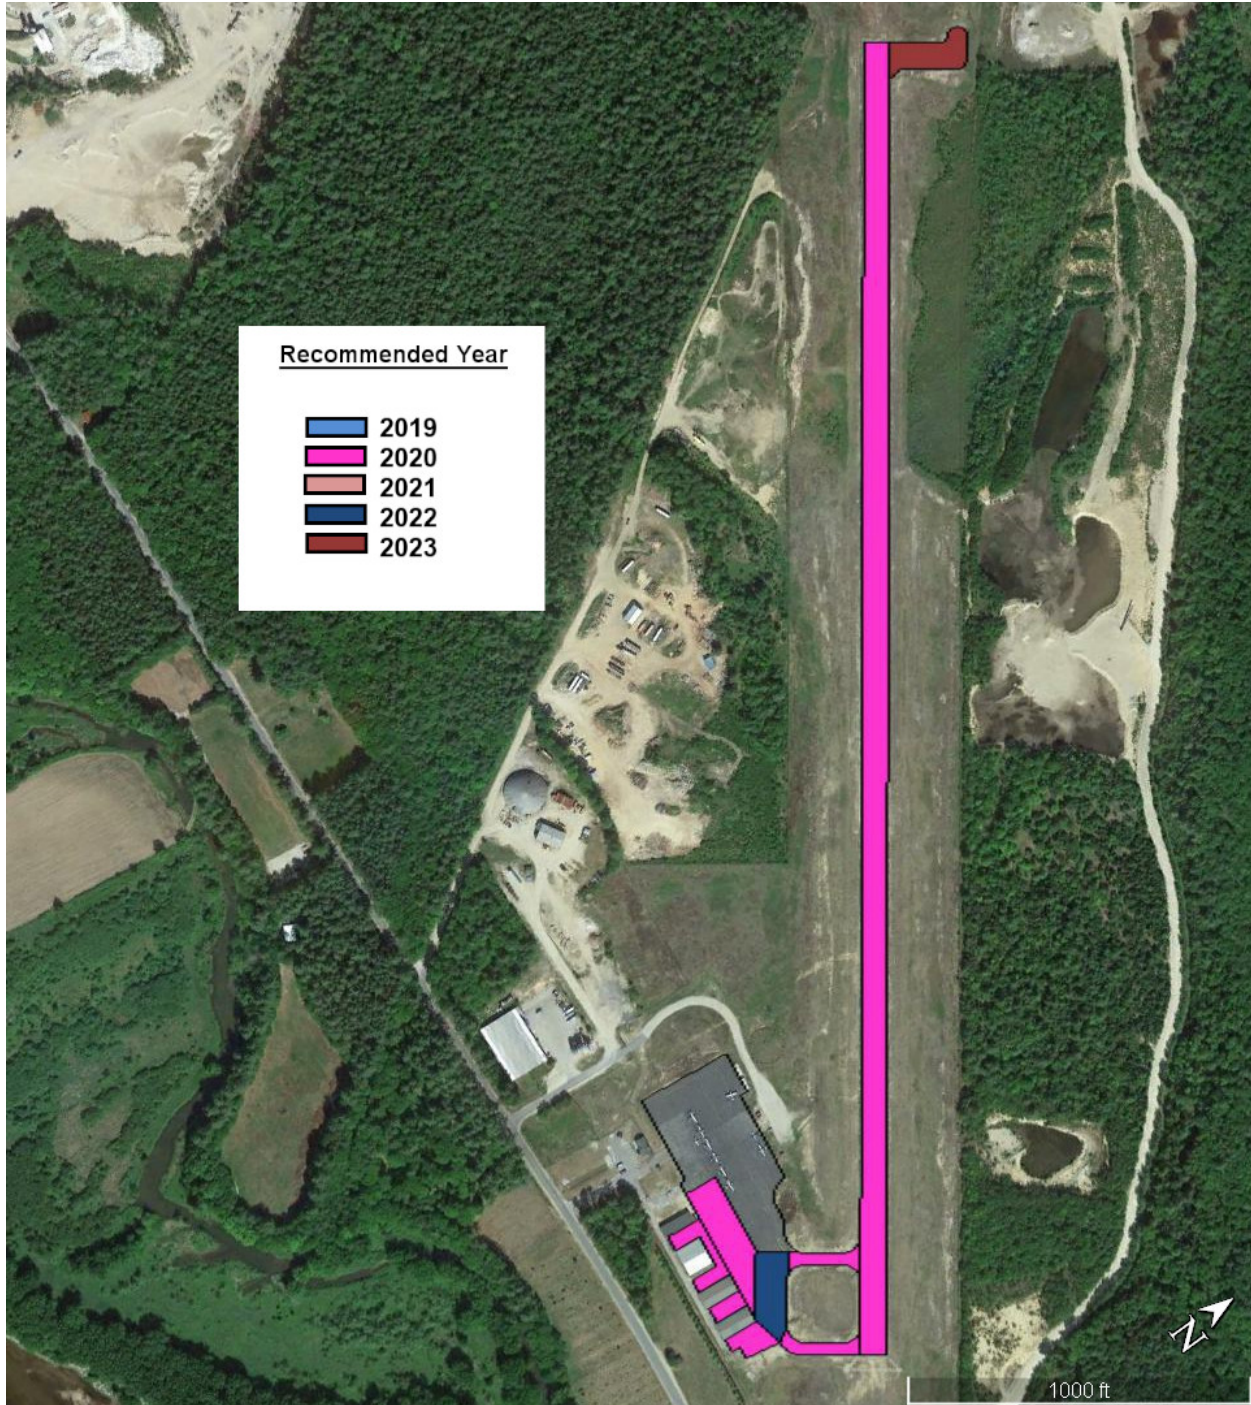
Figure 9. Major M&R

The pavement sections identified for major rehabilitation in Table 10 and shown in Figure 9 are at or are predicted to reach a condition level where major M&R should be considered. While the predicted rehabilitation timeline identifies specific sections and the general timing for the repair, more in-depth project-level studies will be needed to determine exactly how to fix each pavement (i.e. asphalt overlay, reconstruction, or some other repair alternative). Additionally, the airport may find it desirable to adjust the timing of projects to meet fiscal and operational constraints. For example, if the runway and several connector taxiways were forecast to reach the MSL in various years ranging from 2019-2023, it may be preferable to group these pavement sections into a single project.
