# *Maine Department of Transportation*

Pavement Condition Report

## **GREENVILLE MUNICIPAL AIRPORT (3B 1)**

Submitted To:  
Maine Department of Transportation  
16 State House Station  
Augusta, ME 04333

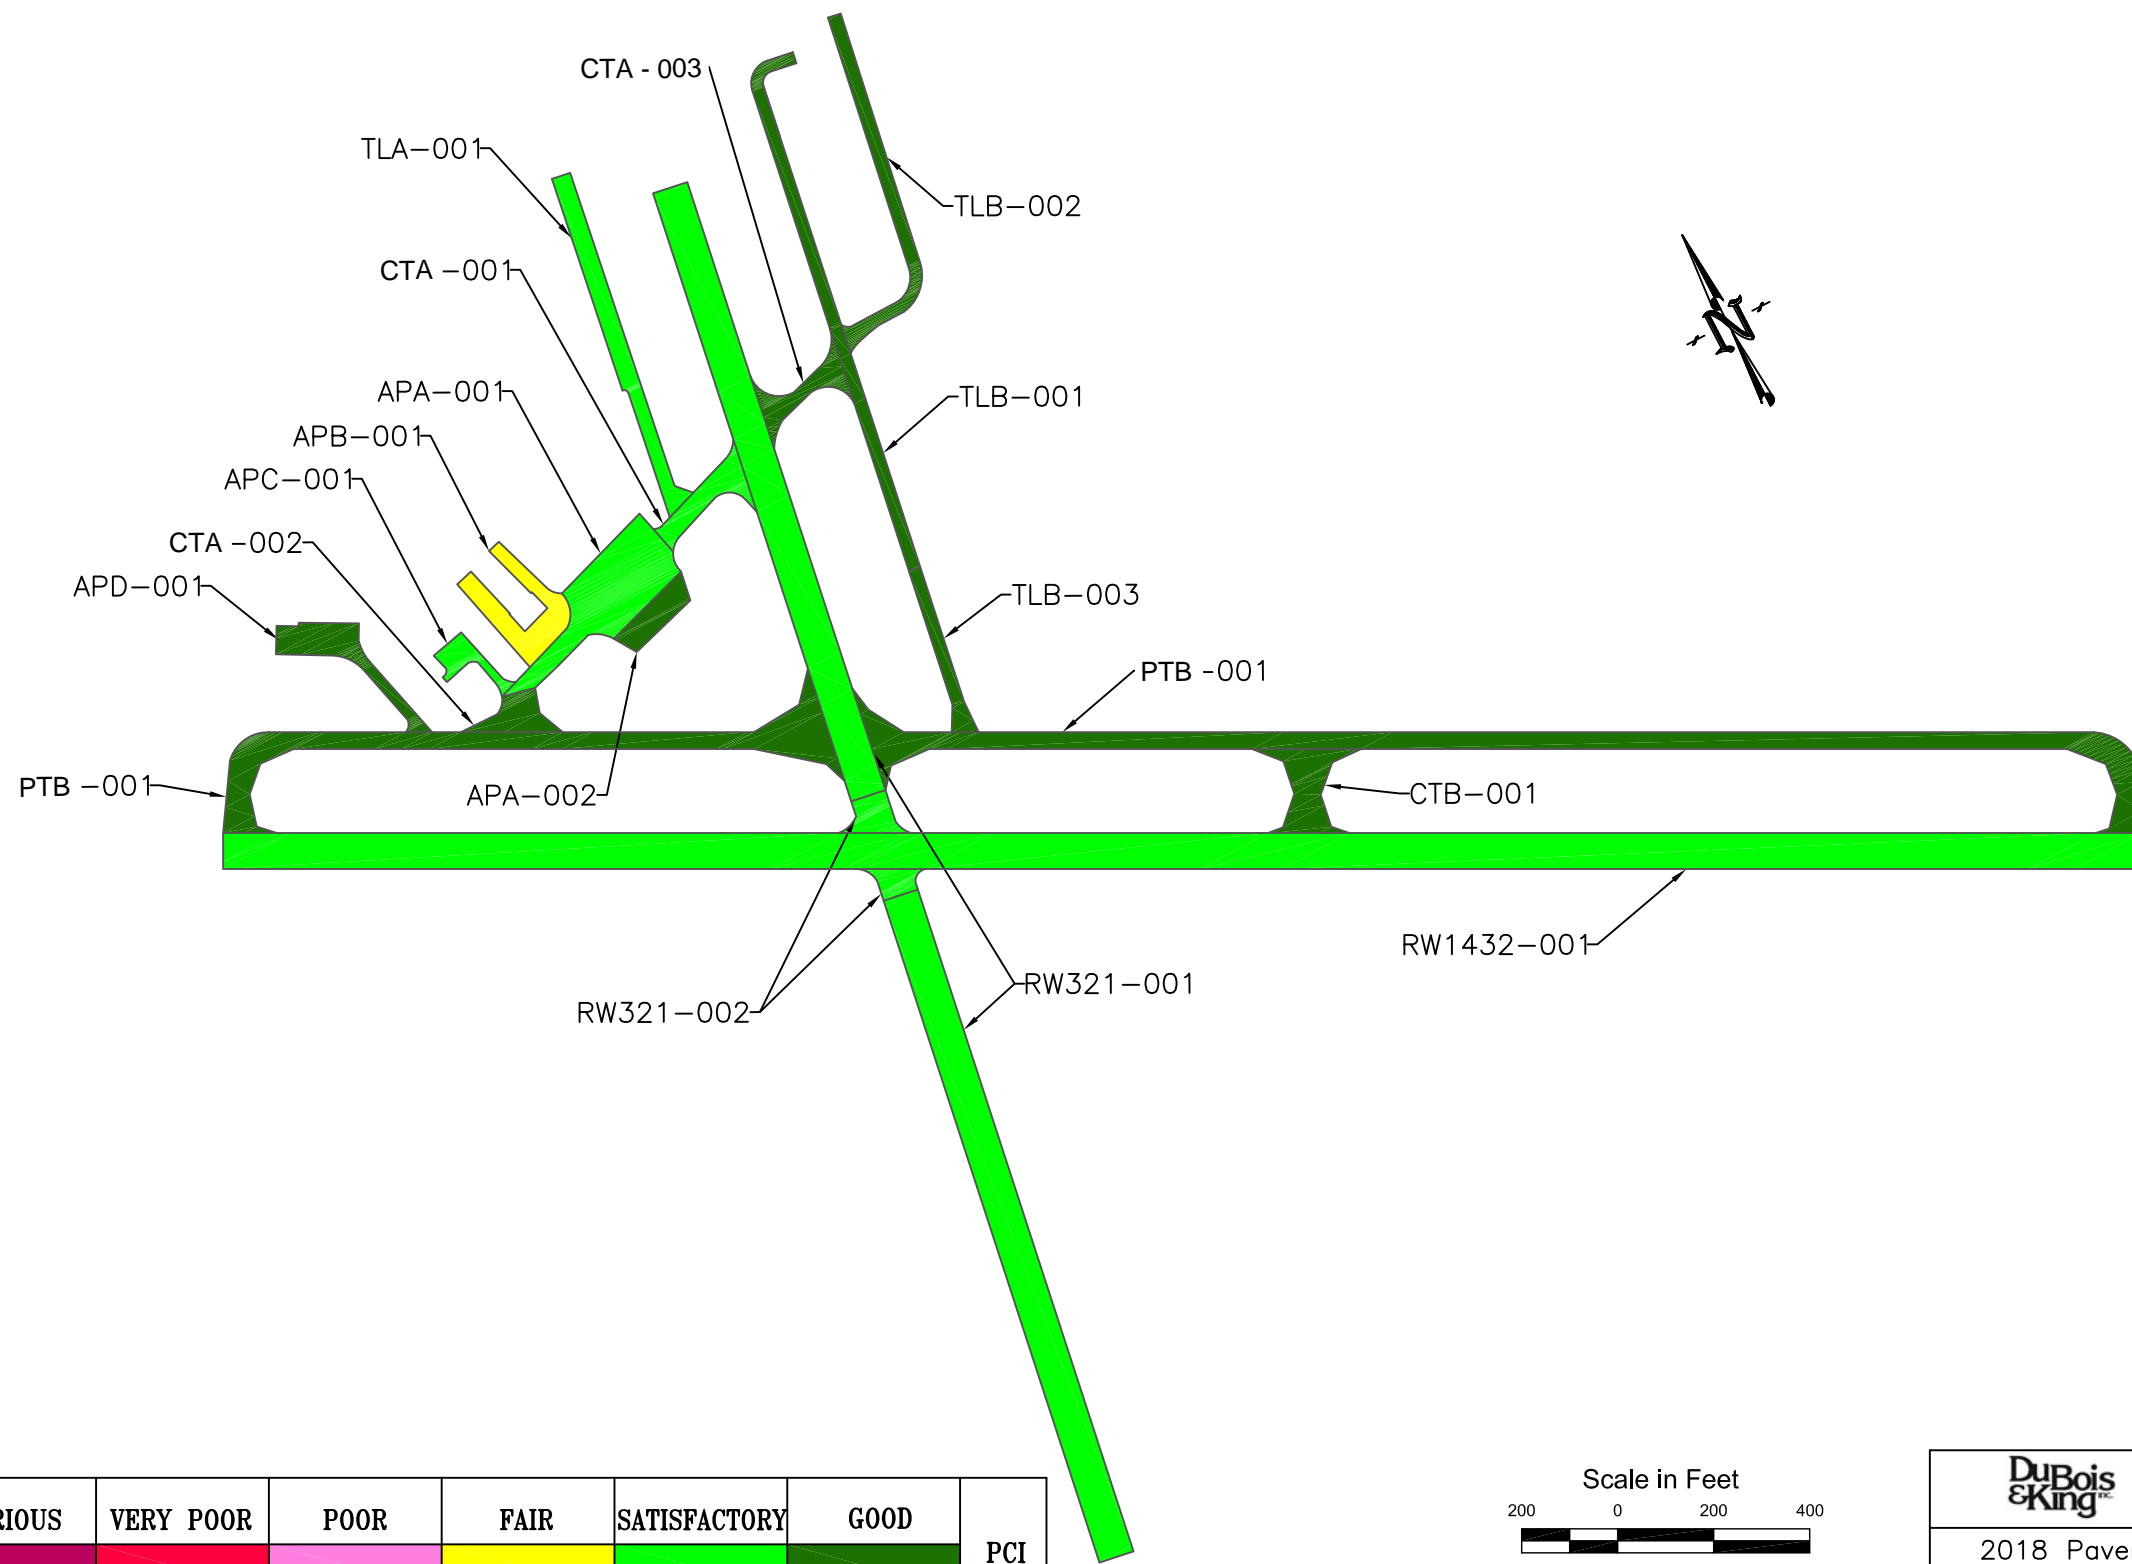
2018 Pavement Condition Map  
Greenville Municipal Airport (3B1)

FAILED	SERIOUS	VERY POOR	POOR	FAIR	SATISFACTORY	GOOD	PCI INDEX
NS	0-10	11-25	26-40	41-55	56-70	71-85	86-100

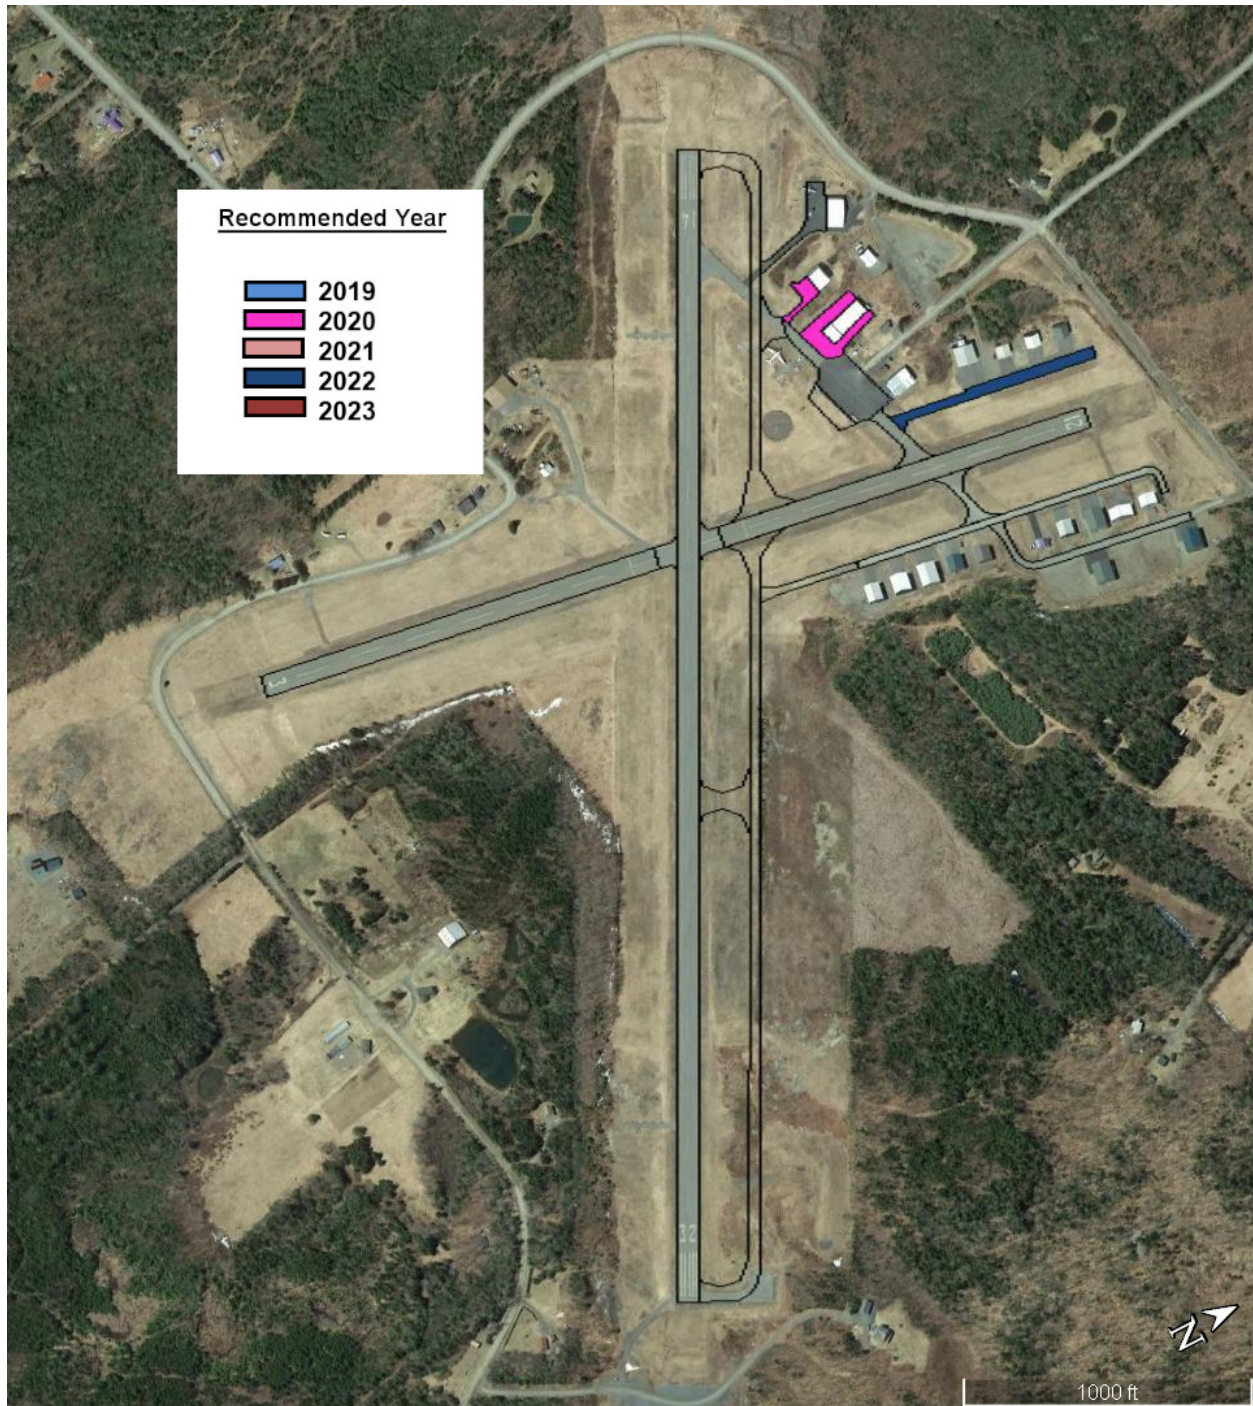
Figure 9. Major M&R

The pavement sections identified for major rehabilitation in Table 10 and shown in Figure 9 are at or are predicted to reach a condition level where major M&R should be considered. While the predicted rehabilitation timeline identifies specific sections and the general timing for the repair, more in-depth project-level studies will be needed to determine exactly how to fix each pavement (i.e. asphalt overlay, reconstruction, or some other repair alternative). Additionally, the airport may find it desirable to adjust the timing of projects to meet fiscal and operational constraints. For example, if the runway and several connector taxiways were forecast to reach the MSL in various years ranging from 2019-2023, it may be preferable to group these pavement sections into a single project.

Branch ID	Section ID	Year	Predicted PCI Before Rehab	Estimated Cost
APB	001	2020	54	\$414,113
APC	001	2020	67	\$18,150
TLA	001	2022	68	\$75,623
<b>5-year Airport Total</b>				<b>\$507,886</b>

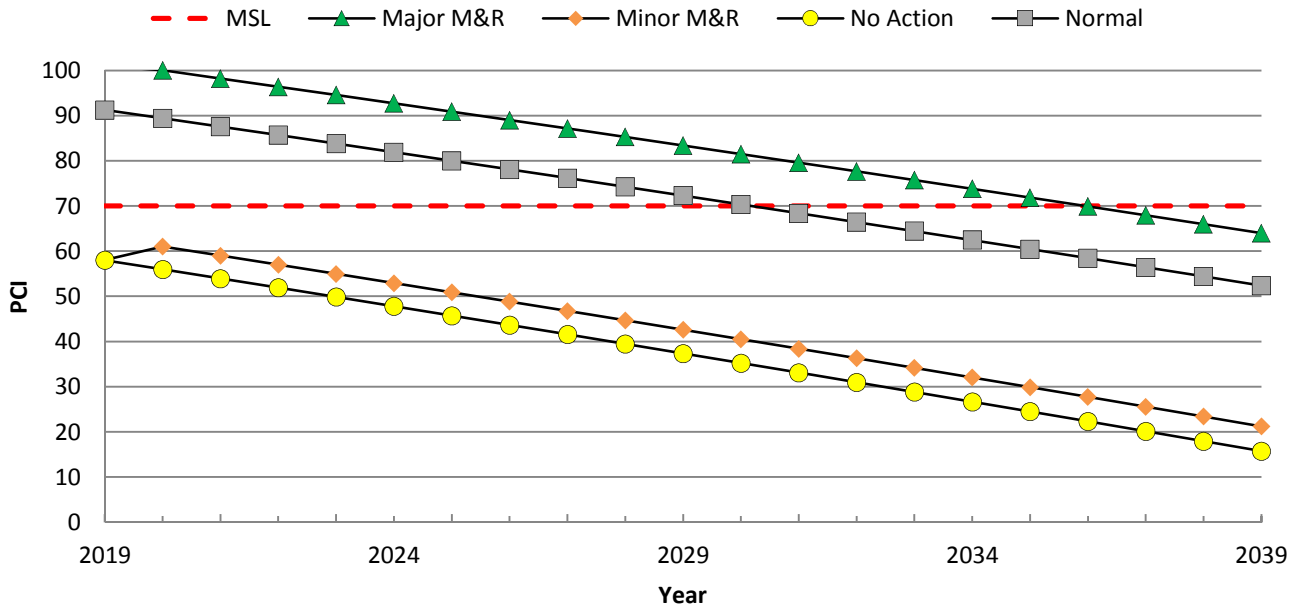
Apron B

<sup>4</sup> Higher than average deterioration rate of 10.5 PCI/Yr for APB-001 is due to low-and medium-severity alligator cracking on a four year old pavement.

M&R	Action	Year / Quantity	Cost (\$)	Ending PCI
Major	Major M&R	2020	414,113	100
Minor	All Minor	2020	1,121	61
1	Patching - AC Deep	60 SqFt	1,121	-
2	-	-	-	-
3	-	-	-	-
4	-	-	-	-
5	-	-	-	-
6	-	-	-	-
7	-	-	-	-

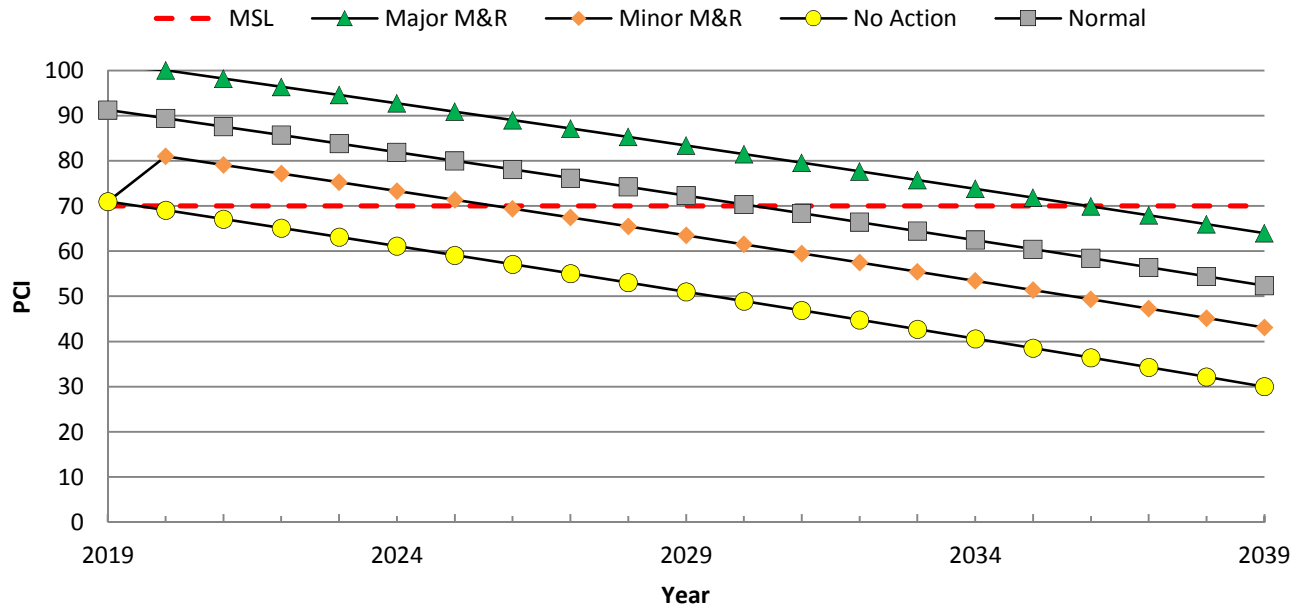
Apron C

<sup>5</sup> Higher than average deterioration rate of 7.3 PCI/Yr for APC-001 is due to a significant amount of medium-severity L&T cracking on a four year old pavement.

M&R	Action	Year / Quantity	Cost (\$)	Ending PCI
Major	Major M&R	2020	18,150	100
Minor	All Minor	2020	436	81
1	Crack Sealing - AC	316 Ft	436	-
2	-	-	-	-
3	-	-	-	-
4	-	-	-	-
5	-	-	-	-
6	-	-	-	-
7	-	-	-	-
