Pavement Condition Report

## **BIDDEFORD MUNICIPAL AIRPORT (KB19)**

To assist individual airports to effectively maintain their pavement infrastructure and help improve airport pavement conditions statewide, the Maine Department of Transportation (MaineDOT) contracted with DuBois & King, Inc. (D&K) to provide pavement evaluation surveys at local airports. Assisting D&K on this effort was Applied Research Associates, Inc. (ARA). This report documents the pavement condition at Biddeford Municipal Airport (B19) in November 2018.

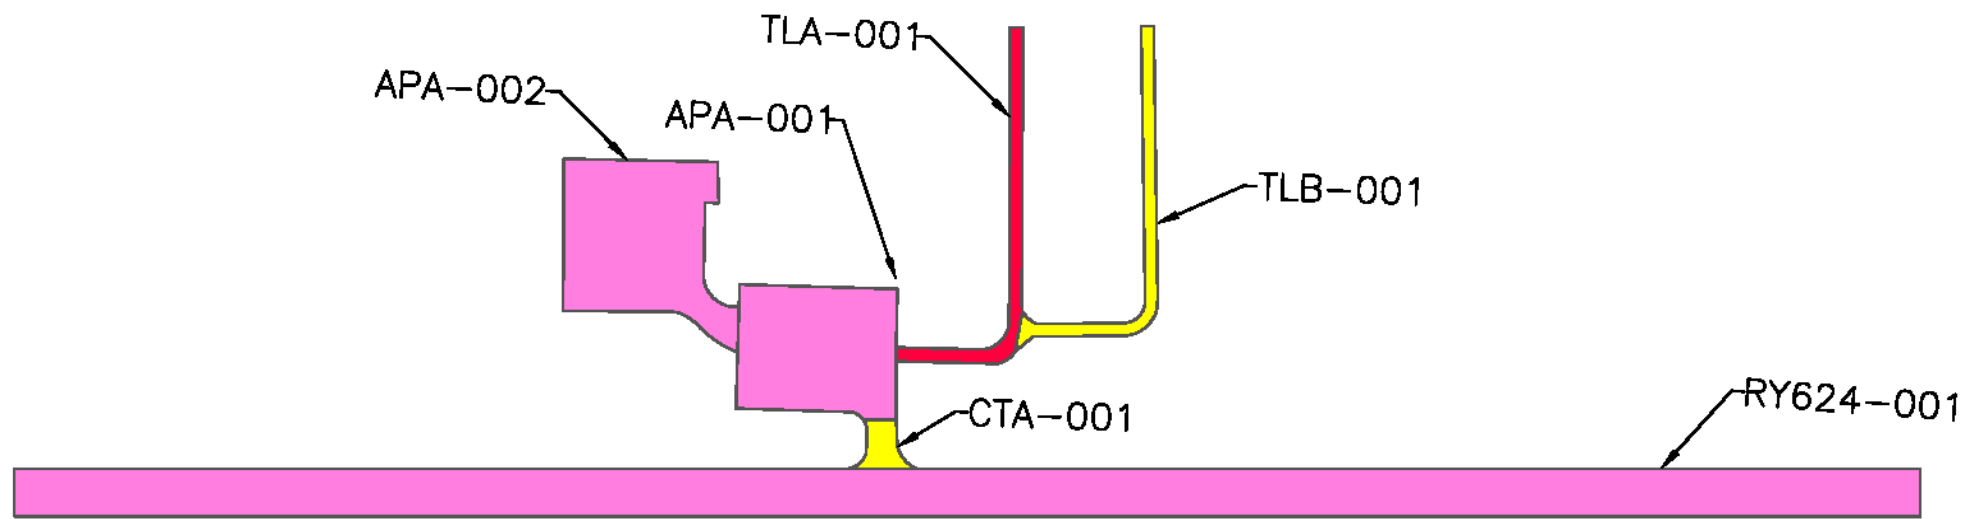
<b>2018 Pavement Condition Map Biddeford Municipal Airport (B19)</b>			
ENGINEER: BDA	DRAWN BY: MJP	DATE: Jul 2019	CTAF 123.0

The average inspected Pavement Condition Index (PCI) for all the airfield pavements at B19 was 50. Runway 6-24 had an average inspected PCI of 54, which is below the MSL of 70. Taxiways had an average inspected PCI of 56, taxilanes had an average inspected PCI of 54, and aprons had an average inspected PCI of 41. A comparison of the average PCI values at B19 to the statewide average PCI values, by branch use, is shown in the figure below.

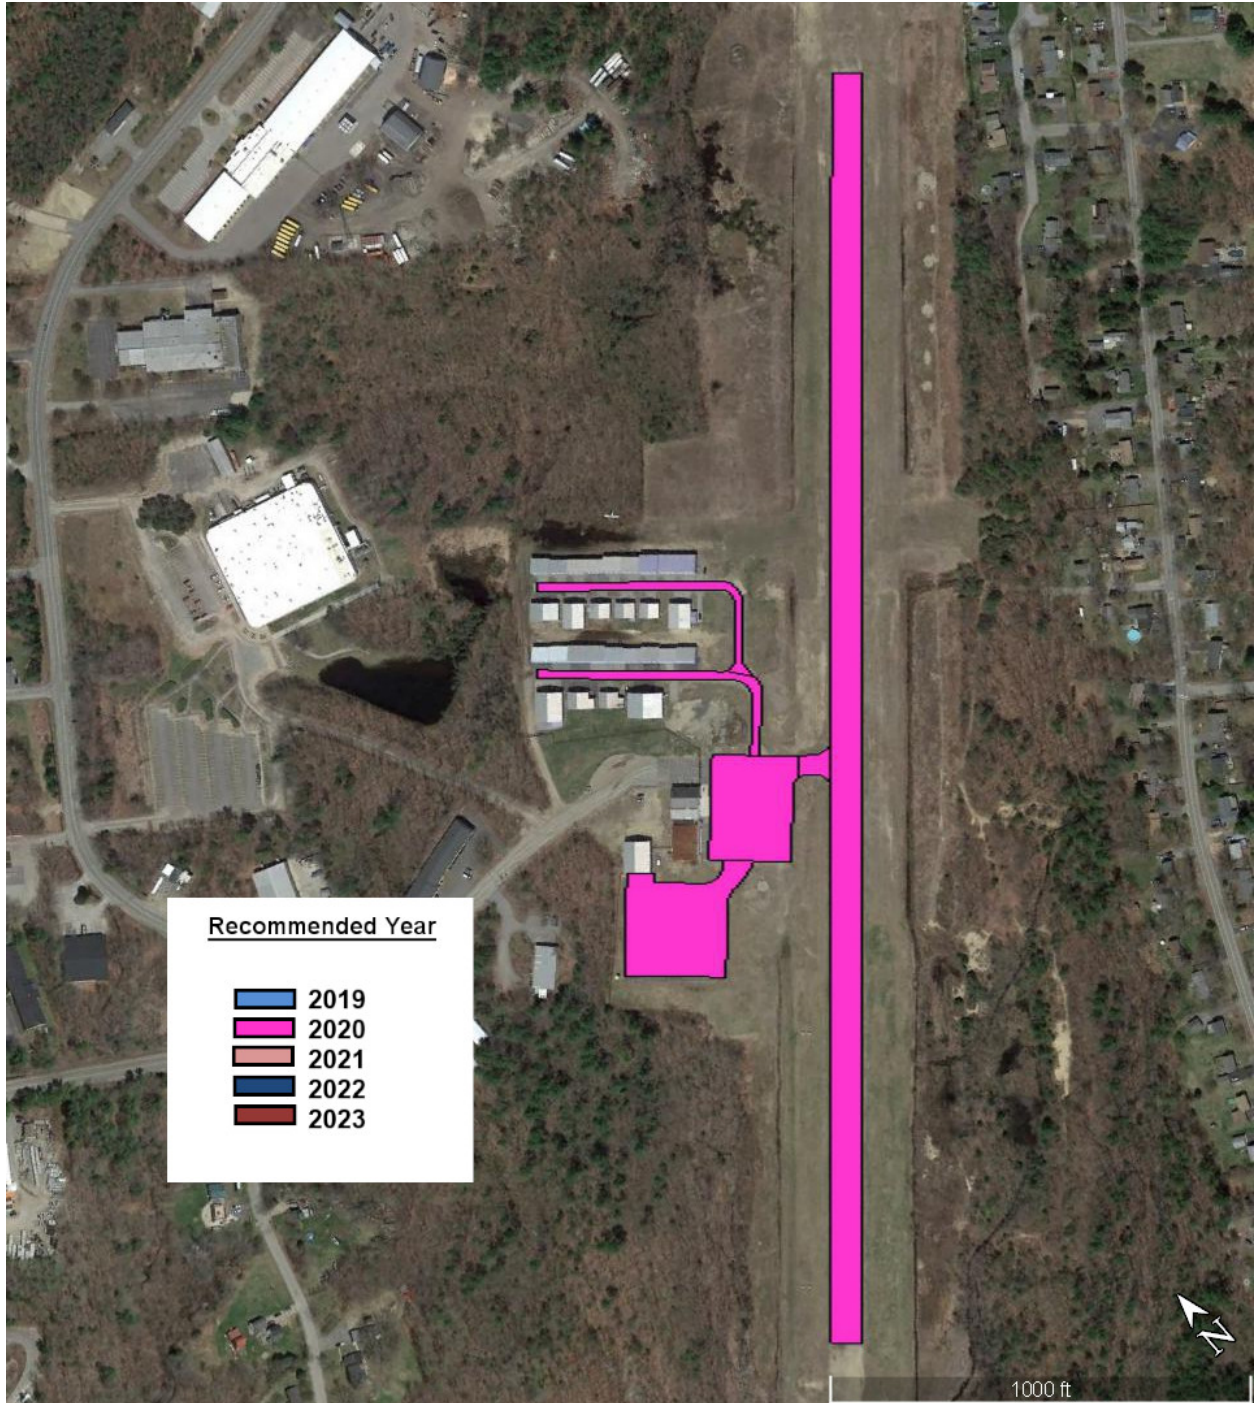
Figure 9. Major M&R

The pavement sections identified for major rehabilitation in Table 10 and shown in Figure 9 are at or are predicted to reach a condition level where major M&R should be considered. While the predicted rehabilitation timeline identifies specific sections and the general timing for the repair, more in-depth project-level studies will be needed to determine exactly how to fix each pavement (i.e. asphalt overlay, reconstruction, or some other repair alternative). Additionally, the airport may find it desirable to adjust the timing of projects to meet fiscal and operational constraints. For example, if the runway and several connector taxiways were forecast to reach the MSL in various years ranging from 2019-2023, it may be preferable to group these pavement sections into a single project.
