Maine Department of Transportation

Pavement Condition Report

CARIBOU MUNICIPAL AIRPORT (KCAR)

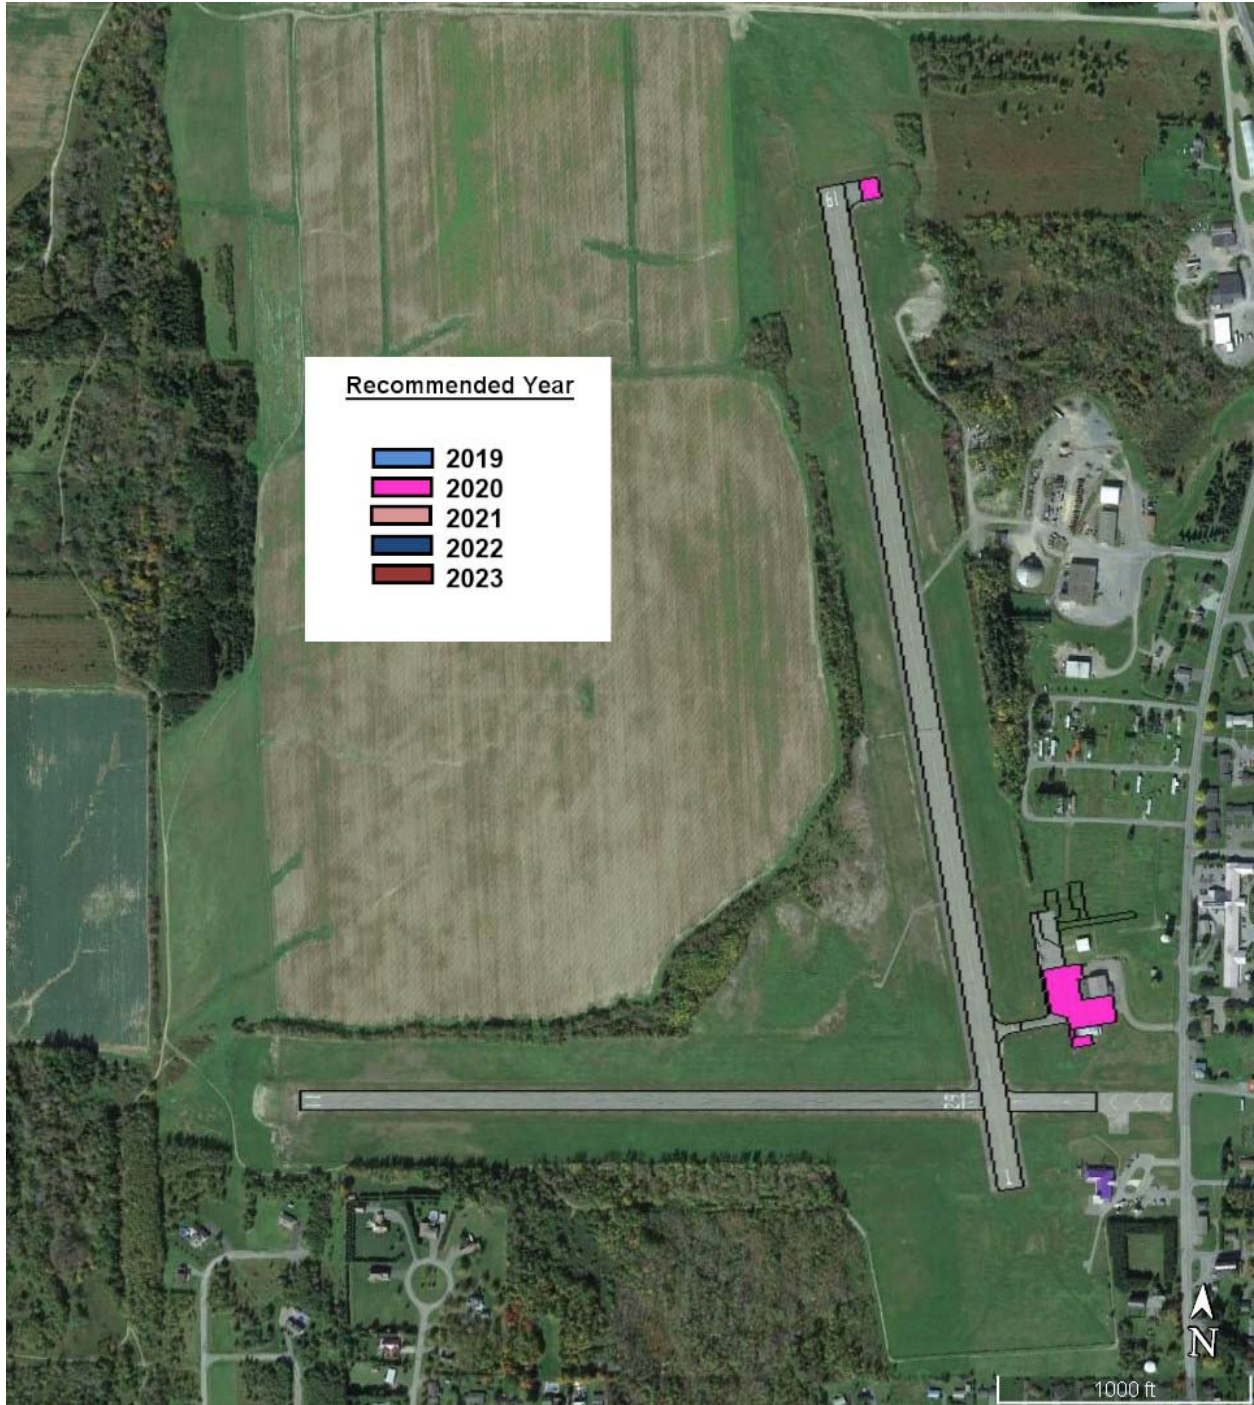
Figure 9. Major M&R

The pavement sections identified for major rehabilitation in Table 10 and shown in Figure 9 are at or are predicted to reach a condition level where major M&R should be considered. While the predicted rehabilitation timeline identifies specific sections and the general timing for the repair, more in-depth project-level studies will be needed to determine exactly how to fix each pavement (i.e. asphalt overlay, reconstruction, or some other repair alternative). Additionally, the airport may find it desirable to adjust the timing of projects to meet fiscal and operational constraints. For example, if the runway and several connector taxiways were forecast to reach the MSL in various years ranging from 2019-2023, it may be preferable to group these pavement sections into a single project.

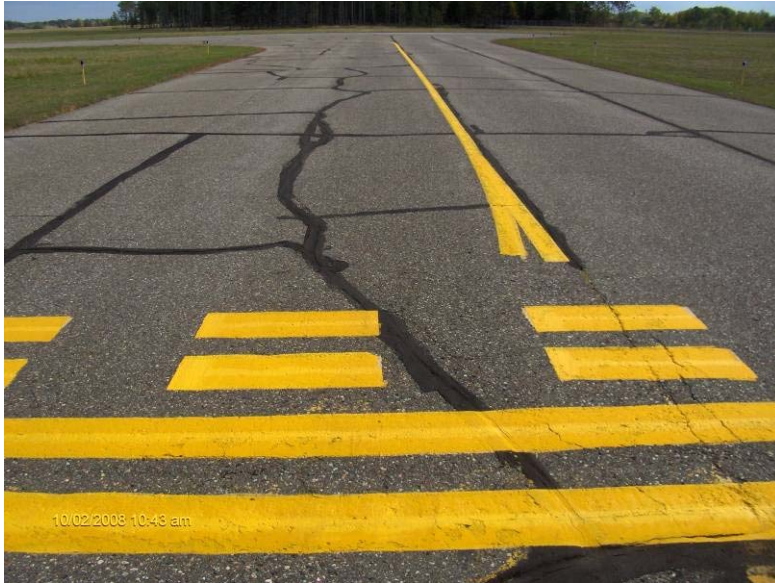
Example of Longitudinal and Transverse Cracking (L&T cracking)

Longitudinal and transverse cracks are caused by pavement aging, by construction, and by subsurface movement. Aging occurs as pavement loses some of its components to the atmosphere and becomes more brittle. Consistent application of pavement sealcoats can help to prevent the occurrence of age related cracks. Cracks will also develop along poorly constructed paving lane joints. Ensuring that joints are made when both sides are still hot, and near the same temperature, is one of the best ways to mitigate this potential problem. Seasonal movement caused by changes in moisture content or temperature differences can also cause pavement cracks. Asphalt pavement placed over a PCC pavement or cement stabilized base course may evidence reflective cracking from the underlying material. Longitudinal and transverse cracks are not caused by wheel loads, although traffic may worsen their condition.

Low severity longitudinal and transverse cracks are less than $\frac{1}{4}$ inch wide, or if sealed with suitable filler material in satisfactory condition can be any width, less than 3 inches, if they are not spalled. Maintenance usually is not indicated for low-severity cracking. Moderately spalled cracks and cracks wider than $\frac{1}{4}$ inch which are not satisfactorily sealed are at medium severity. Medium-severity cracks should be sealed with a high-quality crack filling material. Severely spalled cracks and cracks wider than 3 inches are at high severity. High-severity L&T cracks normally require patching.

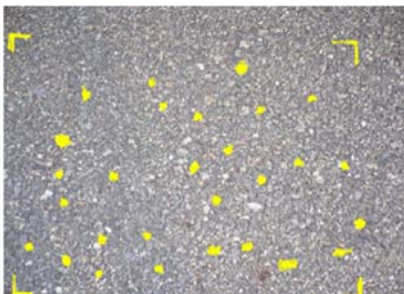
Raveling – At low severity, the number of missing coarse aggregates (> 3/8 inch) is between 5-20 missing/yd², medium severity (pictured below where the missing coarse aggregates have been dotted with yellow paint) is 21-40 missing/yd², and high severity is > 40 missing/yd².

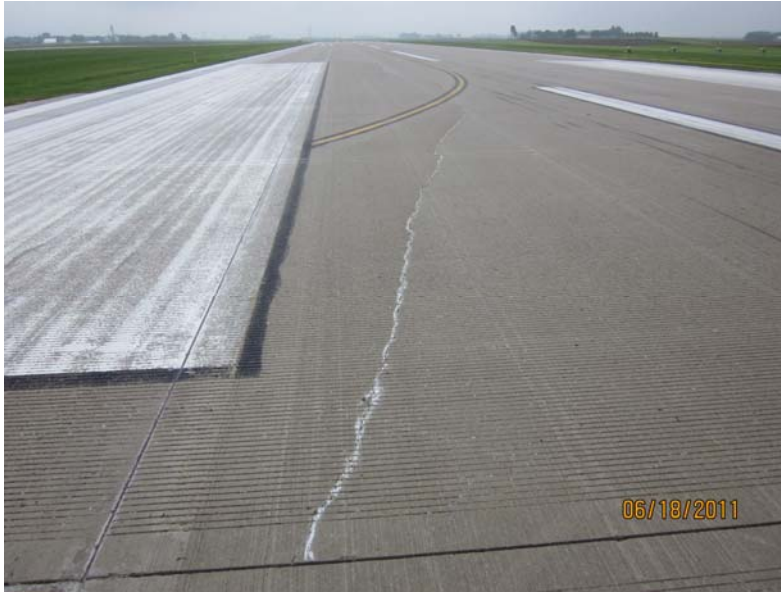
Example of Longitudinal, Transverse, and Diagonal Cracking

LTD cracking is most often a result of externally applied loads and/or constrained temperature deformations. External loads cause LTD cracking through flexure. Temperature changes on restrained slabs will result in stresses due to friction or curling. When any of these stresses exceed the strength of the slab, cracking will occur. LTD cracking is recorded at low, medium, or high severity, depending on the width of crack opening and degree of deterioration. At low severity, the crack is less than $\frac{1}{8}$ th inch wide with little spalling and no corrective action is indicated. At medium severity, LTD cracks can be up to 1 inch wide with moderate spalling, and should be repaired and sealed using procedures similar to joint sealing. At high severity, cracks exceed 1 inch in width and may be severely spalled. High-severity LTD cracking is evidence of serious load failure of the slab, and correction may require patching or slab replacement. If the distress occurs in several adjacent slabs at medium or high severity, major rehabilitation of that pavement area is indicated.

When a slab is divided by LTD cracks into four or more pieces, the slab is said to be "divided" or "shattered." Shattered slab is a separate distress category and is indicative of significant structural failure as the slab loses its ability to distribute loads to subgrade and further slab deterioration can be expected. Shattered slabs are rated in three severities, with slab replacement recommended for medium and high severities.

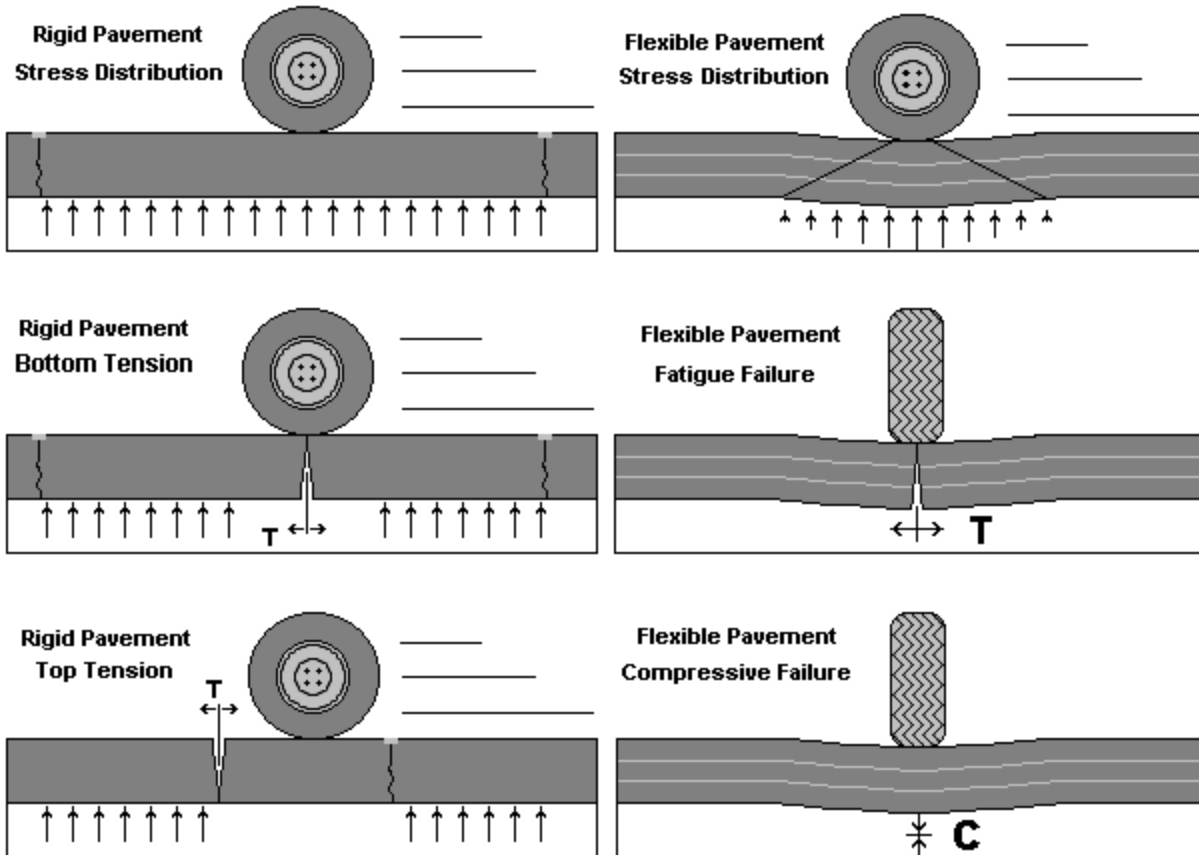
Figure 10. Pavement failure.

Spalls can be caused by either wheel loads or environmental factors, anytime there is movement between adjacent slabs. If a small rock is allowed into a joint, a differential movement between adjacent slabs can cause a spall. Spalling can be minimized by keeping joint and crack sealant intact.
