Maine Department of Transportation

Pavement Condition Report

HOULTON INTERNATIONAL AIRPORT (KHUL)

Submitted By:
DuBois & King & ARA
355 Husson Avenue - Suite 1
Bangor, Maine 04401

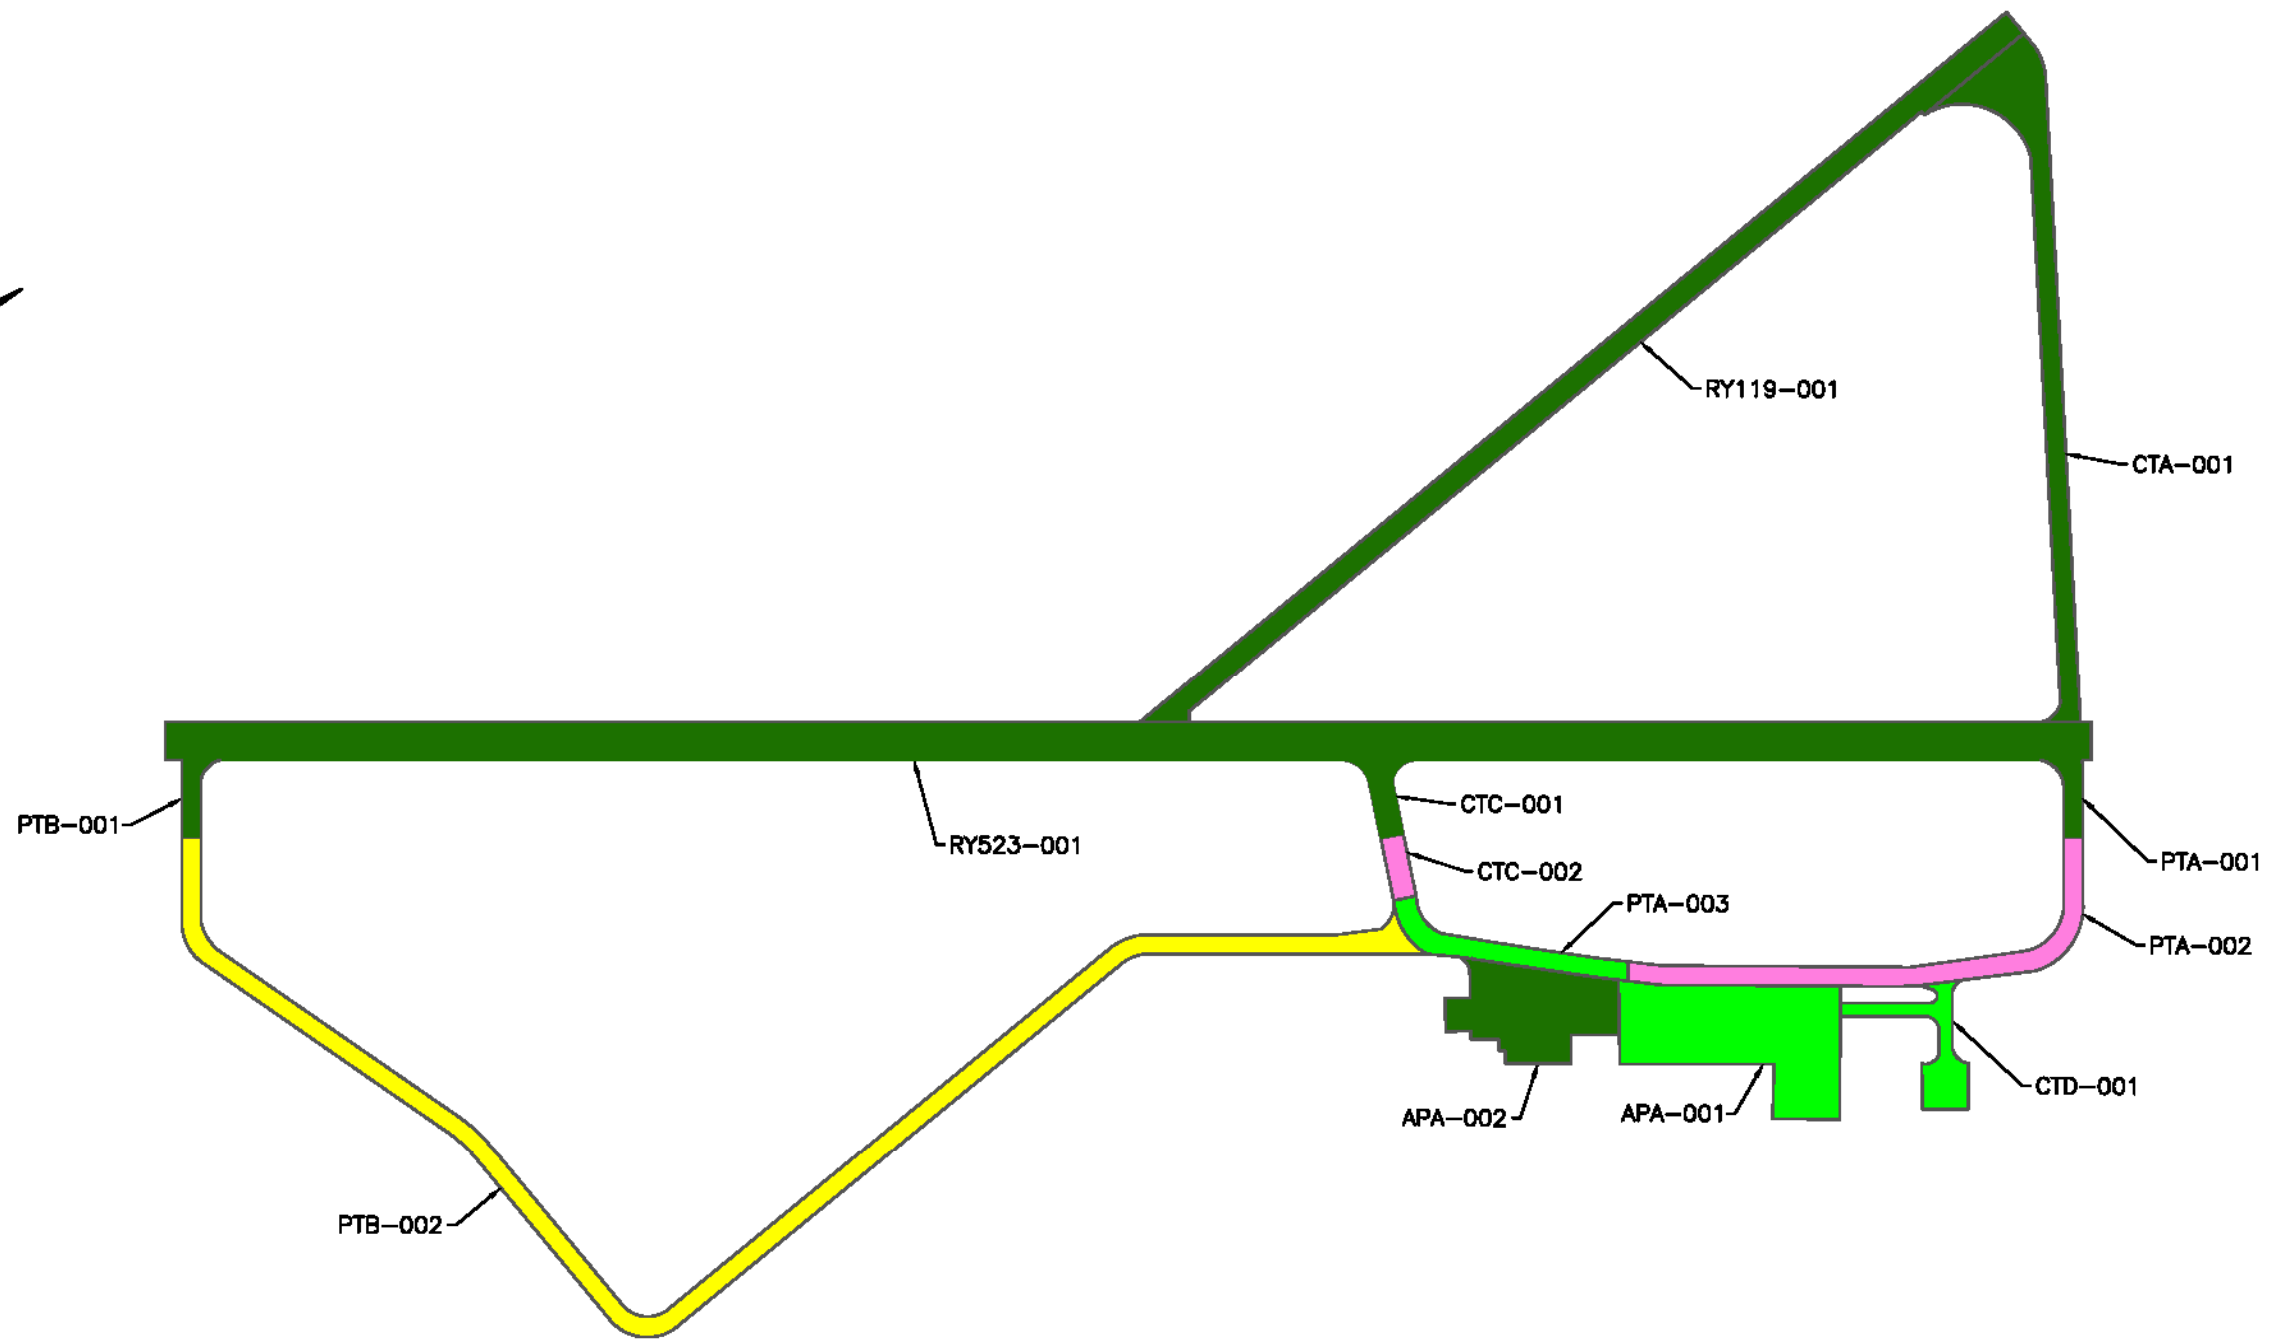
**2018 Pavement Condition Map
Houlton International Airport (HUL)**

The average inspected Pavement Condition Index (PCI) for all the airfield pavements at HUL was 85. Runways had an average inspected PCI of 94, which is above the MSL of 70. Taxiways had an average inspected PCI of 73, and the apron had an average inspected PCI of 84. A comparison of the average PCI values at HUL to the statewide average PCI values, by branch use, is shown in the figure below.

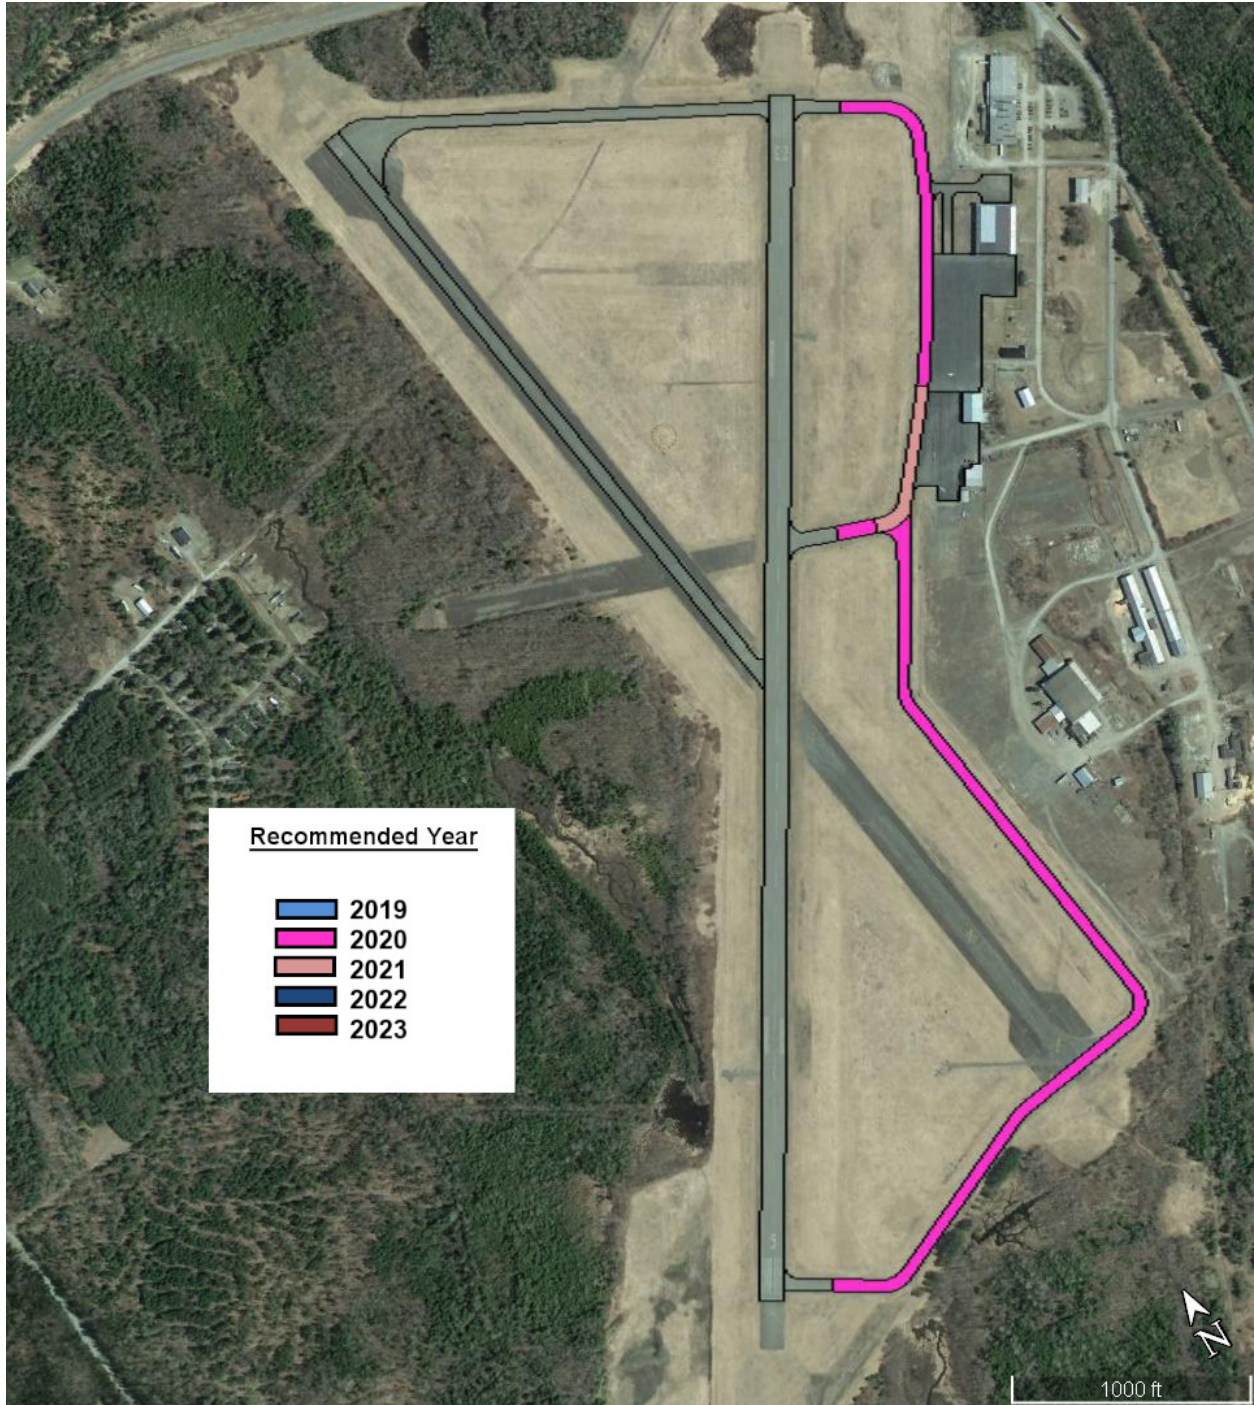
Figure 9. Major M&R

The pavement sections identified for major rehabilitation in Table 10 and shown in Figure 9 are at or are predicted to reach a condition level where major M&R should be considered. While the predicted rehabilitation timeline identifies specific sections and the general timing for the repair, more in-depth project-level studies will be needed to determine exactly how to fix each pavement (i.e. asphalt overlay, reconstruction, or some other repair alternative). Additionally, the airport may find it desirable to adjust the timing of projects to meet fiscal and operational constraints. For example, if the runway and several connector taxiways were forecast to reach the MSL in various years ranging from 2019-2023, it may be preferable to group these pavement sections into a single project.

Branch ID	Section ID	Year	Predicted PCI Before Rehab	Estimated Cost
CTC	002	2020	37	\$201,957
PTA	002	2020	51	\$1,487,135
PTB	002	2020	59	\$4,347,166
PTA	003	2021	69	\$97,760
5-year Airport Total				\$6,134,017

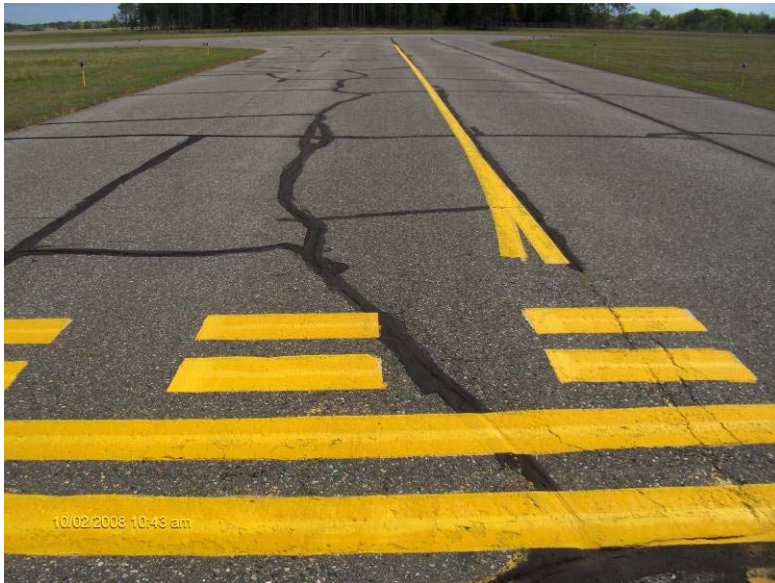
Example of Longitudinal and Transverse Cracking (L&T cracking)

Longitudinal and transverse cracks are caused by pavement aging, by construction, and by subsurface movement. Aging occurs as pavement loses some of its components to the atmosphere and becomes more brittle. Consistent application of pavement sealcoats can help to prevent the occurrence of age related cracks. Cracks will also develop along poorly constructed paving lane joints. Ensuring that joints are made when both sides are still hot, and near the same temperature, is one of the best ways to mitigate this potential problem. Seasonal movement caused by changes in moisture content or temperature differences can also cause pavement cracks. Asphalt pavement placed over a PCC pavement or cement stabilized base course may evidence reflective cracking from the underlying material. Longitudinal and transverse cracks are not caused by wheel loads, although traffic may worsen their condition.

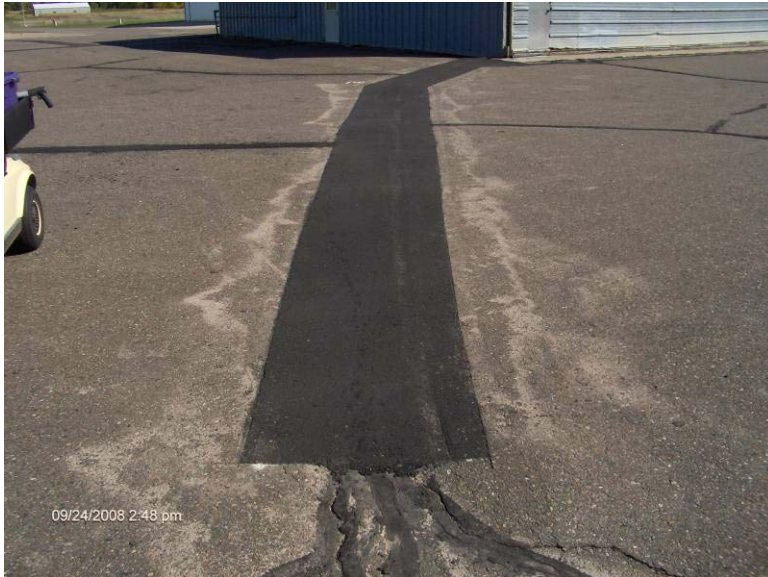
Example of Patching

Patched areas are defined when a portion of the original pavement is replaced with a material intended as a semi-permanent repair. A patch is documented as a defect because it is considered a break in the integrity of the pavement structure. Patches are constructed for a variety of reasons including utility repairs, correcting grade issues, and addressing a defect in the original pavement. The severity level of patches is determined by the amount of distress (i.e. cracking, depression, weathering/raveling, etc.) occurring within the limits of the patched area.

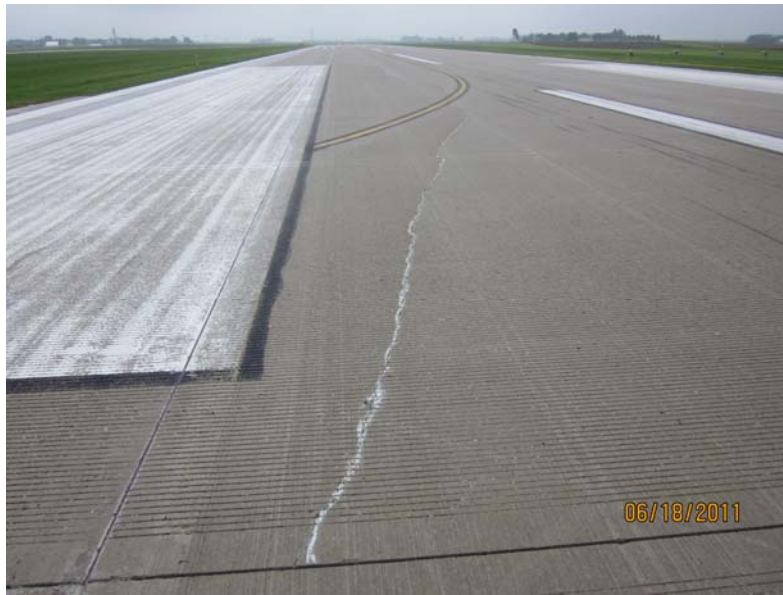
Example of Longitudinal, Transverse, and Diagonal Cracking

LTD cracking is most often a result of externally applied loads and/or constrained temperature deformations. External loads cause LTD cracking through flexure. Temperature changes on restrained slabs will result in stresses due to friction or curling. When any of these stresses exceed the strength of the slab, cracking will occur. LTD cracking is recorded at low, medium, or high severity, depending on the width of crack opening and degree of deterioration. At low severity, the crack is less than 1/8th inch wide with little spalling and no corrective action is indicated. At medium severity, LTD cracks can be up to 1 inch wide with moderate spalling, and should be repaired and sealed using procedures similar to joint sealing. At high severity, cracks exceed 1 inch in width and may be severely spalled. High-severity LTD cracking is evidence of serious load failure of the slab, and correction may require patching or slab replacement. If the distress occurs in several adjacent slabs at medium or high severity, major rehabilitation of that pavement area is indicated.

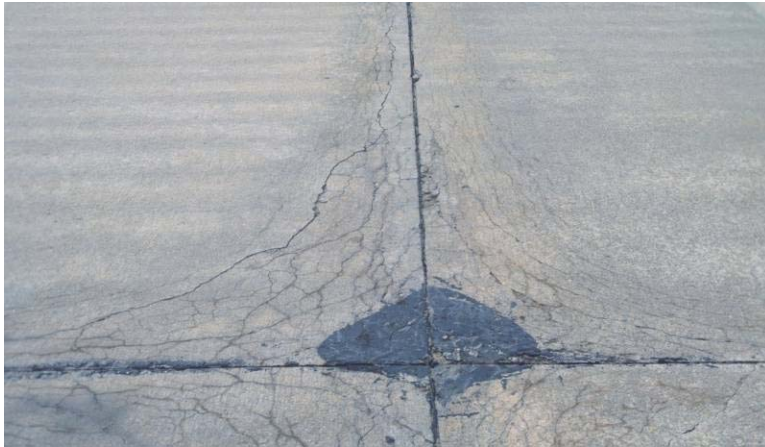
Example of Durability Cracking

Durability cracking (D-cracking) is caused by environmental factors, the most common of which is freezing/thawing. It usually appears as a pattern of hairline cracks running parallel to a joint or crack, or in a corner, where water tends to collect. This type of cracking eventually leads to disintegration of the pavement, creating FOD potential. At low severity, D-cracking is evident, but no disintegration has occurred. As the distress advances to medium severity, the distress pattern is evident over a significant area of the slab, and some disintegration and FOD potential exists. High severity durability cracking is evidenced by extensive cracking with loose and missing pieces and significant FOD potential.

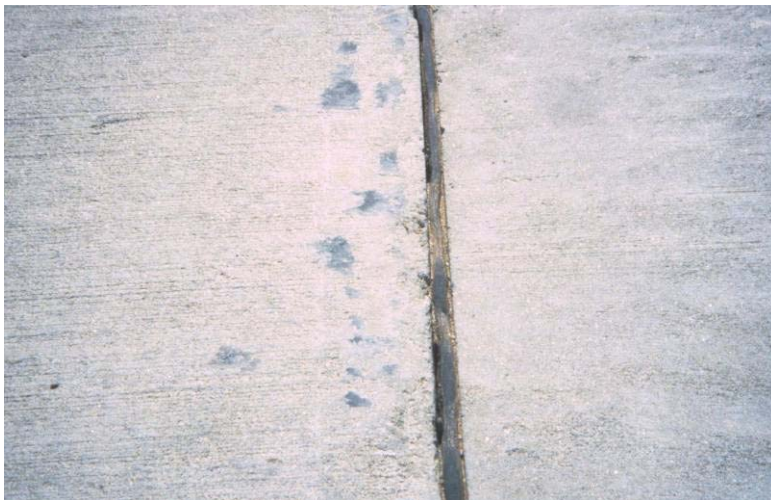
Example of Joint Seal Damage

Joint seal damage is recorded at three severities: low, medium, and high. When joint sealant is in perfect condition (no damage), it is not a distress. At low severity, at least 10 percent of the sealant is debonded but still in contact with the joint edges (i.e., joint sealant is in serviceable condition but should
