Pavement Condition Report

## PRINCETON MUNICIPAL AIRPORT (PNN)

Submitted To:  
Maine Department of Transportation  
16 State House Station  
Augusta, ME 04333

Submitted By:  
**DuBois & King & ARA**  
355 Husson Avenue - Suite 1  
Bangor, Maine 04401

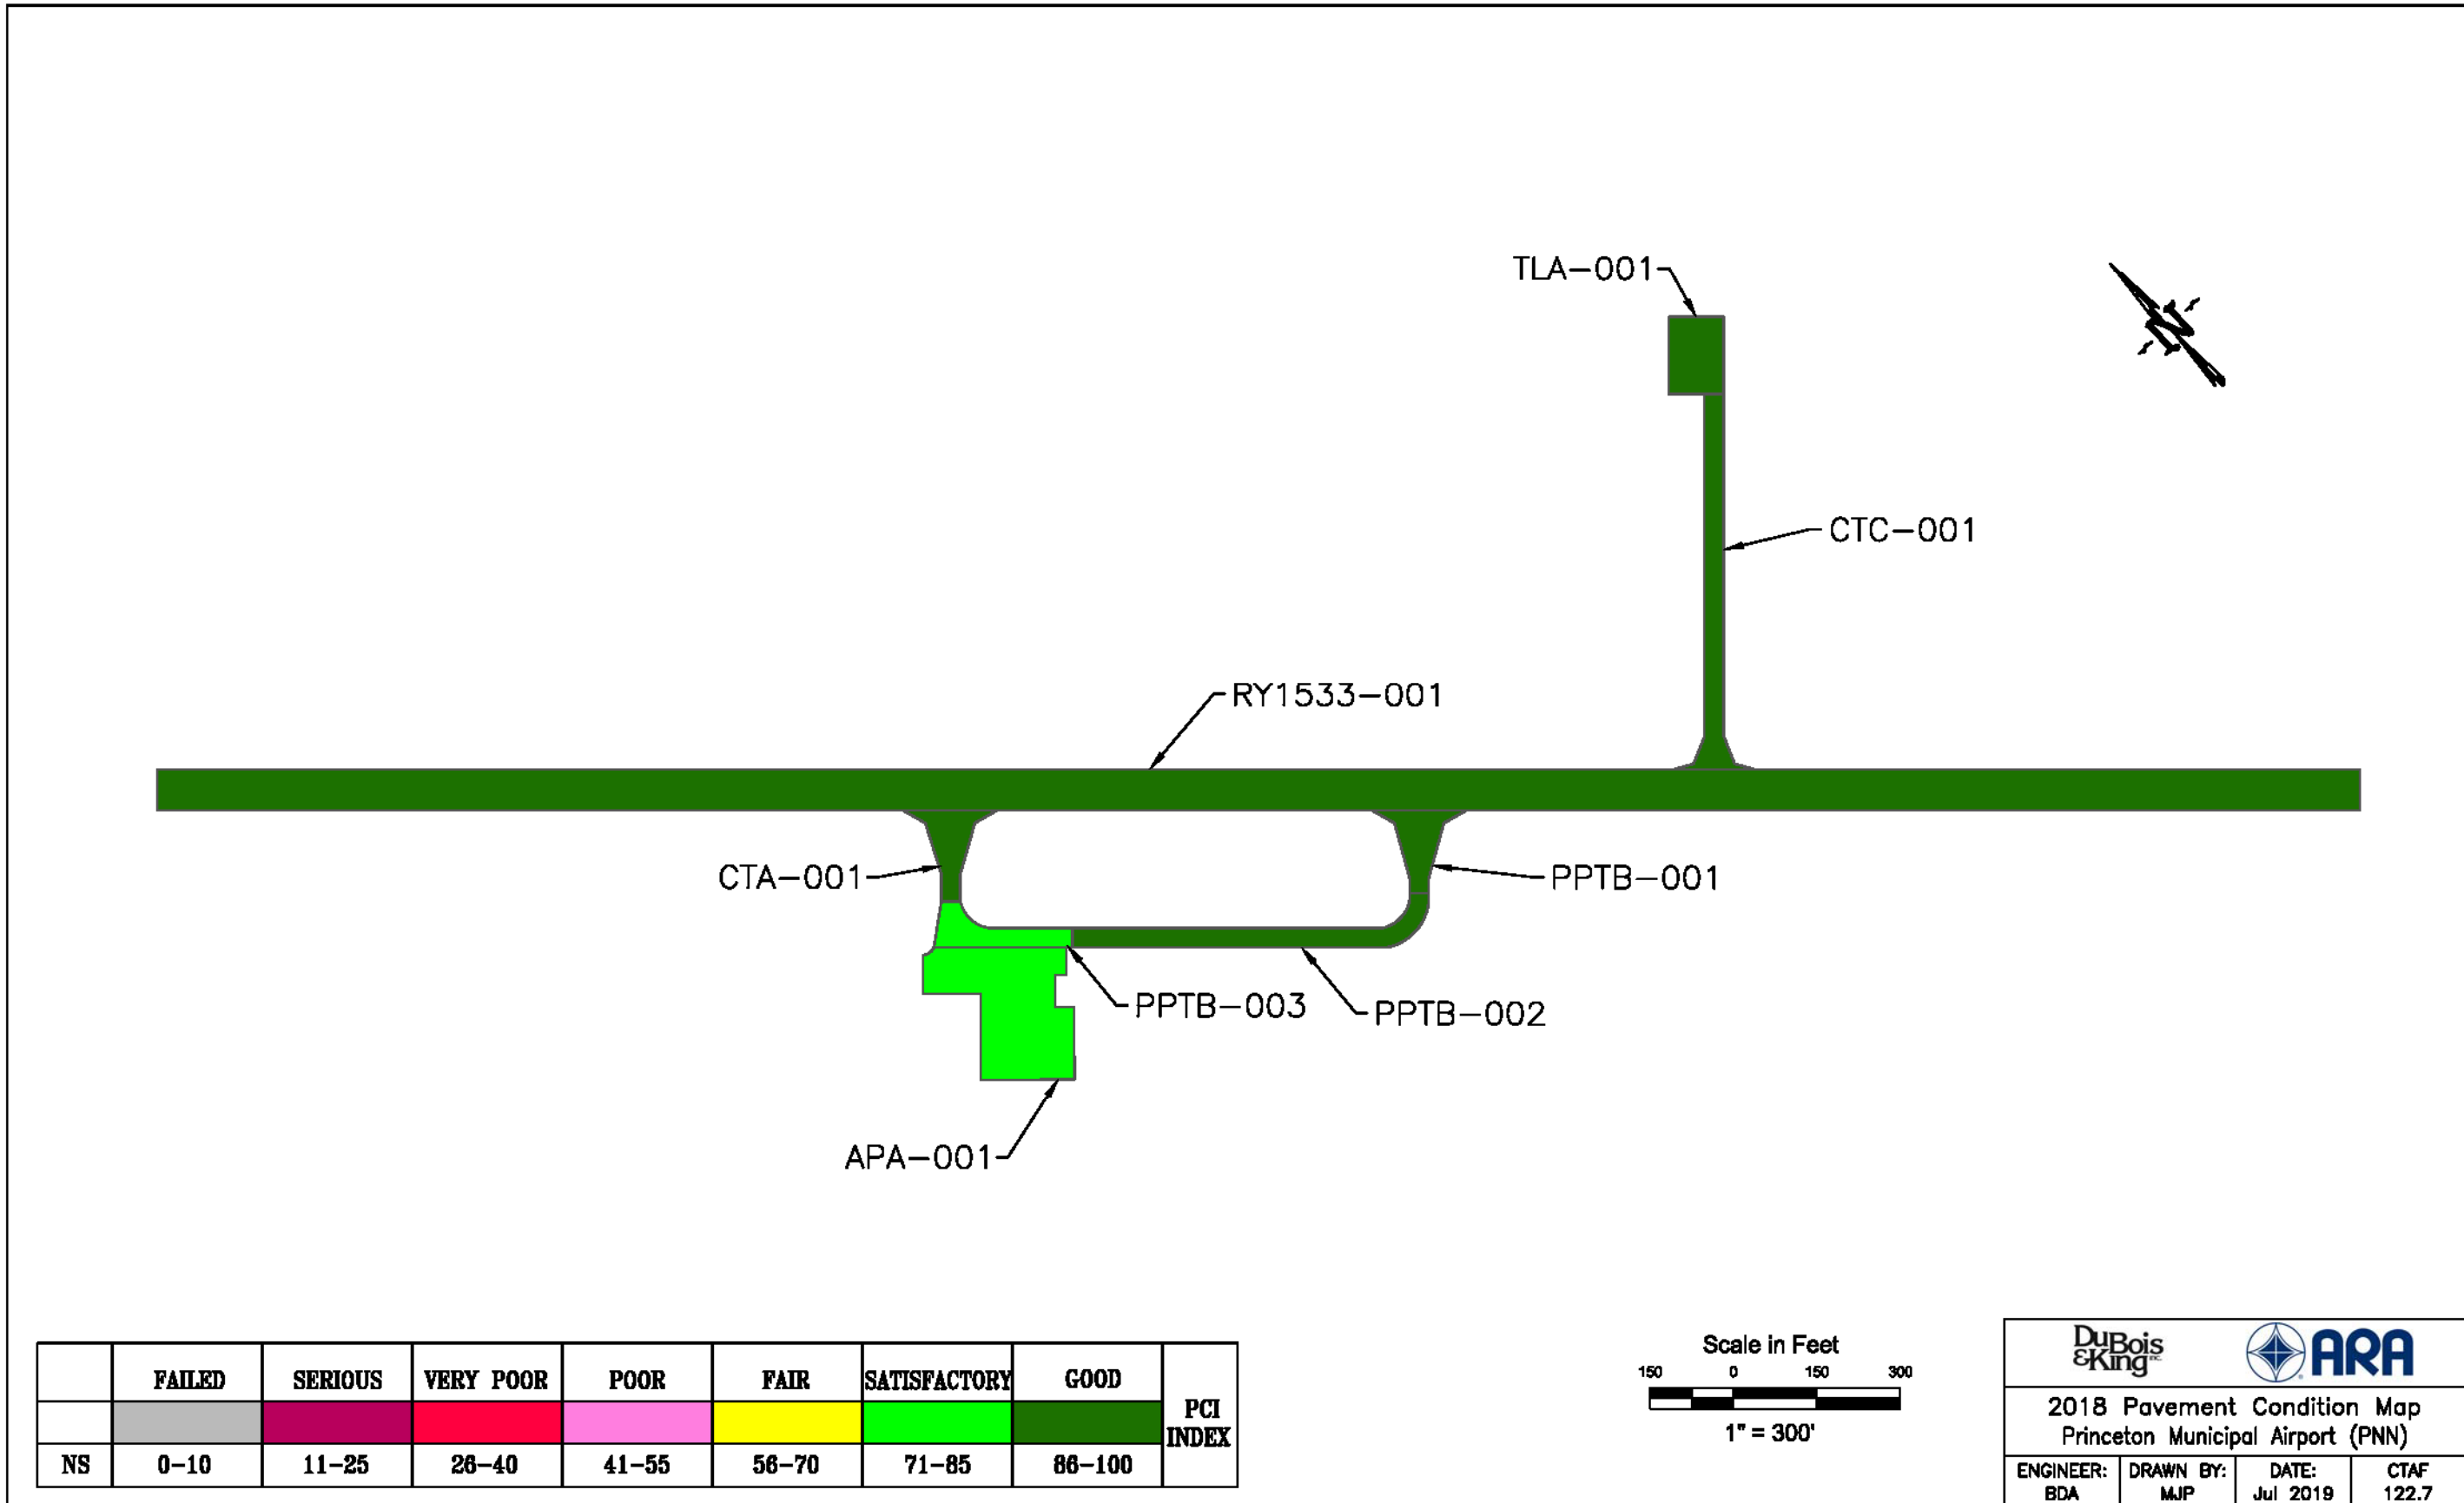
Figure 7. 2018 PCI Map at Princeton Municipal Airport (PNN)

The average inspected Pavement Condition Index (PCI) for all the airfield pavements at PNN was 98. Runway 15-33 had an average inspected PCI of 100, which is above the MSL of 70. Taxiways had an average inspected PCI of 97, taxilanes had an average inspected PCI of 100, and aprons had an average inspected PCI of 85. A comparison of the average PCI values at PNN to the statewide average PCI values, by branch use, is shown in the figure below.

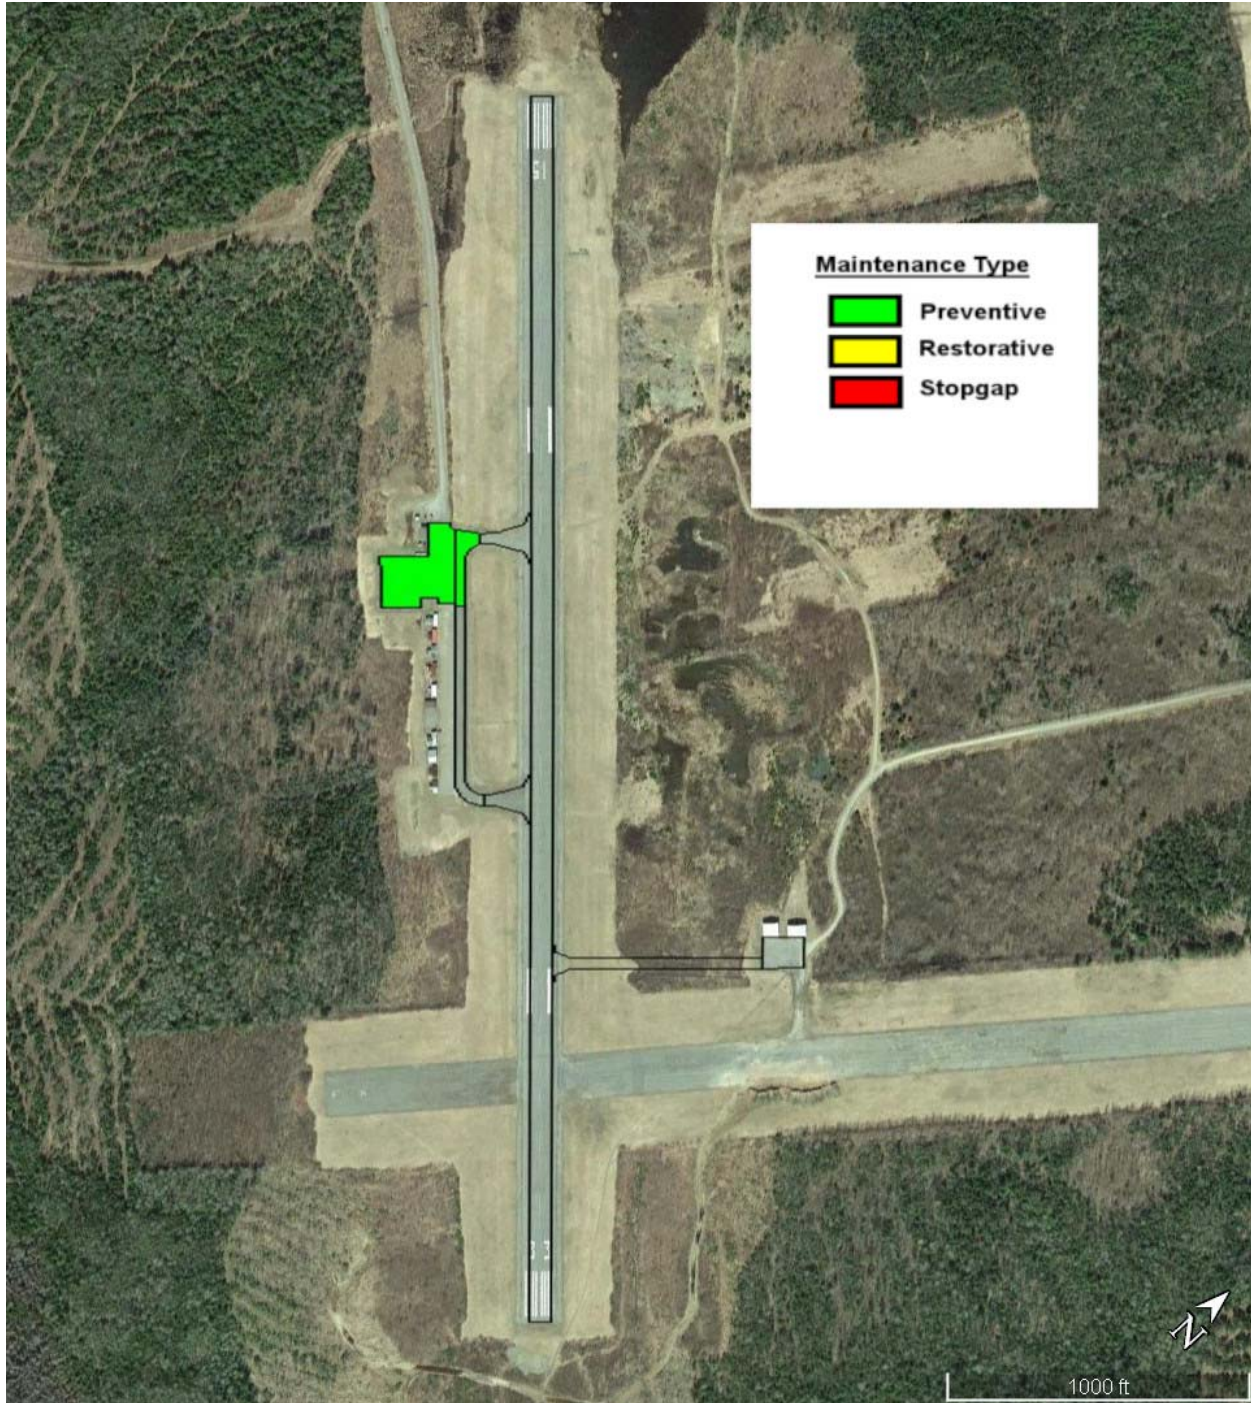
Figure 8. Maintenance type

Branch	Section	Work Type	Quantity	Unit	Cost
APA	001	Crack Sealing - AC	469	Ft	\$647
APA	001	Patching - AC Shallow	42	SqFt	\$706
PPTB	003	Crack Sealing - AC	240	Ft	\$331

It is important to understand that the maintenance plan is based on the distress types, severities, and quantities found during the 2018 PCI survey. As field conditions change, the maintenance plan will become less accurate. Therefore, the maintenance plan will be most useful if implemented as soon as is practical. Applying maintenance treatments should be an annual event at the airport, and this maintenance plan can serve as a baseline for that work. The recommended maintenance type for each section is shown in Figure 9 and summarized in Table 8. Recommended maintenance actions by section are provided in Table 9. Guidelines for performing crack sealing and patching techniques are provided in appendix F.

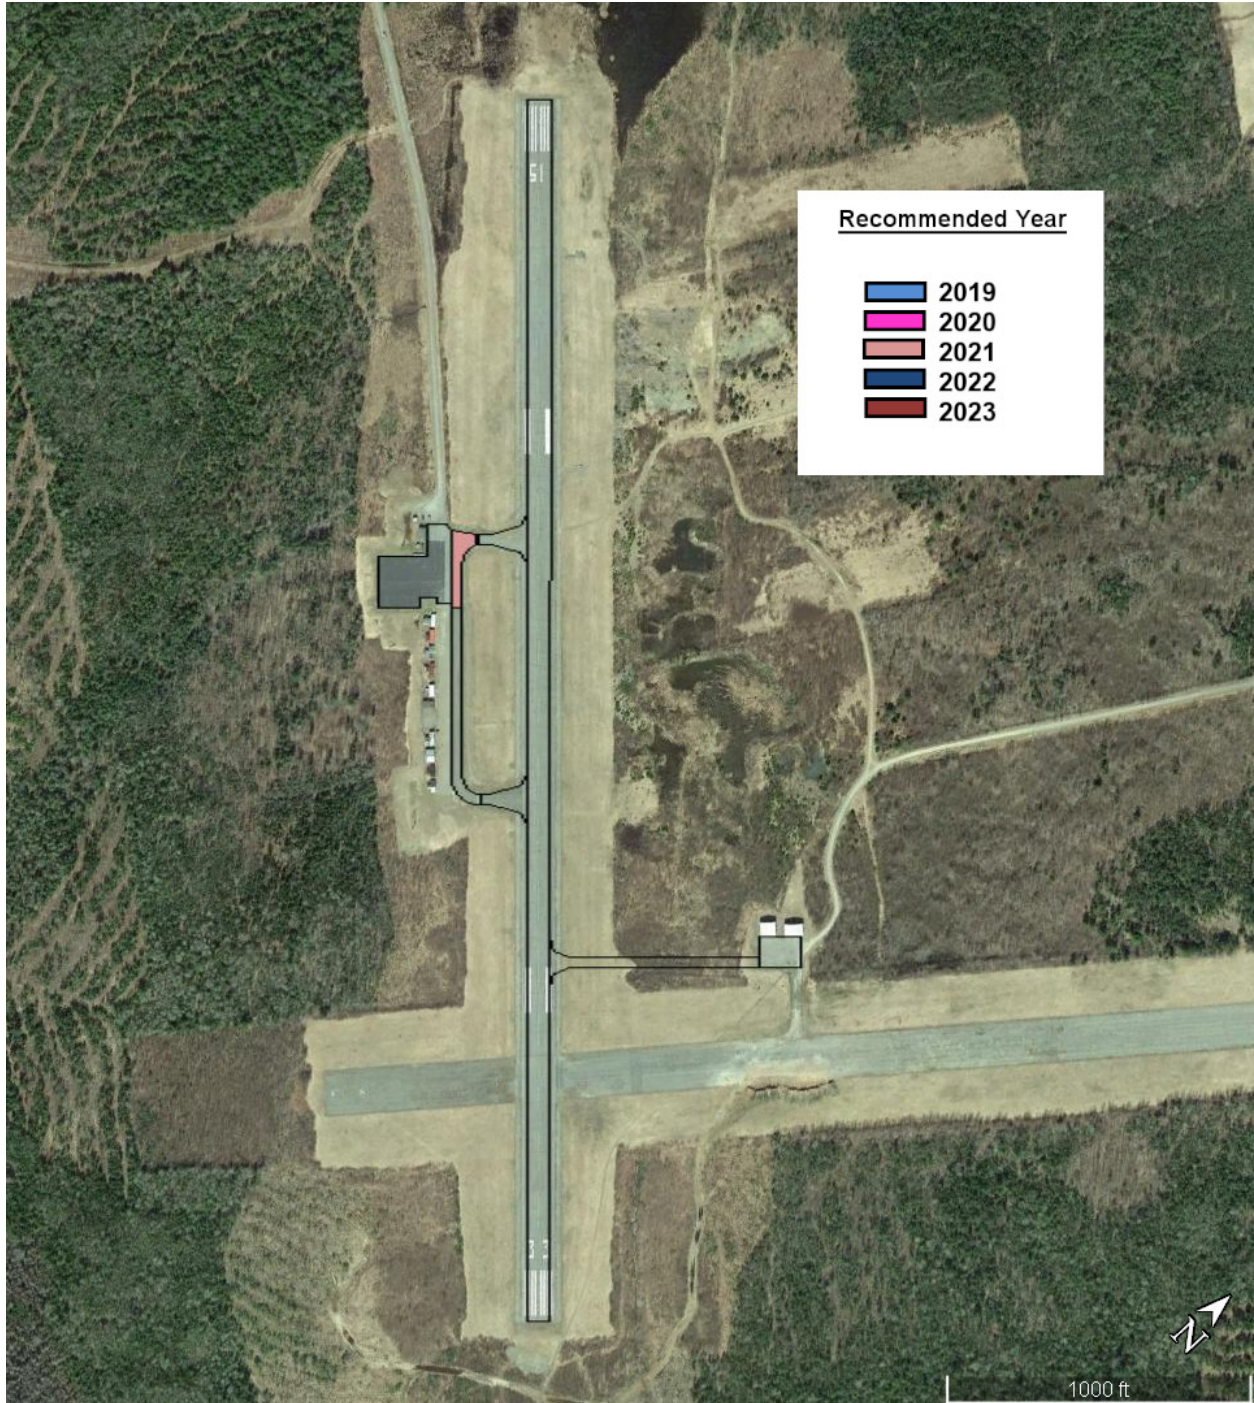
Figure 9. Major M&R

The pavement sections identified for major rehabilitation in Table 10 and shown in Figure 9 are at or are predicted to reach a condition level where major M&R should be considered. While the predicted rehabilitation timeline identifies specific sections and the general timing for the repair, more in-depth project-level studies will be needed to determine exactly how to fix each pavement (i.e. asphalt overlay, reconstruction, or some other repair alternative). Additionally, the airport may find it desirable to adjust the timing of projects to meet fiscal and operational constraints. For example, if the runway and several connector taxiways were forecast to reach the MSL in various years ranging from 2019-2023, it may be preferable to group these pavement sections into a single project.

Branch ID	Section ID	Year	Predicted PCI Before Rehab	Estimated Cost
PPTB	003	2021	70	\$31,074
<b>5-year Airport Total</b>				<b>\$31,074</b>

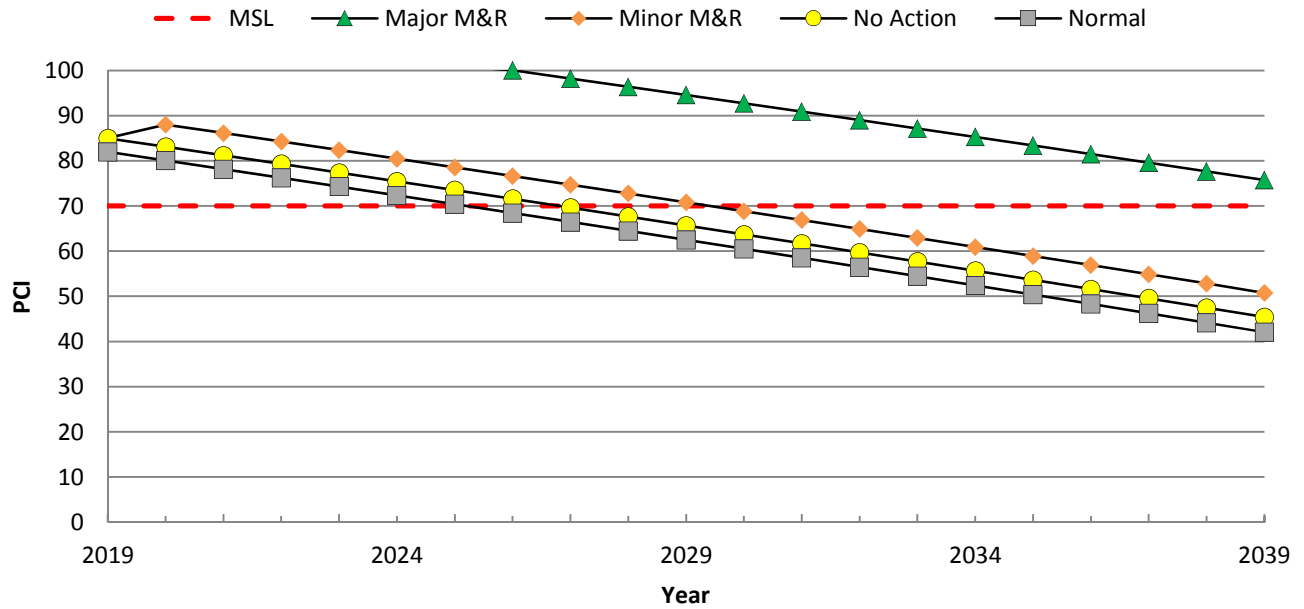
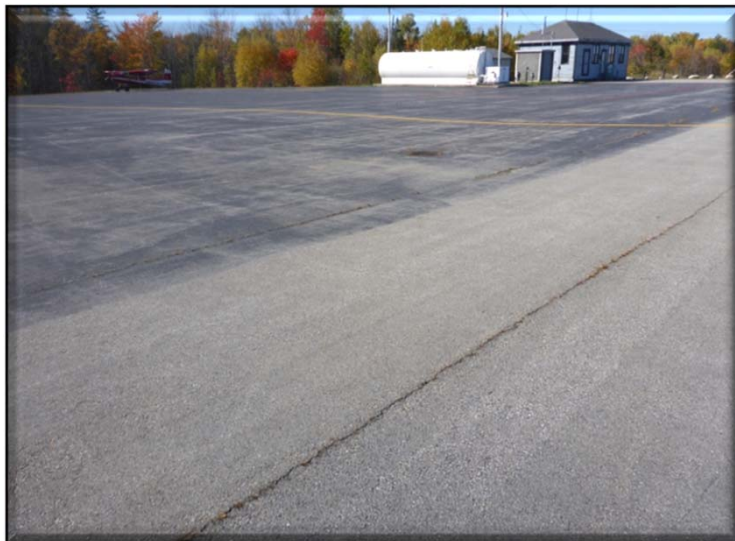
Apron A

M&R	Action	Year / Quantity	Cost (\$)	Ending PCI
Major	Major M&R	2026	128,422	100
Minor	All Minor	2020	1,353	88
1	Patching - AC Shallow	42 SqFt	706	-
2	Crack Sealing - AC	469 Ft	647	-
3	-	-	-	-
4	-	-	-	-
5	-	-	-	-
6	-	-	-	-
7	-	-	-	-

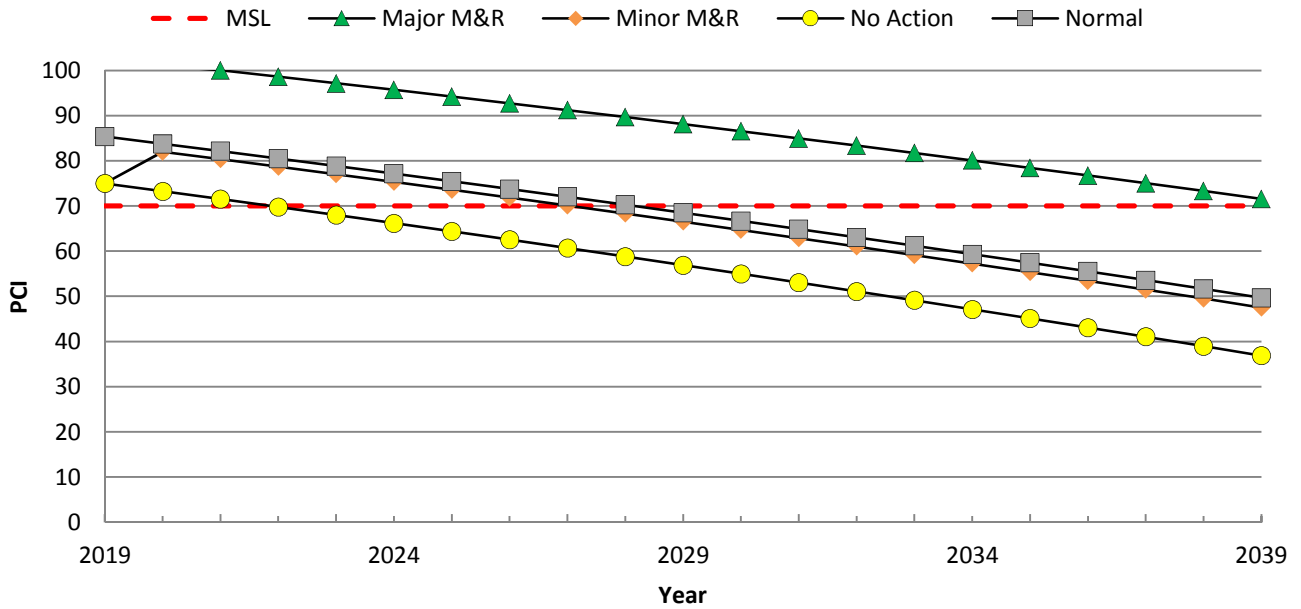
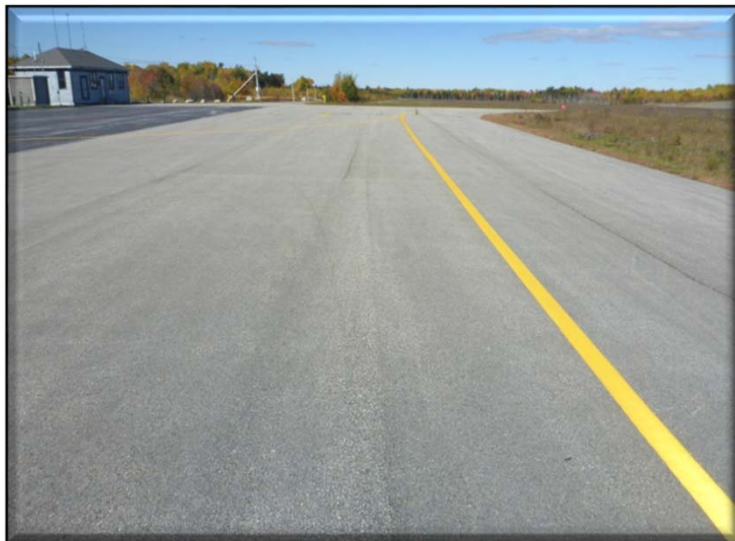
Partial Parallel Taxiway I

M&R	Action	Year / Quantity	Cost (\$)	Ending PCI
Major	Major M&R	2021	31,074	100
Minor	All Minor	2020	331	82
1	Crack Sealing - AC	240 Ft	331	-
2	-	-	-	-
3	-	-	-	-
4	-	-	-	-
5	-	-	-	-
6	-	-	-	-
7	-	-	-	-
