Highway and Bridge Barrier Rail Report

State of Maine Department
of Transportation, November
2016

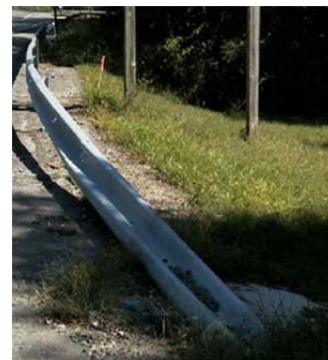
The database reports 37 turndowns still exist with 28 of these being on HCP 1. These systems were discontinued in the 90's due to safety performance issues. Each of these locations should be reviewed to determine if a turndown actually exists, does it impose a safety concern and how the system should be replaced.

Figure 3 - Typical Turndown Installation

12. Review the turndown locations identified in MATS as soon as possible to determine our risk if left in place. The department should fund a replacement program in the next 3 year work plan. It is estimated replacement of all turndowns would cost \$250,000. Note: Programmed with Safety Funding in 2019.

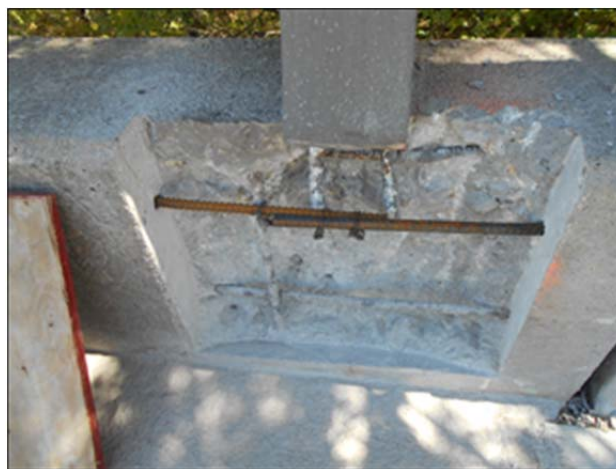
Concrete Bases, supporting a Bridge Rail System can also be challenging in evaluation. There are levels of concrete deterioration which need judgement to categorize. The area of concern is usually the portion below a post baseplate; however, in some cases, the full length of the system (all concrete “city” rail). A High priority repair may have exposed rebar, baseball size, and larger chunks of concrete missing or large cracks extending from the anchor bolts to edge of concrete base.

Figure 6 - Typically a concrete base repair would be focused beneath or partially beneath a rail post.

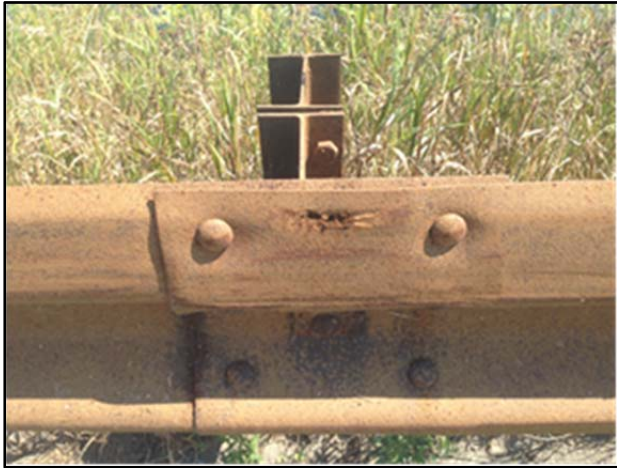
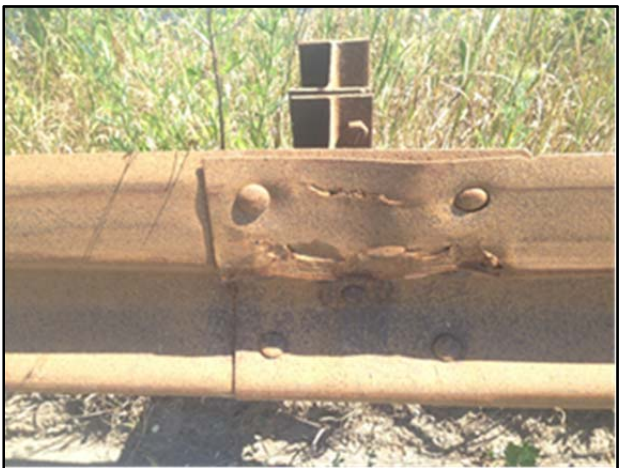
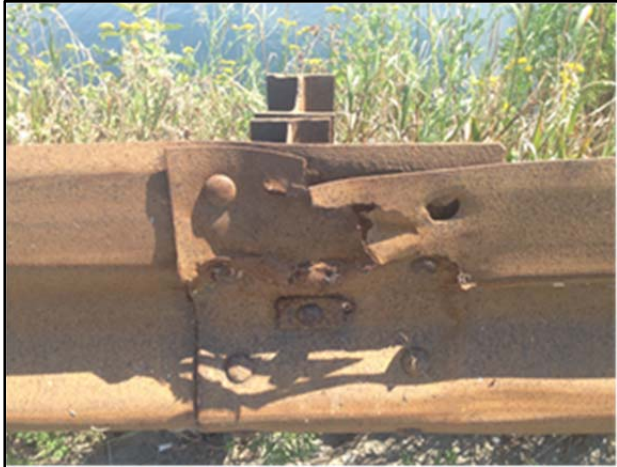
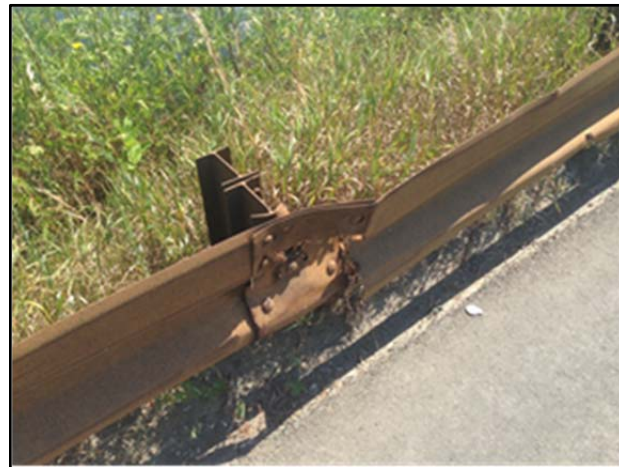
Appendix C - Photos – Corten rail, old cable rail

Weathered Steel w-beam rail sequence of level of corrosion at laps.
