I. Executive Summary

This study assesses the performance of the roof drainage systems at Historic New England's properties in Maine. This study was commissioned by Historic New England as current predictions for future weather suggest more frequent, intense storms and more rainfall in New England. As concerned stewards of multiple historic properties across New England, Historic New England seeks an evaluation of the current systems, including capacity and performance. As the properties are historic sites used as educational tools, ideally the systems are both functional and historically accurate.

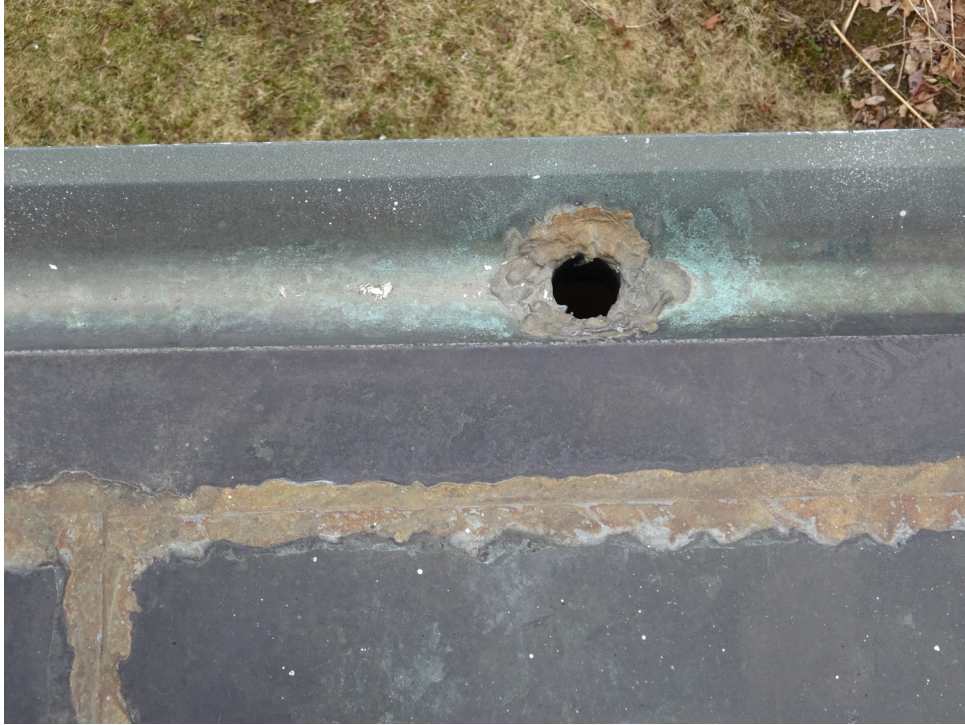
Above: A build-up of solder around this outlet is hampering water flow. Soldered joints should be smooth so the water can flow into the outlet. Photograph taken by Margaret Gaertner, April 20, 2018.

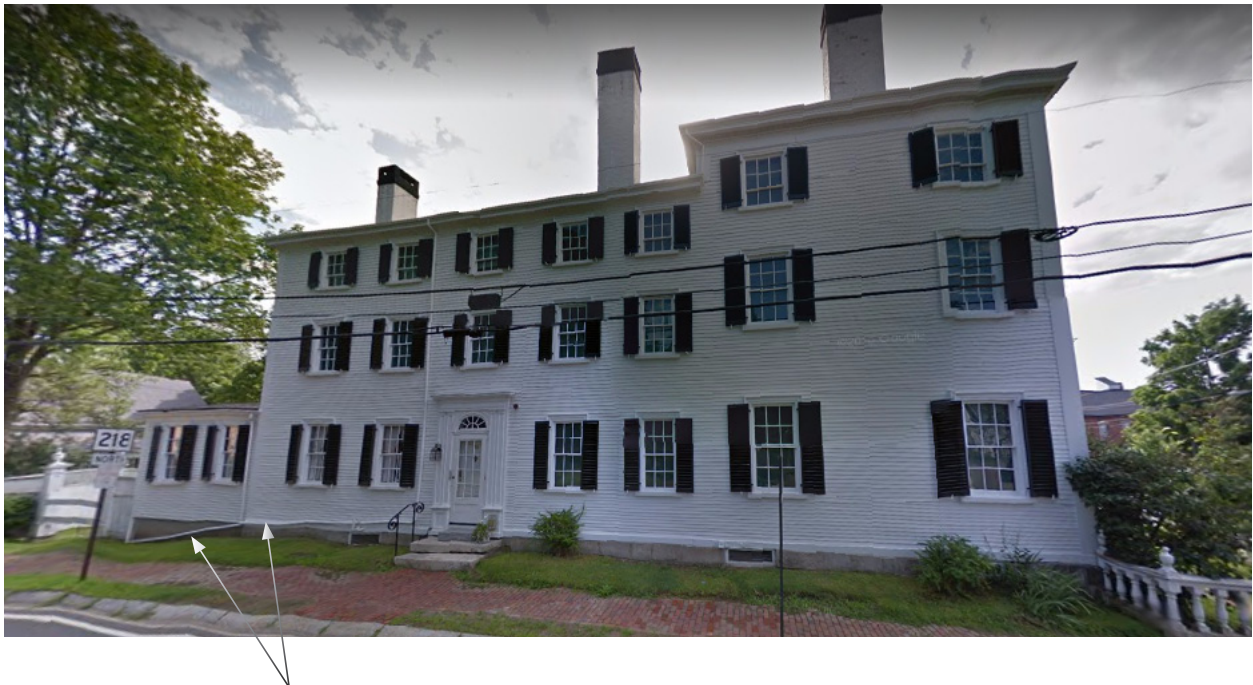
Above: At Nickels-Sortwell, runoff from the roof of the main house, the three-story ell, and the one-story ell all flow into nearly horizontal lengths of pipe. The pipe at the one-story ell is carrying the most runoff. Source: Google maps.

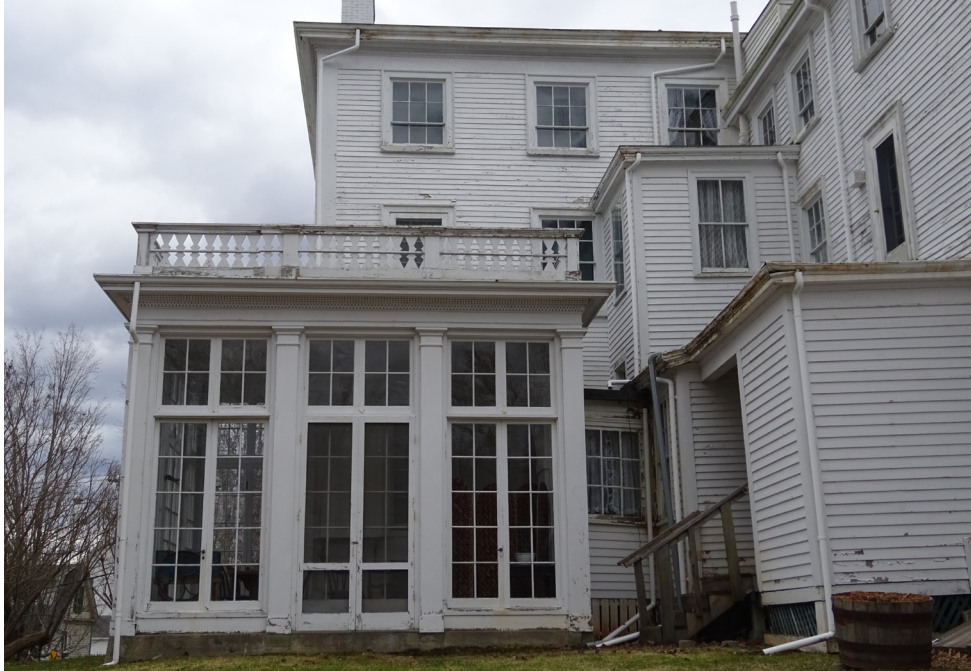
Above, the north facade of the main house and solarium. Several leaders drain into the space to the right of the solarium, causing settlement in the building, paint failure and decay of wood cornices and gutters. Below, a closer view of the decay and paint failure. Photographs taken by Margaret Gaertner, April 20, 2018.

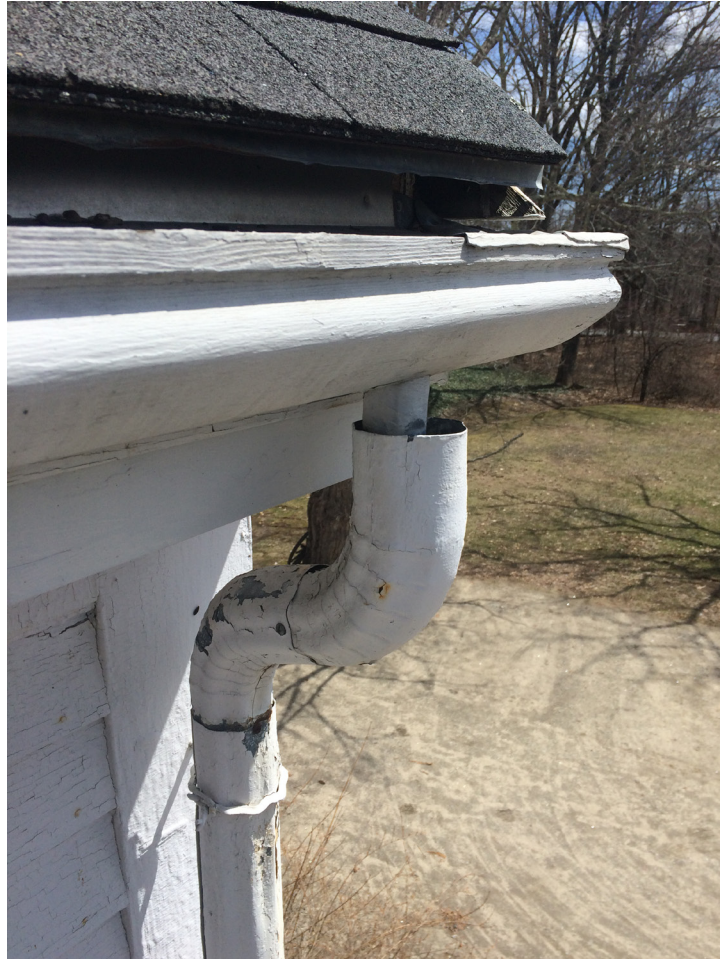
This wooden gutter at the Parson Smith House has an undersized outlet made of metal. It was found that most of the historic wooden gutters had undersized outlets. Photograph taken by Shawn Beckwith, April 18, 2018.

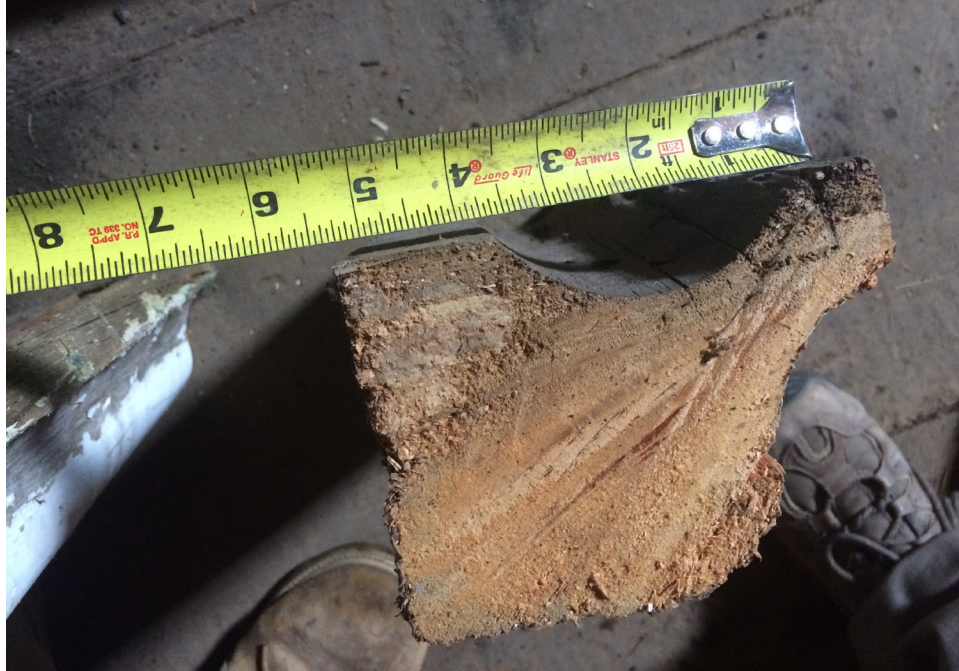
This piece of wooden gutter was found stored in the Marrett barn. It is not known where it was installed. Note the shallow depth of the trough. A gutter of similar profile remains in place on the rear of the Marrett main house and calculations show it is undersized for current rain events. Photograph taken by Shawn Beckwith, April 18, 2018.
