Feasibility/Alternatives Analysis Report Montgomery Dam, Megunticook River Camden, ME

May 3, 2019

Town of Camden,
Maine

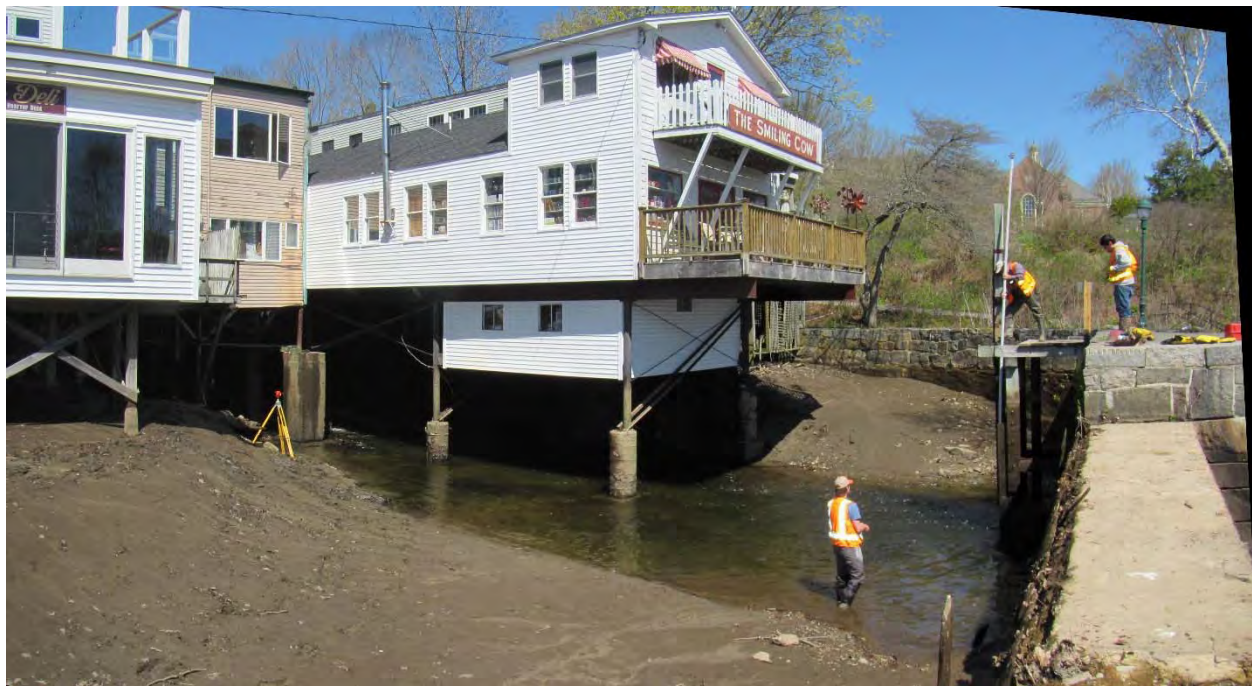
During the field investigation, the impoundment was drawn down, which afforded a view of the condition of the stream in the study reach if the dam were lowered. Immediately upstream of the dam, the channel concentrates in the vicinity of the existing head gate between ledge outcrops under a shallow mantle of accumulated sediment. During the field assessment, an abandoned relict tank was observed in the lower impoundment on the south side of the channel (Figure 24). The origin and purpose of the tank is unknown, but observations by Town of Camden staff suggest that the tank is empty. In conjunction with sediment testing, a composite sediment sample was retrieved from the tank area. See Section 4.5.1 for more details.

Figure 24. View of lower impoundment and north end of spillway in drawn down condition, May 8, 2018. Relict tank is located in the vicinity of the survey tripod at the left of the image.

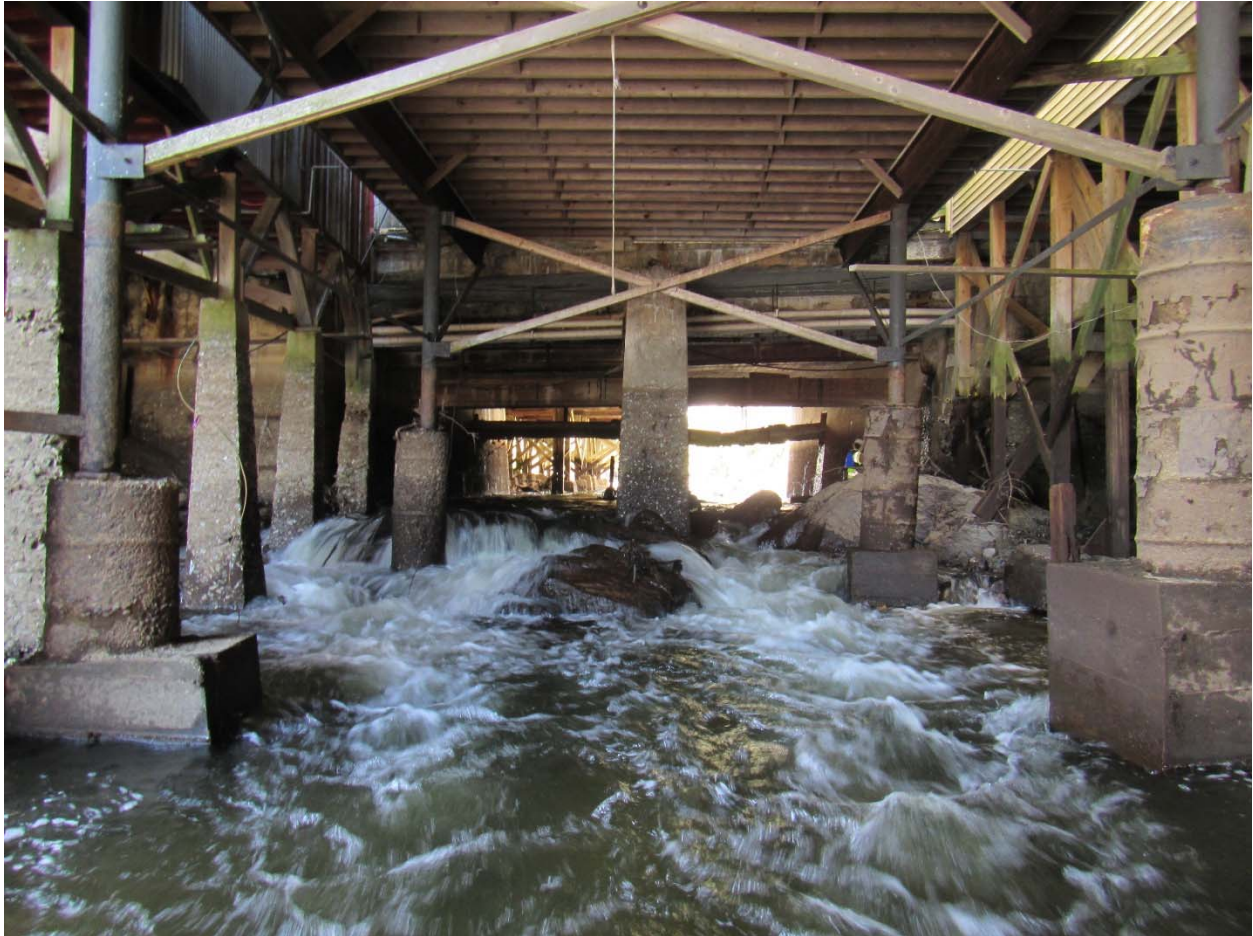
Figure 26. View upstream at Main Street bridge in drawn down condition, May 8, 2018. Hydraulic drop at downstream bridge opening in center of photo. Stain lines apparent on posts indicate normal pool elevation.
