Addendum No. 1

CURTIS HALL RENOVATIONS

Maine Maritime Academy

Haley Ward, Inc. (Haley Ward) completed a limited Hazardous Materials Assessment (HMA) on August 25, 2023, to identify and assess hazardous materials on or within Curtis Hall located on the Maine Maritime Academy campus in Castine, Maine.

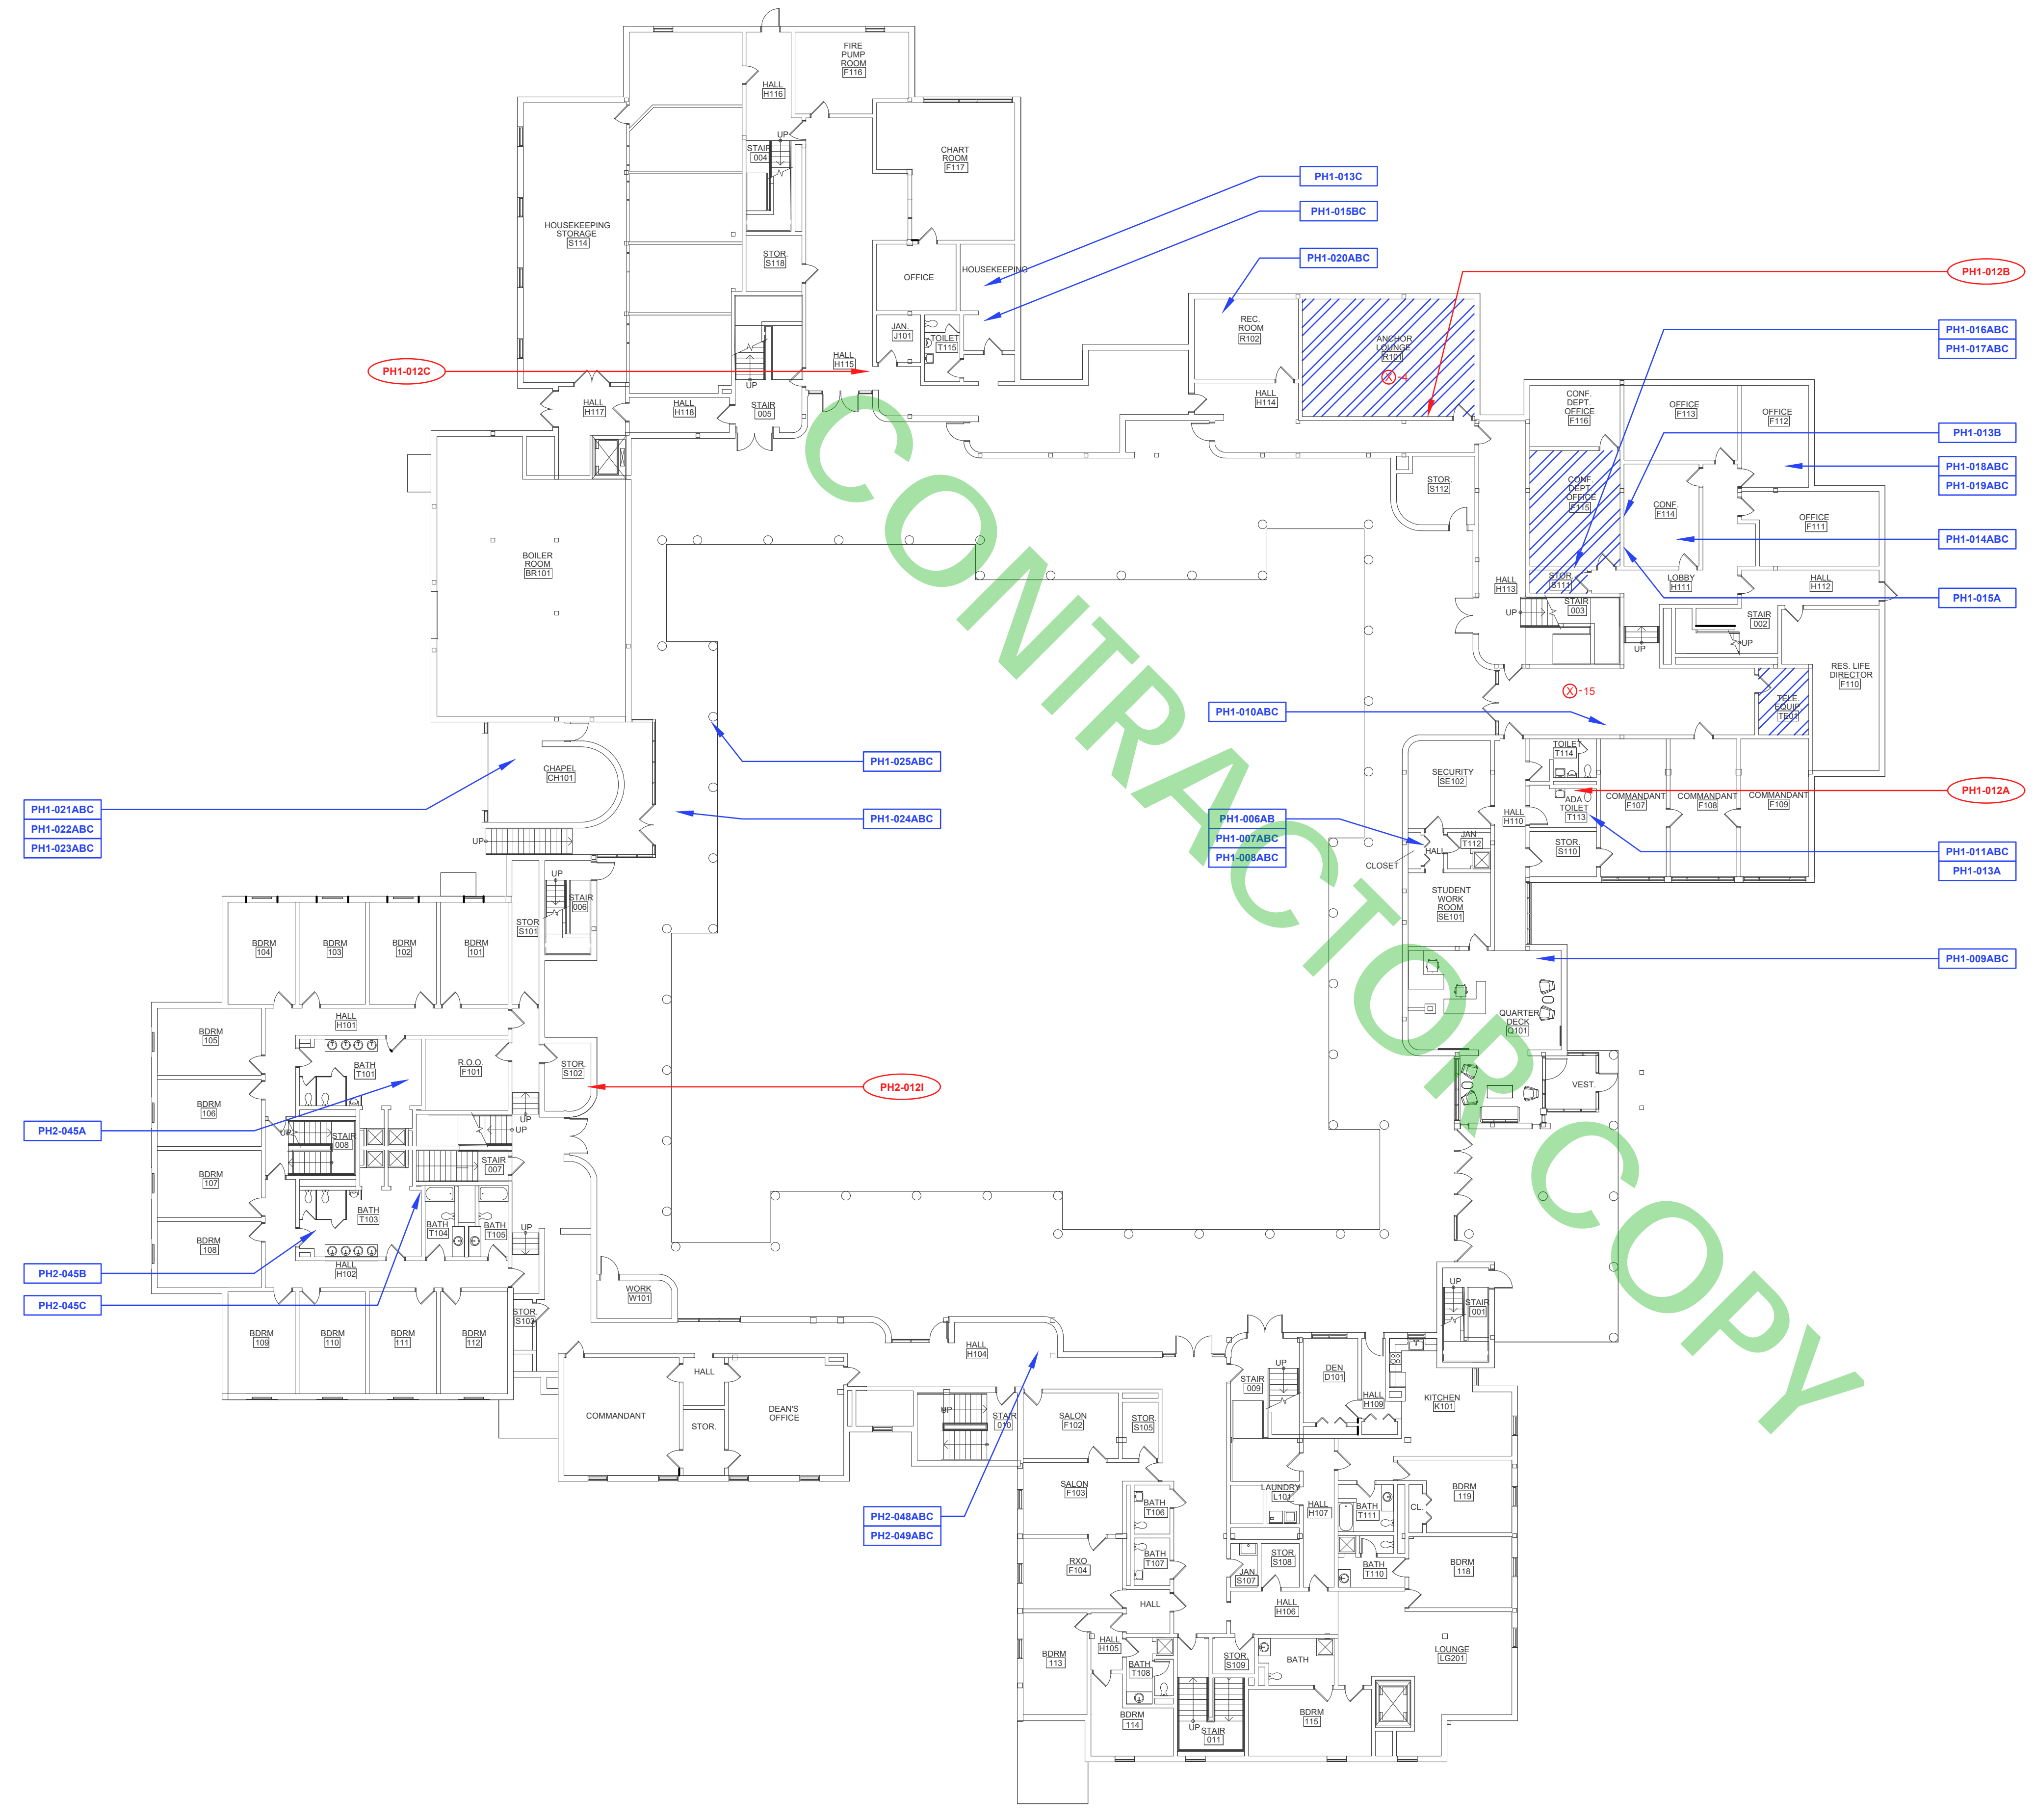
FIRST FLOOR PLAN
SCALE: 1/16"=1'-0"

- PH1-001A SAMPLE NUMBER AND LOCATION
TESTING POSITIVE FOR ASBESTOS
- PH1-002A SAMPLE NUMBER AND LOCATION
TESTING NEGATIVE FOR ASBESTOS
- 1 ACM INSULATED PIPE FITTING ABOVE CEILING

NOTE:
ALL EXTERIOR WINDOWS HAVE ASBESTOS
CONTAINING CAULKING. (REFER TO SAMPLE
PH1-030A)

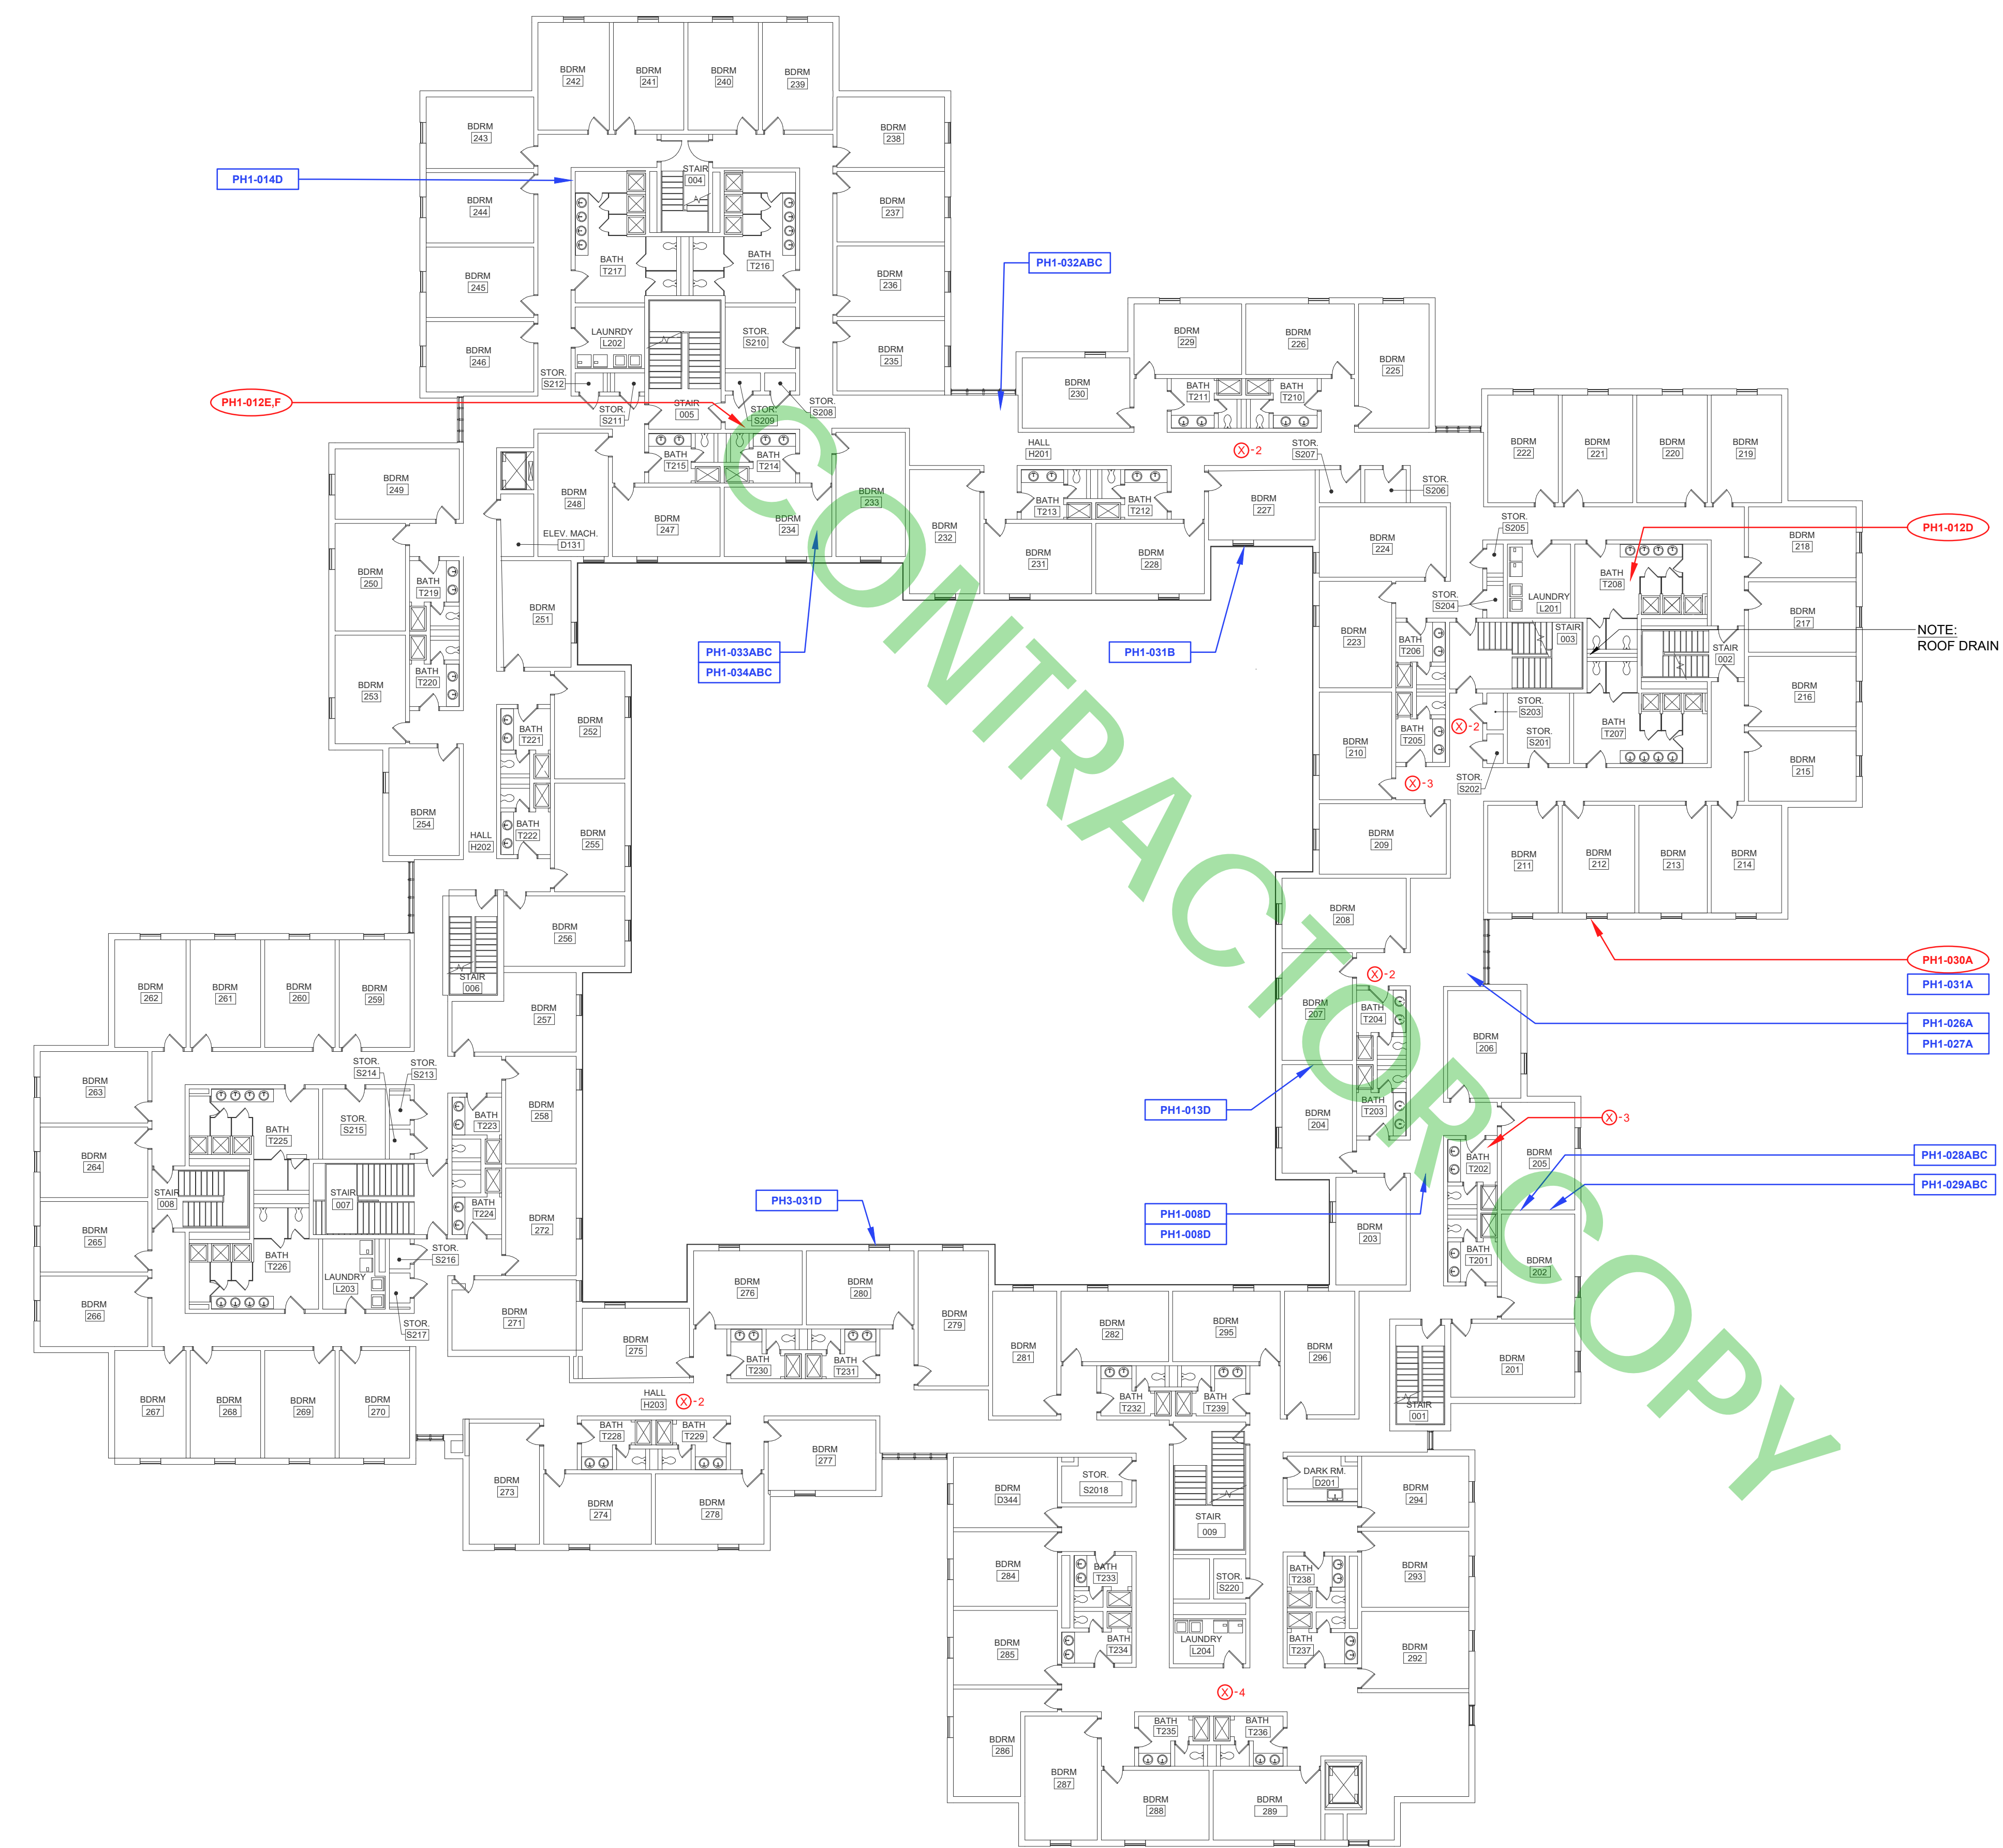
SECOND FLOOR PLAN
SCALE: 1/16"=1'-0"

- PH-002A SAMPLE NUMBER AND LOCATION TESTING NEGATIVE FOR ASBESTOS
- PH-001B SAMPLE NUMBER AND LOCATION NOT ANALYZED (POSITIVE STOP)
- ⊗-1 ACM INSULATED PIPE FITTING ABOVE CEILING

NOTE:
 ALL EXTERIOR WINDOWS HAVE ASBESTOS
 CONTAINING CAULKING. (REFER TO SAMPLE
 PH1-030A)

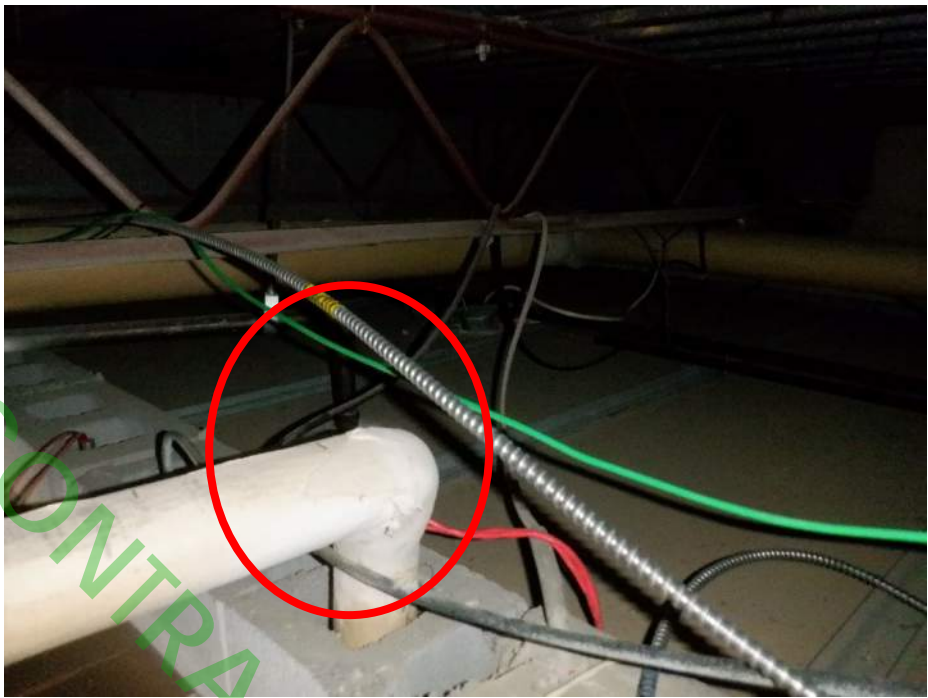
Photo No. 3

Photo Date: August 24, 2023	
Site Location: Maine Maritime Academy Curtis Hall	
Description: Mud pipe fitting insulation located in ceiling plenum.	
Photo By: DAK

Current state regulations require that identified ACM which may be impacted by planned renovation/demolition activity be removed by a MDEP licensed asbestos abatement contractor in accordance with applicable state and federal regulations prior to disturbance of ACM by such planned activities. In accordance with National Emissions Standards for Hazardous Air Pollutants (NESHAP) (40 CFR 61), and MDEP Asbestos Management Regulations, a contractor conducting a renovation and/or demolition activity that would disturb regulated ACM must: (1) notify the U.S. Environmental Protection Agency (USEPA) Administrator and the MDEP of such activities, (2) use proper removal procedures, (3) use proper engineering controls to limit emissions of asbestos

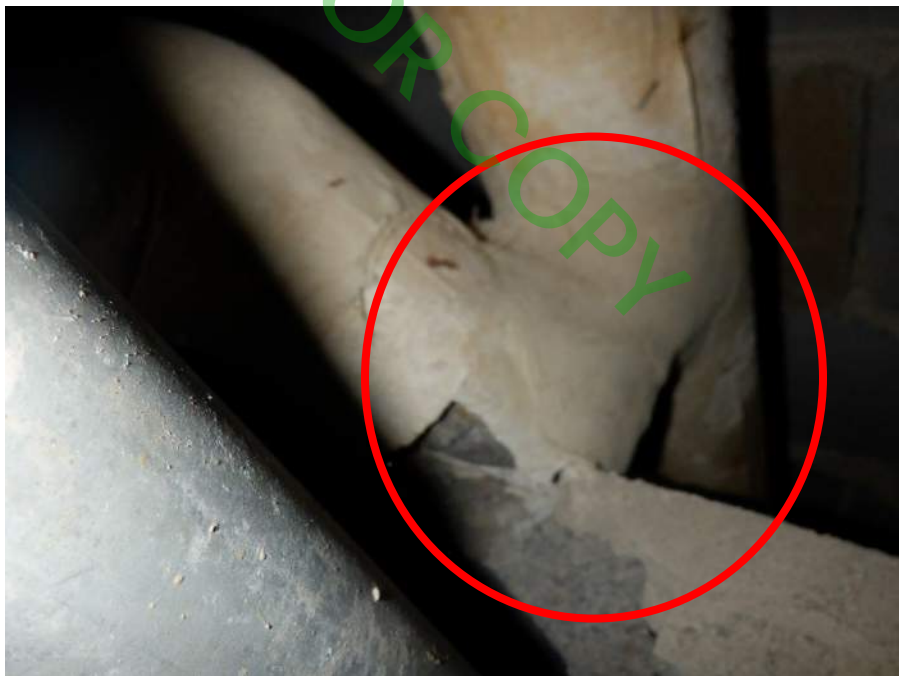
Photo No. 4

Photo Date: August 24, 2023	
Site Location: Maine Maritime Academy Curtis Hall	
Mud pipe fitting insulation located in ceiling plenum.	
Photo By: DAK

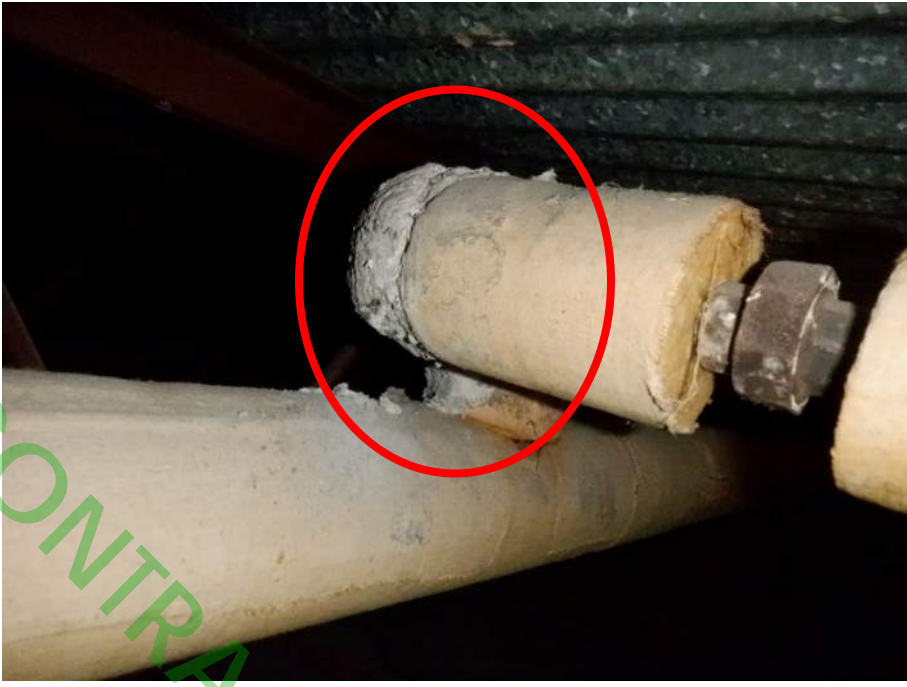
Photo No. 5

Photo Date: August 25, 2023	
Site Location: Maine Maritime Academy Curtis Hall	
Description: Mud pipe fitting insulation on fiberglass-insulated piping.	
Photo By: DAK

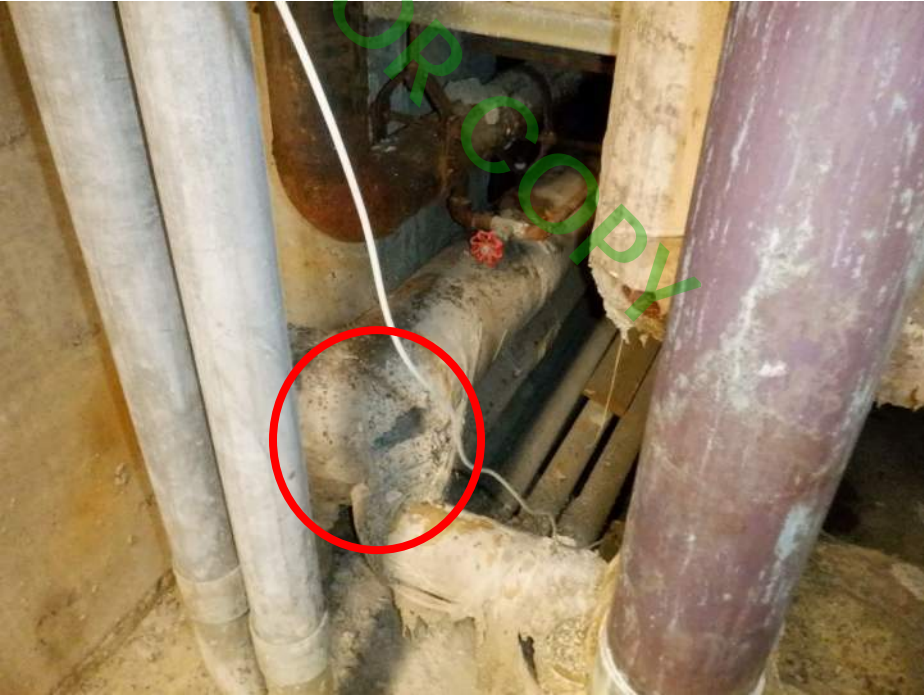
Photo No. 6

Photo Date: August 25, 2023	
Site Location: Maine Maritime Academy Curtis Hall	
Description: Pipe chase located in Ground Floor Armory.	
Photo By: DAK

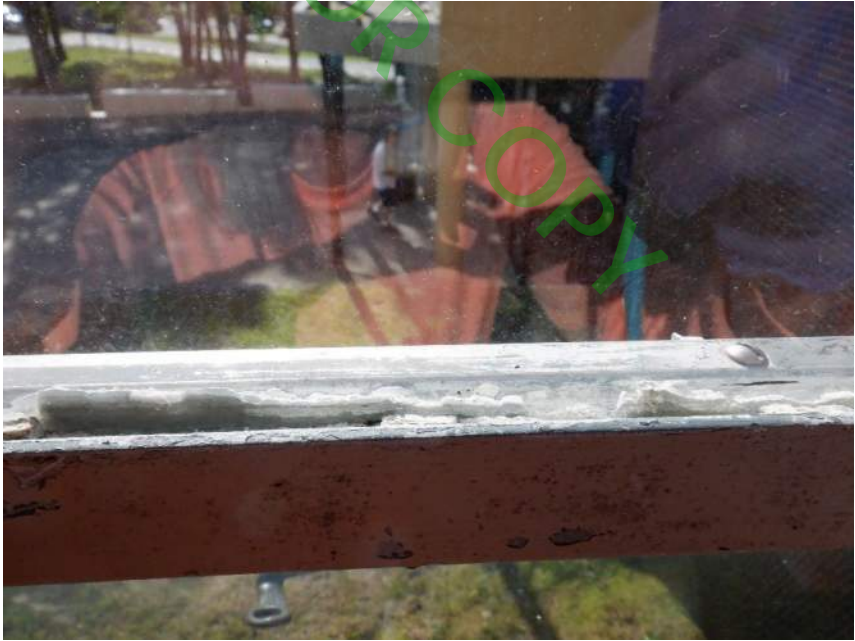
Photo No. 10

Photo Date: August 24, 2023	
Site Location: Maine Maritime Academy Curtis Hall	
Description: Non Asbestos-containing Window Glazing	
Photo By: DAK
