# Mackworth Island

Conceptual Utilization  
Master Plan

Final Report

January 27, 2023

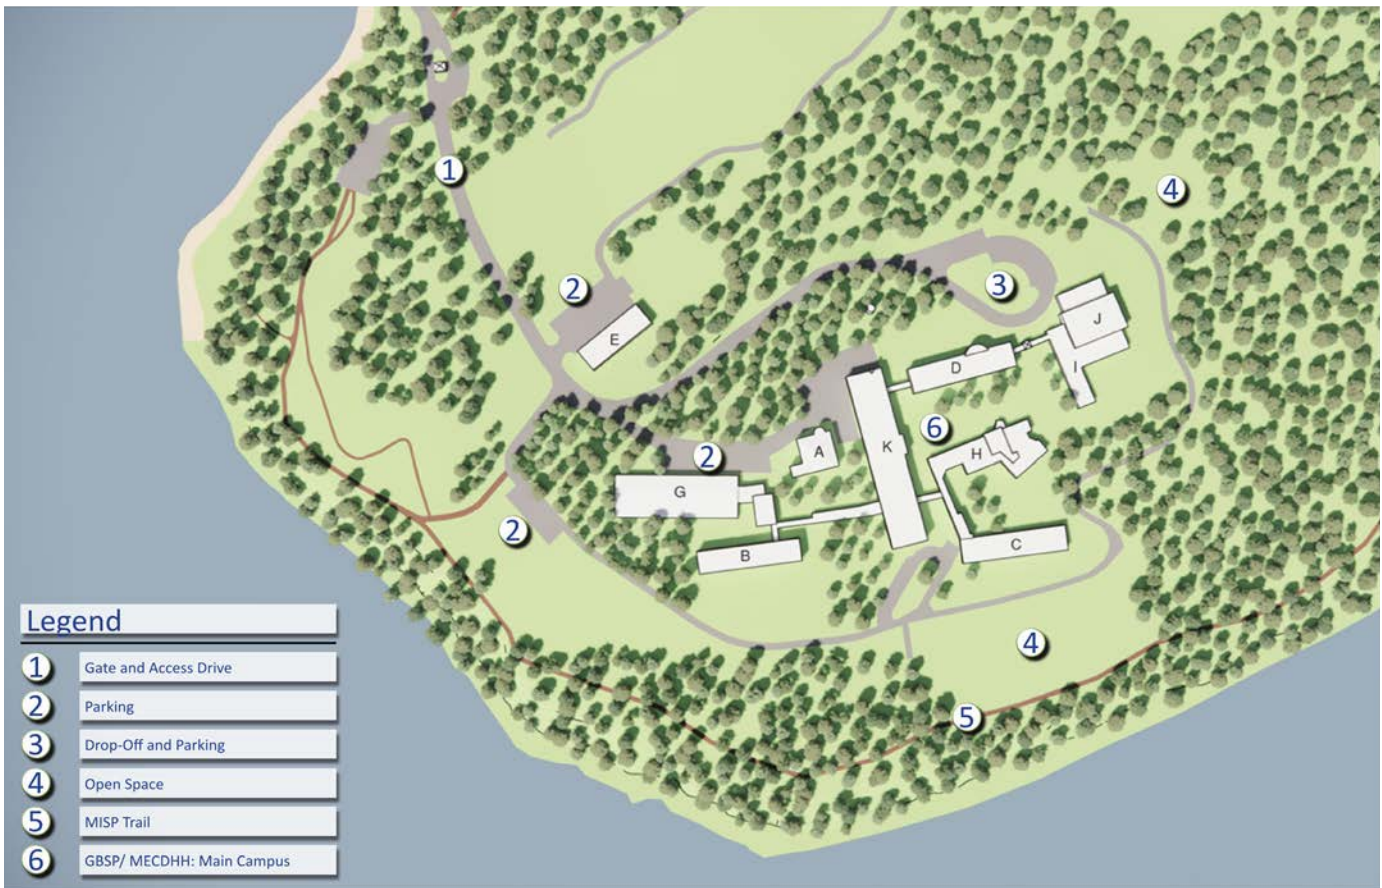
GOVERNOR BAXTER SCHOOL FOR THE DEAF CAMPUS EXISTING CONDITIONS SITE PLAN

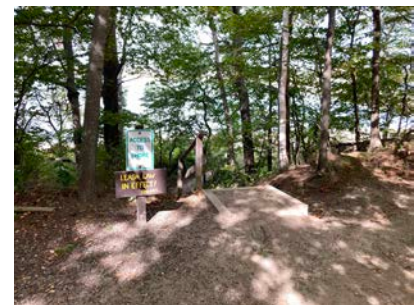
SHORE ACCESS

- Areas of waterfront erosion were noted along the State Park trail, especially in locations where informal access ways from the trail to the shore have been created.

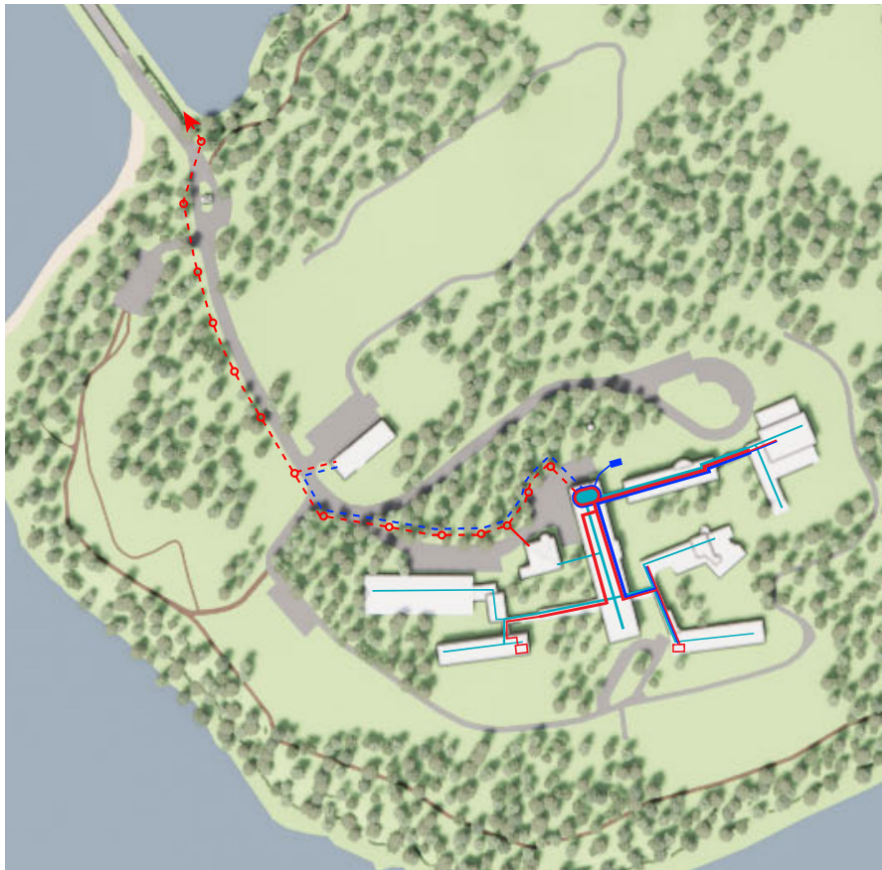
Master Planning recommendations include changing the utility distribution from a central plant model to creating a system where utility infrastructure serves each building independently. This change improves overall energy performance by designing systems that are optimized for each particular building. It also eliminates the need for the connector buildings which the current piping is distributed through.

CAMPUS UTILITIES PLAN DIAGRAM

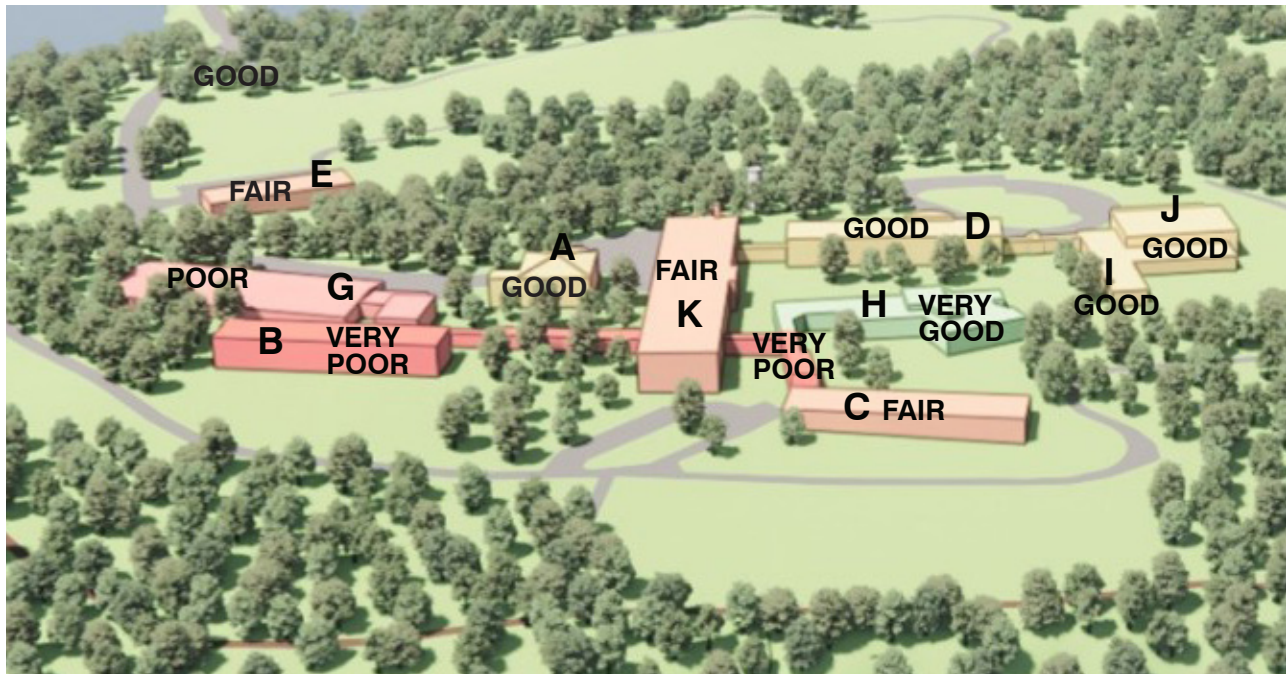
Facility condition varies greatly from building to building. Some buildings are in a state of extensive decline and should be considered for removal and others are in very good working order. Images and assessment summary charts below reflect overall condition: green is very good, yellow is good, orange is fair, red is poor, and dark red is very poor.

FACILITIES CONDITION CAMPUS AERIAL VIEW

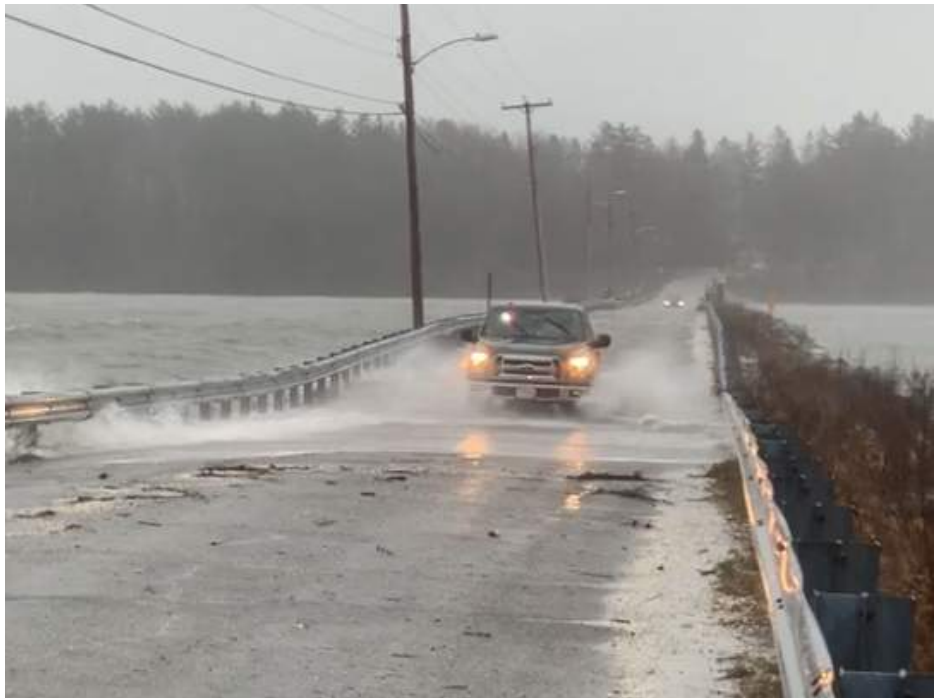
CAUSEWAY OVERTOPPING DURING DECEMBER 23, 2022 STORM

The causeway, a stone armored filled construction, has immediate, short-term and long-term improvement needs. It is low and overtopped by wave action during significant storm events. It is reported that the low portions of the causeway are overtopped by seawater more than once per year. Each overtopping event undermines the integrity of the causeway by pulling fine material from the composition and leaving gaps which accelerates settling. Immediate concerns include utility pole damage, and transverse steel beam play at one of the bridge support locations. Short-term needs include repair and stabilization of the two locations where the marine mattresses have failed, and settlement of the causeway has occurred. Long-term needs include reducing vulnerability from sea level rise and storm surge. This may be achieved by rebuilding the causeway at a higher elevation, partial replacement of the causeway, or complete replacement with a bridge. Recommended modifications include raising the causeway between 6 feet and 10 feet above its current road height to meet the Maine Climate Council's (MCC) 'Commit to Manage' (C2M) and/or the more conservative 'Prepare to Manage' (P2M) design criteria. Depending on the forecast, the causeway and bridge will be underwater throughout the year within 27 or 47 years.

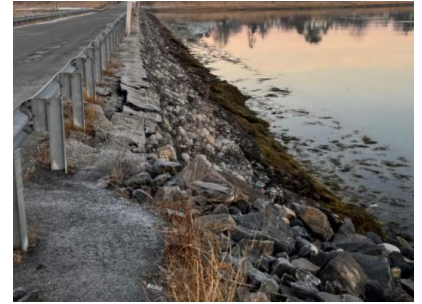
EMBANKMENT DETAIL

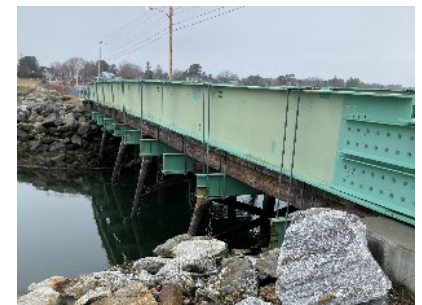
BRIDGE

The bridge, overseen by Maine Department of Transportation (MDOT), was rehabilitated in 2011 by adding structural steel above and below the existing timber structure. It is posted with a weight limit of 22 tons. Aside from creating limitations of island access by large, heavy vehicles, the bridge is in good working condition. GEI recommends an investigation to determine whether it is cost-effective in the short-term to increase the load capacity of the bridge to fully accommodate construction traffic associated with campus improvements. In the long term, a new raised bridge will be needed to accommodate sea level rise (see MCC projections above).

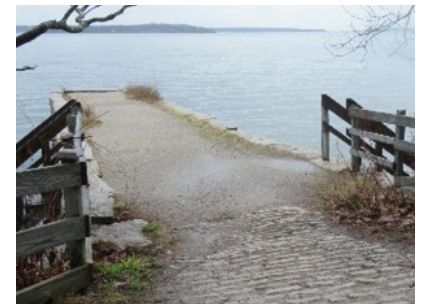
STONE PIER

The Stone Pier, a historic component of the original Baxter property, is in relatively good condition but lacks deep-water access. An extension to deep-water is needed to provide an effective boat landing and might be accommodated with the addition of a ramp and float for seasonal

access and/or a fixed pier for year-round access. Such alterations are not recommended since no specific need was identified to support it. No use beyond pedestrian recreation has been presented as a viable use for the pier in its current condition during the Master Planning process.

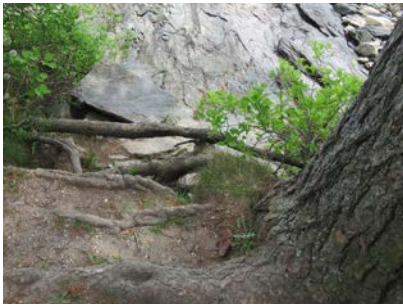
BLUFF EROSION AND LEDGE ARMOR

A review of the coastal embankments identified a history of embankment armoring at several areas of active erosion that should be monitored. Imported rip rap armoring supplements areas of natural armoring such as ledge. The most cost-effective long-term resiliency response will be to introduce a program of regrading, replanting and relocating trails and overlooks to increase the setback to the top of bank.

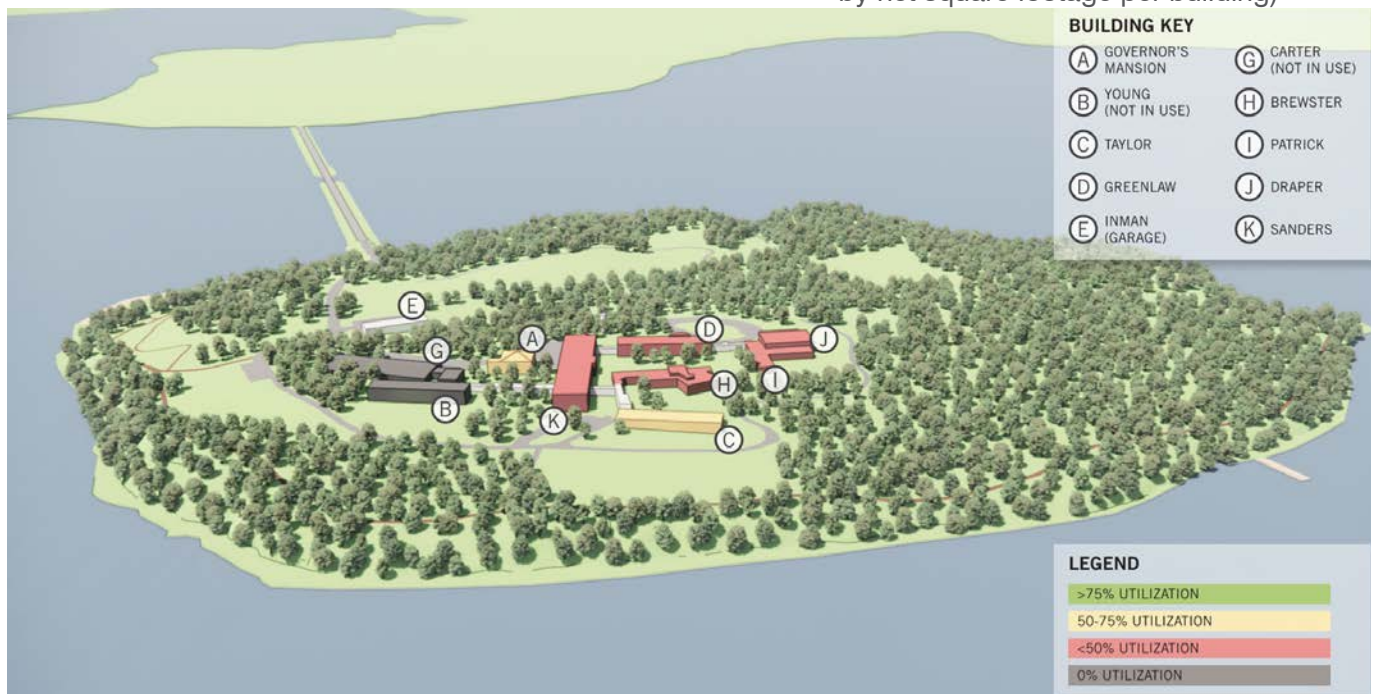
CAMPUS UTILIZATION DIAGRAM

**SPACE UTILIZATION OF EXISTING CAMPUS BUILDINGS:** (Current utilized square footage divided by net square footage per building)

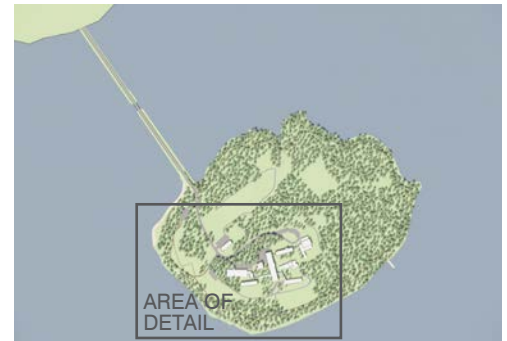
**PHASE 1: KEY PLAN**

Phase 1 accomplishes the removal of unused and potentially hazardous buildings and opens views to the Mansion. Site improvements assist in wayfinding and navigation as well as celebrating the campus as the home for the Deaf Community.

The removal of empty buildings and associated connectors. The addition of site elements including new campus gateway entrance, screening vegetation, and reduction of mowed area at State Park trail to create a better-defined buffer at the campus edge.

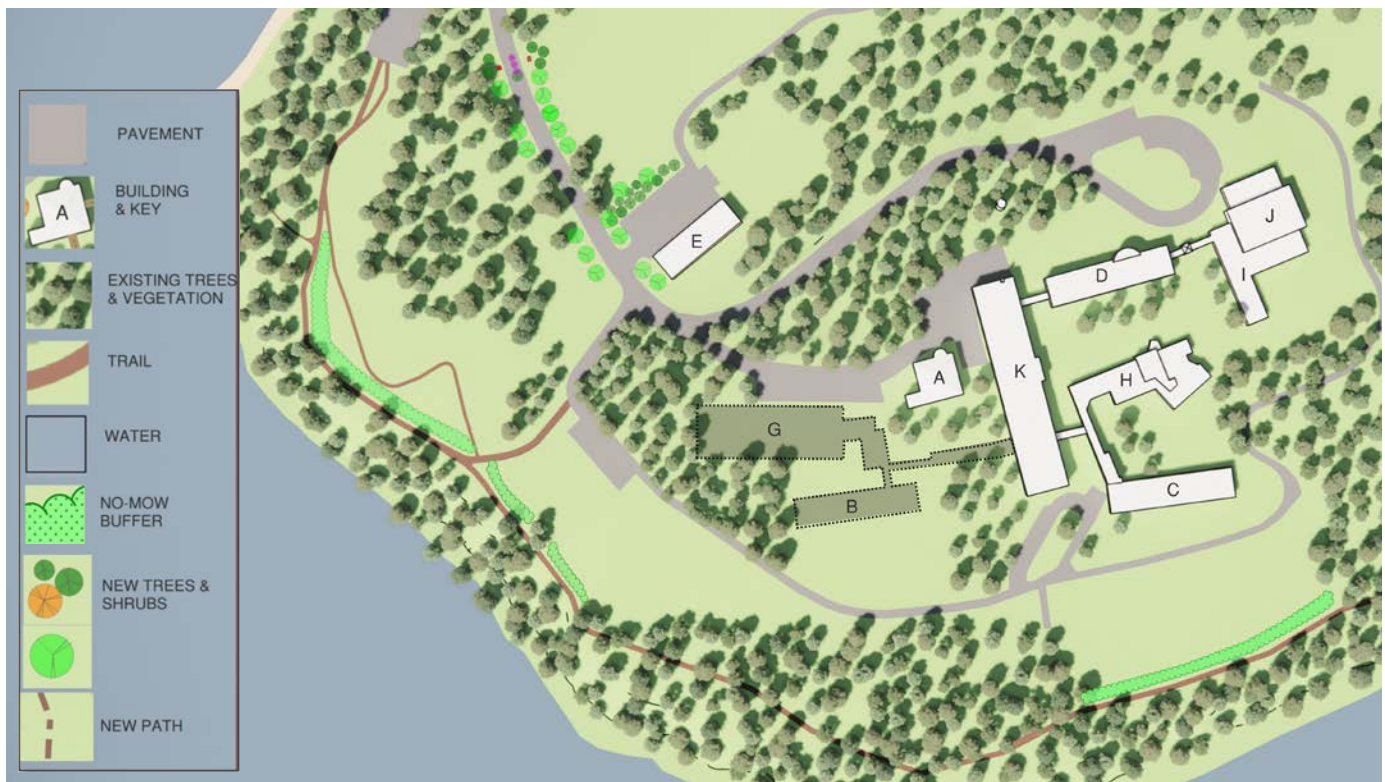
- Relocate campus utilities including IT
- New Campus Entry Gate & Signage
- New Tree Screening at Building E/ Service Area
- Trail Buffer - "No Mow" Zone

**PHASE 1: REMOVALS AND DEVELOPMENT PLAN**

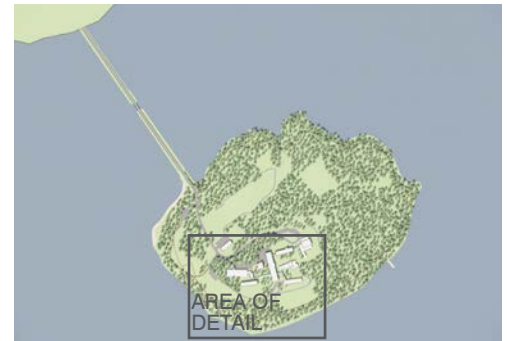
**PHASE 2 KEY PLAN**

Underutilized buildings H and K will be reorganized with minimal renovation expense to allow building C to be vacated.

The removal of building C and associated connector. Renovation of the gym (building J) for improved use for assembly events.

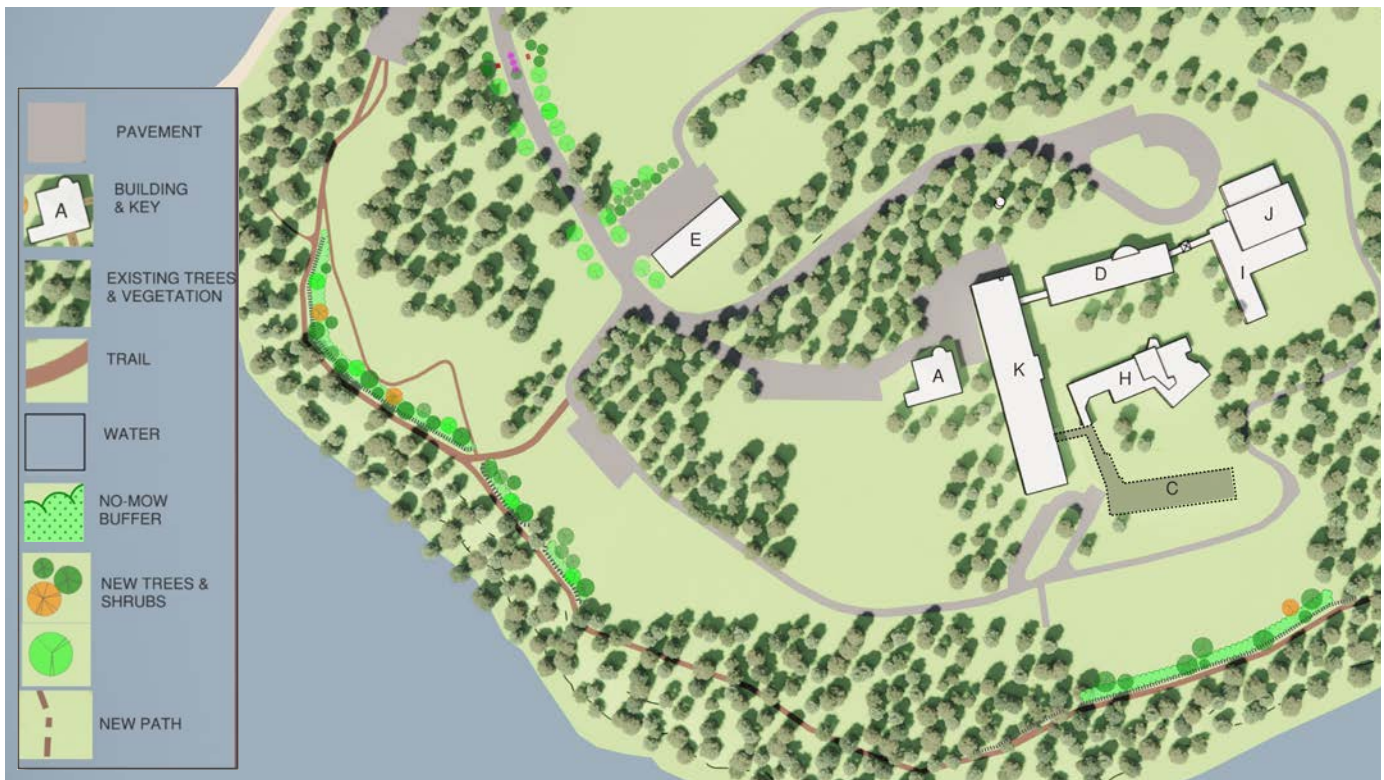
- Renovate Building J gymnasium and associated support spaces
- Consolidate Building H
- Consolidate Building C lease space into Building K
- Additional plantings and site improvements along campus and trail edges

**PHASE 2: REMOVALS AND DEVELOPMENT PLAN**

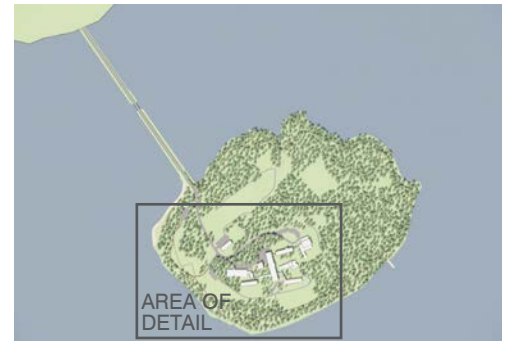
**PHASE 3: KEY PLAN**

Phase 3 accomplishes the final removal of outmoded buildings and completes the MECDDH vision for a right-sized campus. Site improvements assist in wayfinding and navigation as well as celebrating the campus as the home for the Deaf Community. A replacement for building K is envisioned to connect to building D and include public-facing program spaces such as meeting rooms and food preparation.

The removal of building K and associated connector. Addition of new building. The addition of site elements including new school drop-off loop entrance and additional site improvements at State Park trail to create a better-defined buffer at the campus edge.

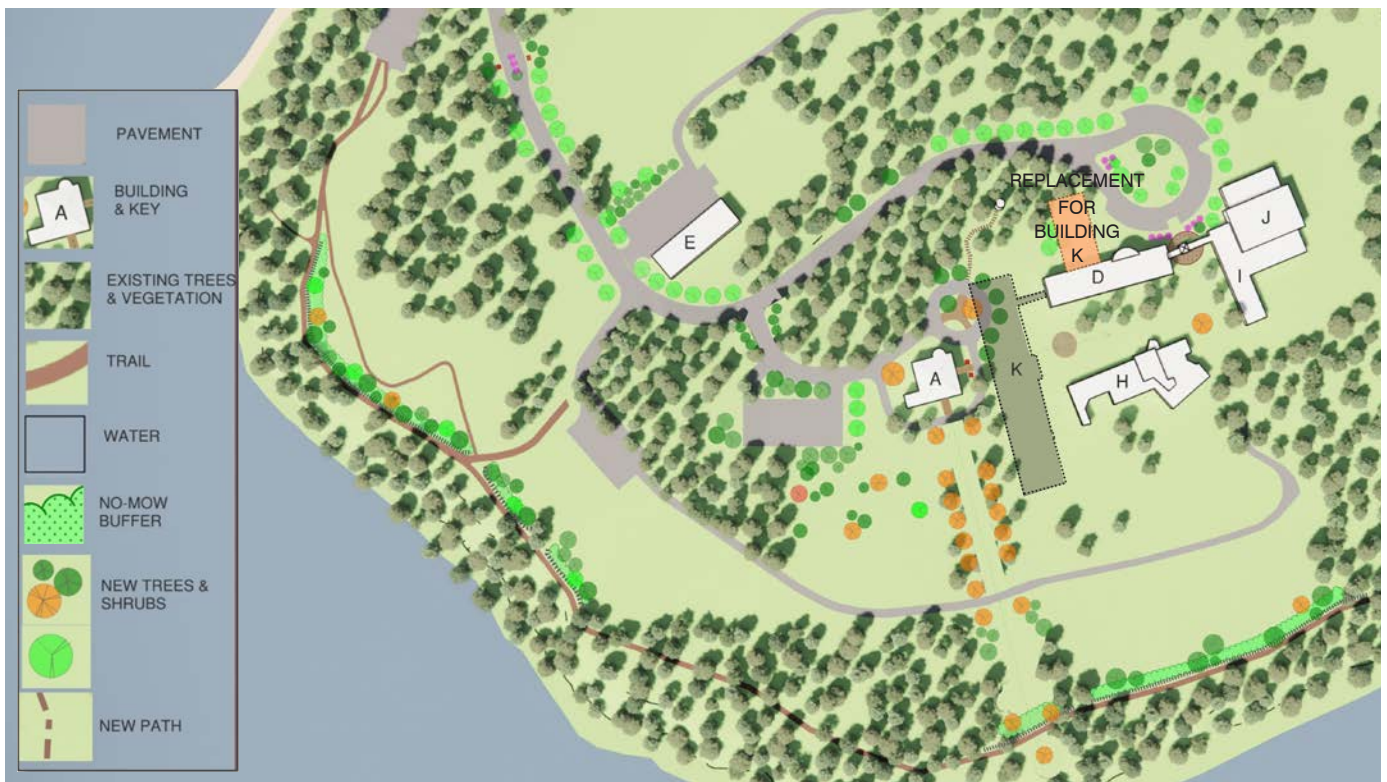
- Improved Access Driveways and New Loop Road
- New Access Drive to Mansion
- Build new building 'K'
- New Drop-off Loop and Turnaround Building A
- Develop campus building systems to remove central heat

**PHASE 3: REMOVALS AND DEVELOPMENT PLAN**

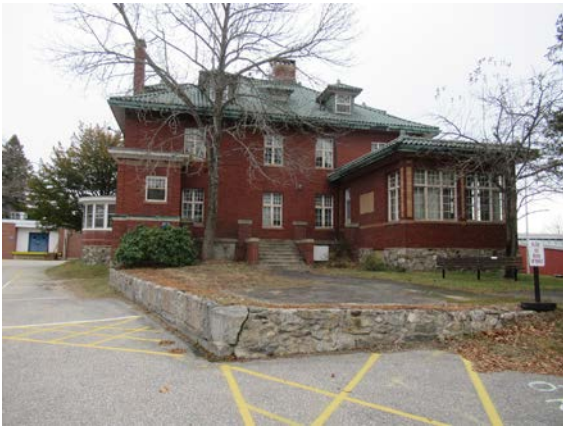
**MANSION: BUILDING A**

Year Constructed **1917**  
 Use **Office**  
 Building GSF **7,988 GSF**  
 Number of Floors **2 + Attic & Basement**  
 Construction type **Masonry & Wood (Porch floor is Concrete & Steel)**  
 Average rating (scale of 0-5) **3.5**  
 Overall Condition Rating **Good**

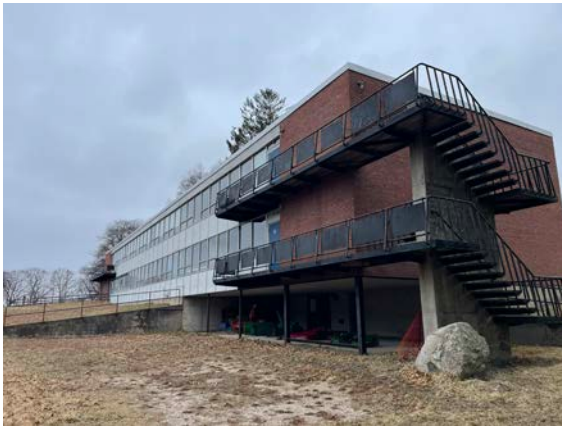
### YOUNG HALL: BUILDING B

Year Constructed **1959**  
 Use **Dormitory**  
 Building GSF **15,580 GSF**  
 Number of Floors **2 + Partial Utility Basement**  
 Construction type **Masonry & Steel**  
 Average rating (scale of 0-5) **1.2**  
 Overall Condition Rating **Very Poor (Remove)**

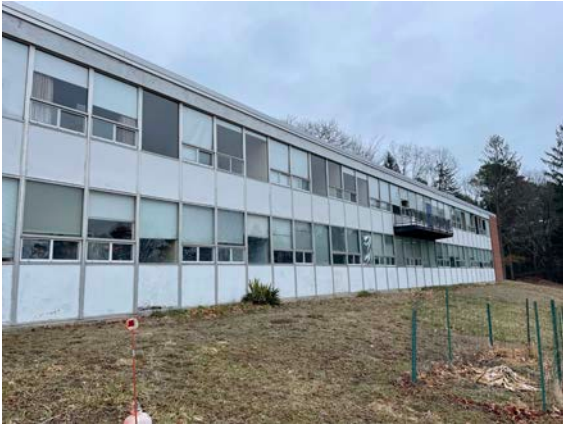
**TAYLOR HALL: BUILDING C**

Year Constructed	1958
Use	Office & Dormitory
Building GSF	13,460 GSF
Number of Floors	2
Construction type	Masonry & Steel
Average rating (scale of 0-5)	2.2
Overall Condition Rating	Fair

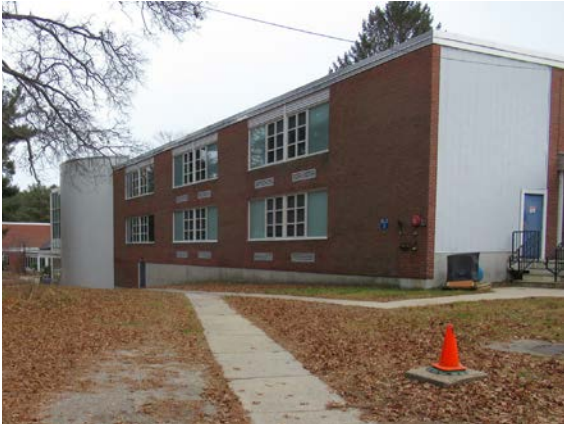
### GREENLAW: BUILDING D

Electrical				Lighting		Mechanical				Plumbing					Structure				38 Total Review Categories	
Service Entrance	Panel / Distribution	Emergency Power	Lighting	Lighting Controls	Boiler	Fuel	HVAC	Specialty Areas	Toilet Rooms	Kitchen	Domestic Water	Sprinkler Riser	Sprinkler Distribution	Showers	Observable Steel	Observable Masonry	Headers / Lintels	Misc Metals / Stairs	Total Score	Building Average Rating
4	4	4	4	n/a	n/a	n/a	4	n/a	3	n/a	2	3	3	n/a	4	3	3	4	108.0	3.38

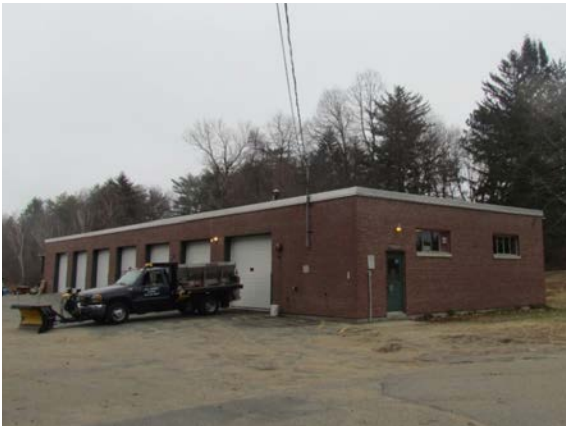
**INMAN GARAGE: BUILDING E**

Electrical			Lighting		Mechanical				Plumbing						Structure				38 Total Review Categories	
Service Entrance	Panel / Distribution	Emergency Power	Lighting	Lighting Controls	Boiler	Fuel	HVAC	Specialty Areas	Toilet Rooms	Kitchen	Domestic Water	Sprinkler Riser	Sprinkler Distribution	Showers	Observable Steel	Observable Masonry	Headers / Lintels	Misc Metals / Stairs	Total Score	Building Average Rating
4	2	4	3	n/a	n/a	n/a	4	n/a	1	2	2	3	3	1	3	2	2	n/a	55.0	2.12

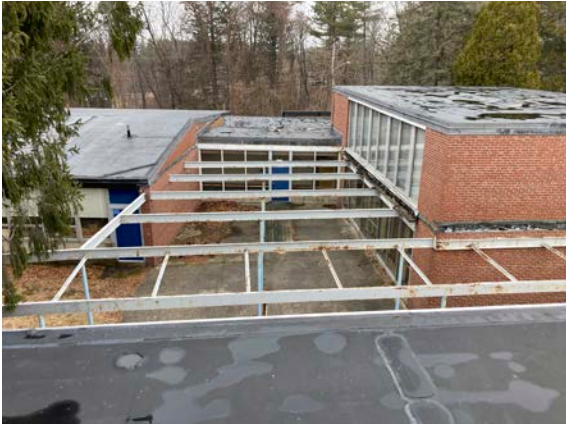
### CARTER: BUILDING G

Electrical			Lighting		Mechanical				Plumbing					Structure				38 Total Review Categories		
Service Entrance	Panel / Distribution	Emergency Power	Lighting	Lighting Controls	Boiler	Fuel	HVAC	Specialty Areas	Toilet Rooms	Kitchen	Domestic Water	Sprinkler Riser	Sprinkler Distribution	Showers	Observable Steel	Observable Masonry	Headers / Lintels	Misc Metals / Stairs	Total Score	Building Average Rating
3	2	1	1	n/a	n/a	n/a	3	n/a	1	n/a	2	3	3	1	2	2	2	n/a	57.0	1.84

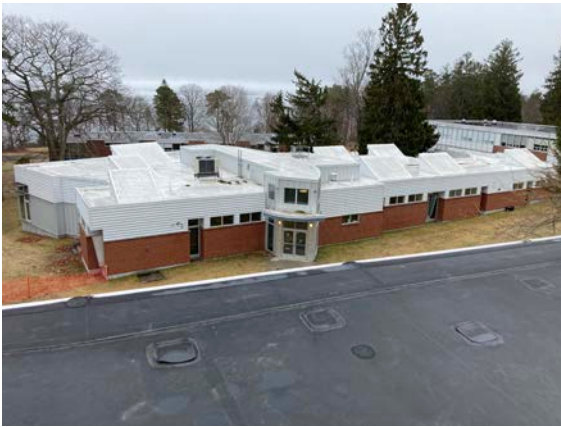
**BREWSTER: BUILDING H**

Electrical			Lighting		Mechanical				Plumbing						Structure				38 Total Review Categories	
Service Entrance	Panel / Distribution	Emergency Power	Lighting	Lighting Controls	Boiler	Fuel	HVAC	Specialty Areas	Toilet Rooms	Kitchen	Domestic Water	Sprinkler Riser	Sprinkler Distribution	Showers	Observable Steel	Observable Masonry	Headers / Lintels	Misc Metals / Stairs	Total Score	Building Average Rating
4	4	4	4	4	n/a	n/a	4	n/a	4	4	4	4	4	n/a	5	4	4	4	134.5	3.96

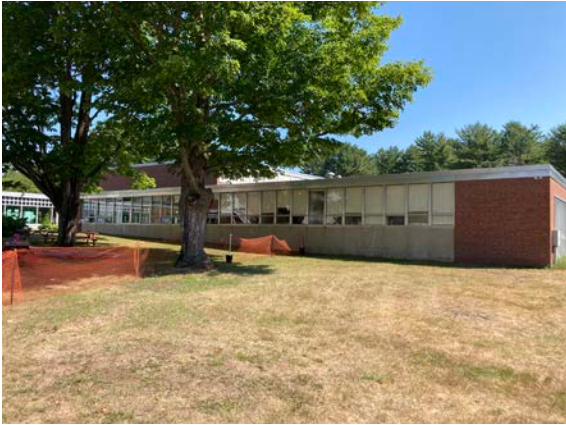
### **PATRICK HALL: BUILDING I**

Electrical																			38 Total Review Categories	
Service Entrance	Panel / Distribution	Emergency Power	Lighting	Lighting Controls	Boiler	Fuel	HVAC	Specialty Areas	Toilet Rooms	Kitchen	Domestic Water	Sprinkler Riser	Sprinkler Distribution	Showers	Observable Steel	Observable Masonry	Headers / Lintels	Misc Metals / Stairs	Total Score	Building Average Rating
n/a	n/a	n/a	2	n/a	n/a	n/a	3	n/a	n/a	n/a	2	3	3	n/a	n/a	2	2	2	63.0	2.63

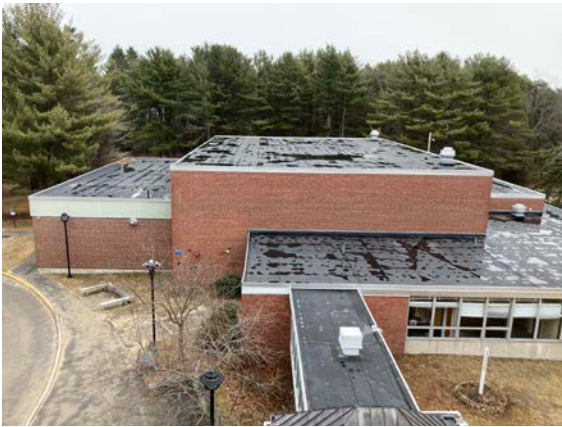
### DRAPER HALL: BUILDING J

Electrical			Lighting		Mechanical				Plumbing					Structure				38 Total Review Categories		
Service Entrance	Panel / Distribution	Emergency Power	Lighting	Lighting Controls	Boiler	Fuel	HVAC	Specialty Areas	Toilet Rooms	Kitchen	Domestic Water	Sprinkler Riser	Sprinkler Distribution	Showers	Observable Steel/Giulams	Observable Masonry	Headers / Lintels	Misc Metals / Stairs	Total Score	Building Average Rating
n/a	n/a	n/a	2	n/a	n/a	n/a	2	n/a	1	n/a	2	3	4	1	3	3	3	3	73.5	2.63

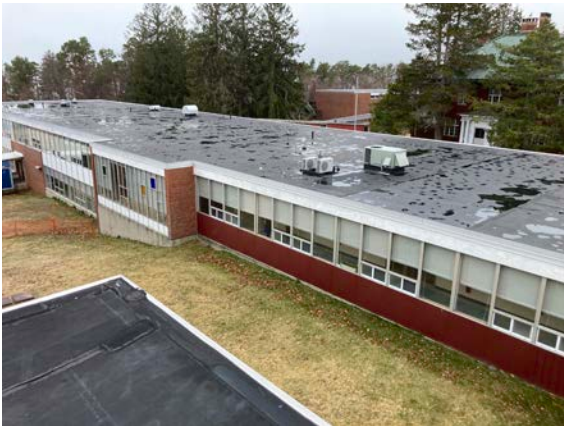
### SANDERS HALL: BUILDING K

Electrical			Lighting		Mechanical				Plumbing						Structure				38 Total Review Categories	
Service Entrance	Panel / Distribution	Emergency Power	Lighting	Lighting Controls	Boiler	Fuel	HVAC	Specialty Areas	Toilet Rooms	Kitchen	Domestic Water	Sprinkler Riser	Sprinkler Distribution	Showers	Observable Steel	Observable Masonry	Headers / Lintels	Misc Metals / Stairs	Total Score	Building Average Rating
3	2	2	1	n/a	4	2	3	n/a	1	2	2	3	3	1	3	3	2.5	2	81.0	2.31

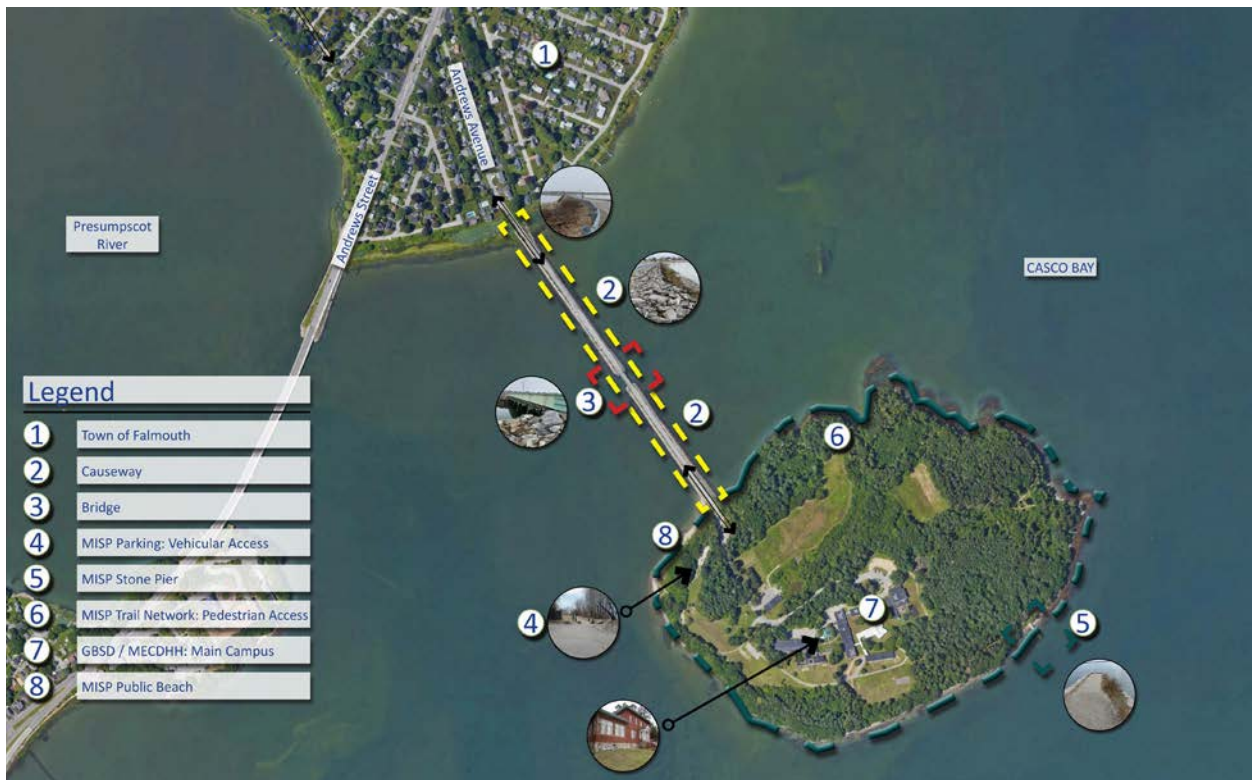
**EXISTING CONDITION SITE CONTEXT PLAN**

Mackworth Island is located in Casco Bay just north of Portland in Falmouth, Cumberland County, Maine. The 100-acre island is predominantly undeveloped. GBSD/ MECDHH occupies about 15-acres near the center of the island while Mackworth Island State Park (MISP) encompasses the remainder of the island. MISP includes a gate house, visitor and staff parking, a perimeter trail system with shore access points and all other land not part of GBSD. The Portland Water District owns a pump house and water main serving the coastal islands.

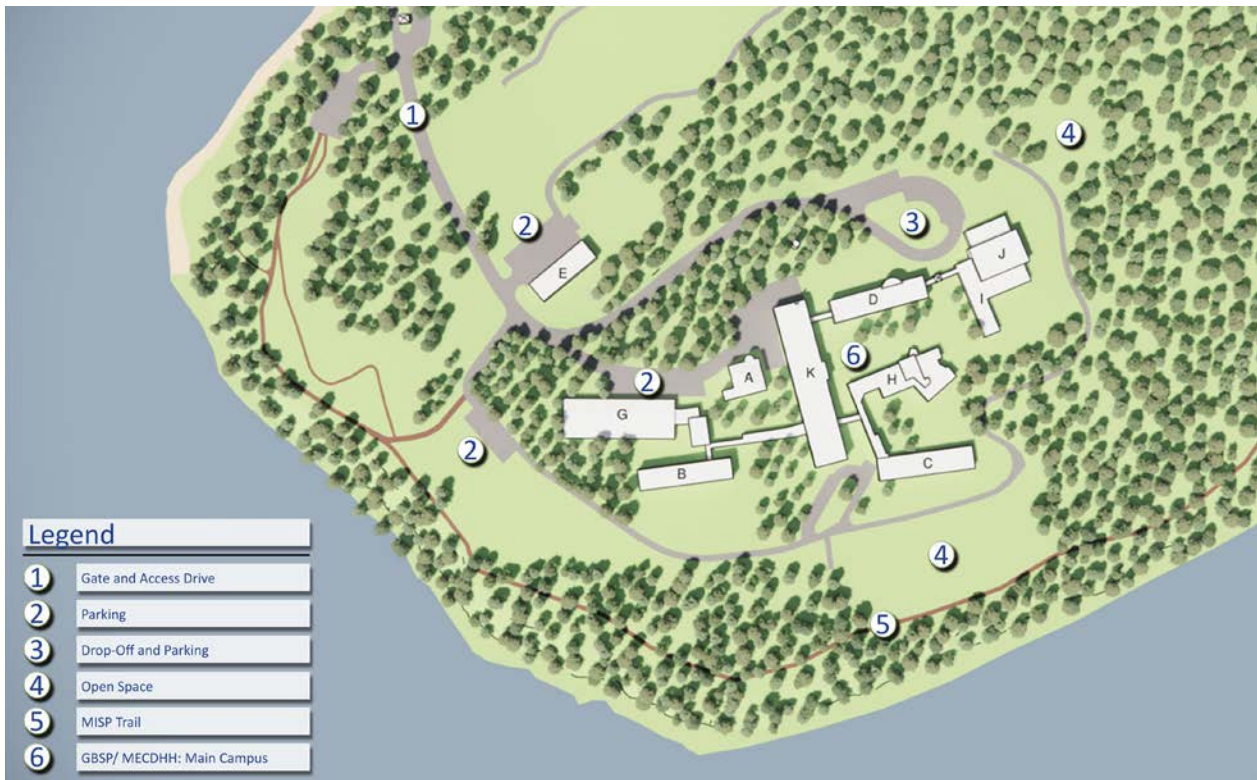
**EXISTING CONDITIONS GBSD/ MECDHH CAMPUS**

The GBSD/ MECDHH campus, developed around the Baxter Mansion is located on the height of land and includes the administrative, academic and support buildings; paved access drives and parking for staff and visitors, walks, open space, and recreation facilities. A detailed inventory of the existing buildings prepared by the architects and engineers is found in the Facilities Assessment reports. A detailed inventory of traffic and parking is provided in the Traffic Report.

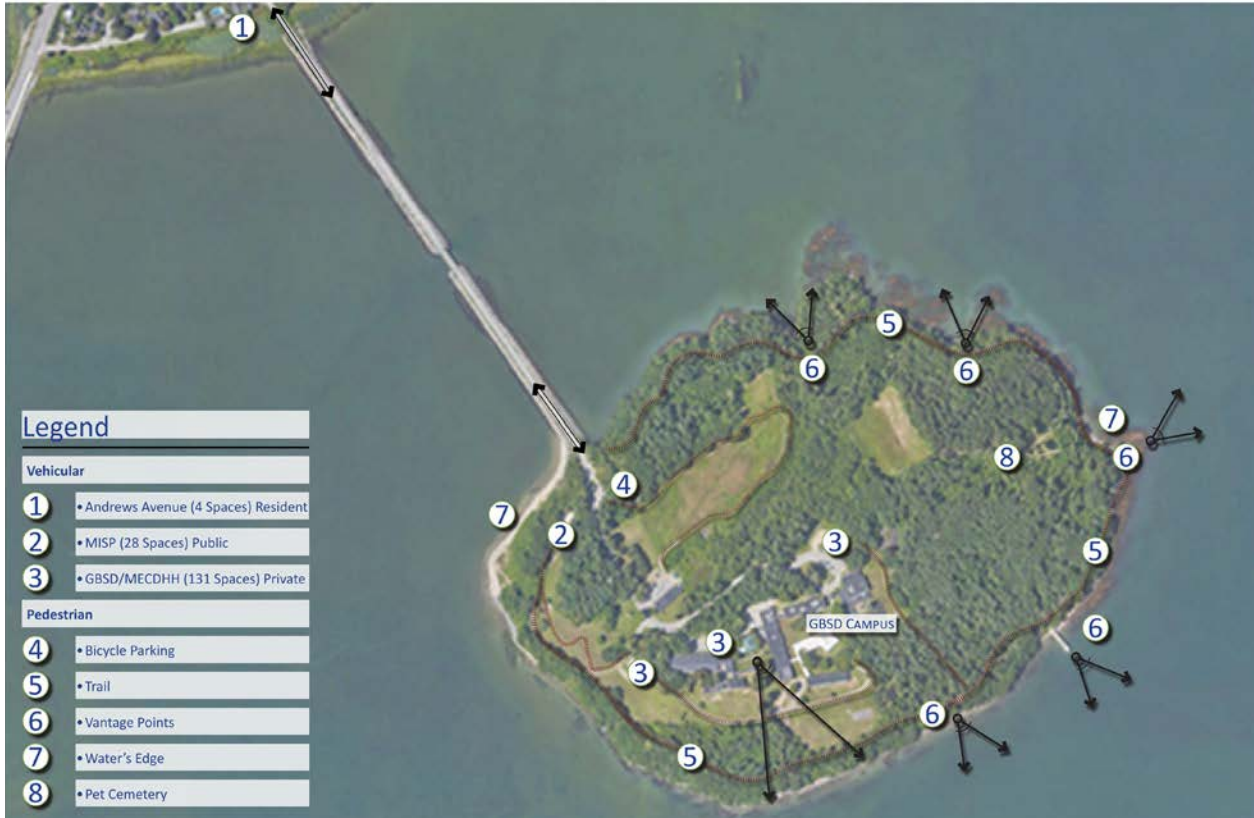
**SITE INVENTORY – CIRCULATION AND ELEMENTS**

Beyond the MISP Gatehouse, a single road serves Mackworth Island/ GBSD. The roadway diverges at the approach to GBSD. The upper driveway provides access to the Baxter Mansion and upper campus. The lower driveway provides access to the Preschool and lower campus. Access to the school property is controlled by a metal gate and signage.

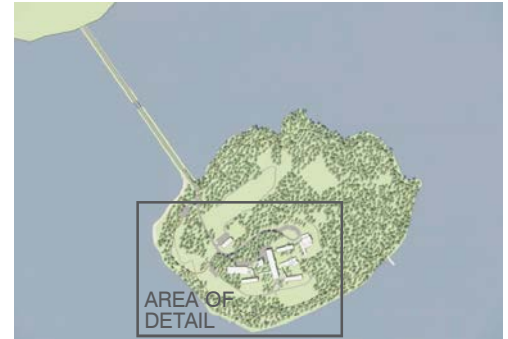
**PHASE 1: KEY PLAN**

Removal of empty buildings and associated connectors. Addition of site elements including new campus gateway entrance, screening vegetation, and reduction of mowed area at State Park trail to create a better-defined buffer at the campus edge.

Phase 1 accomplishes the removal of unused and potentially hazardous buildings and opens views to the Mansion. Site improvements assist in wayfinding and navigation as well as celebrating the campus as the home for the Deaf Community.

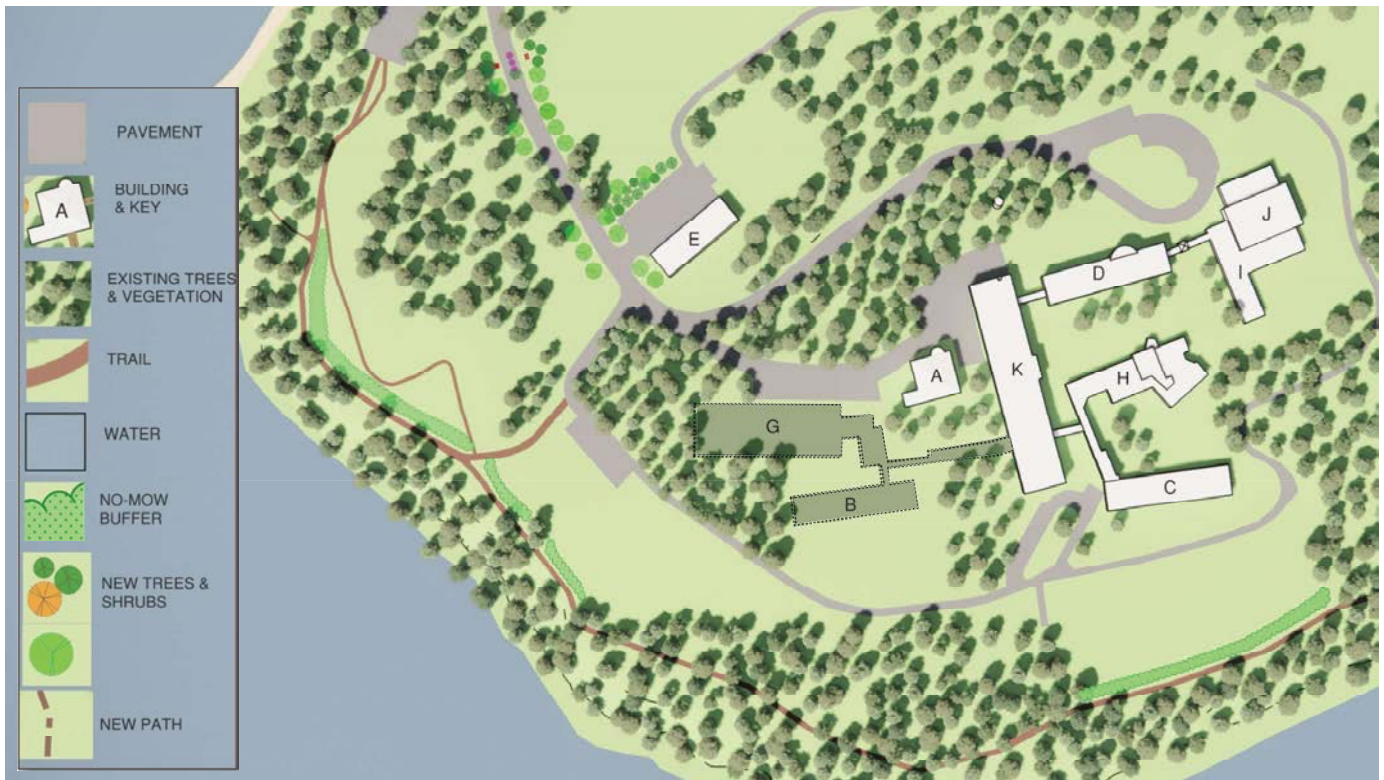
**PHASE 1: REMOVALS AND DEVELOPMENT PLAN**

- Relocate campus utilities including IT entrance to directly connect to Building K
- New Campus Entry Gate & Signage to improve wayfinding and security
- New Tree Screening at Building E/ Service Area to better define access to school and improve campus aesthetics
- Trail Buffer - "No Mow" Zone approximately 50 feet from trail edge to reduce park visitors entering campus grounds

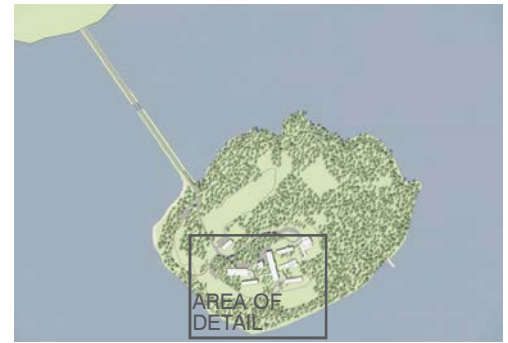
**PHASE 2 KEY PLAN**

Phase 2 accomplishes the removal of underutilized buildings that are very energy inefficient and require significant capital expenditure to renovate for future viability. Removal improves utilization for existing facility spaces. Although Building C is functional, it is reliant on the connector elements to supply heat and water. The need to remove the connectors influenced the recommendation to remove Building C.

Underutilized buildings H and K will be reorganized with minimal renovation expense to allow building C to be vacated. Building C and associated connector are to be removed. Renovation of the gym (building J) for improved use for assembly events.

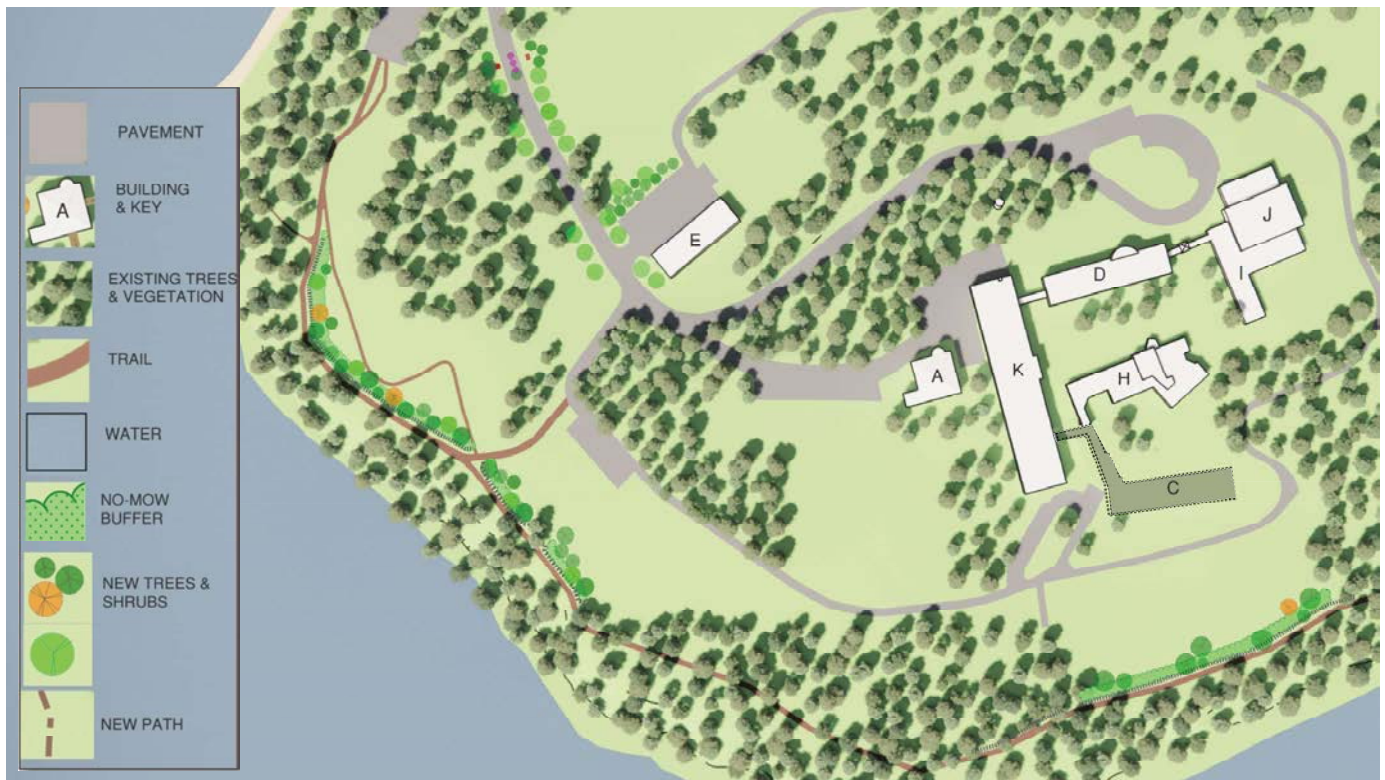
**PHASE 2: REMOVALS AND DEVELOPMENT PLAN**

- Renovate Building J gymnasium and associated support spaces to improve utilization of existing large function space
- Consolidate Building H
- Consolidate Building C lease space into Building K
- Additional plantings and site improvements along campus and trail edges

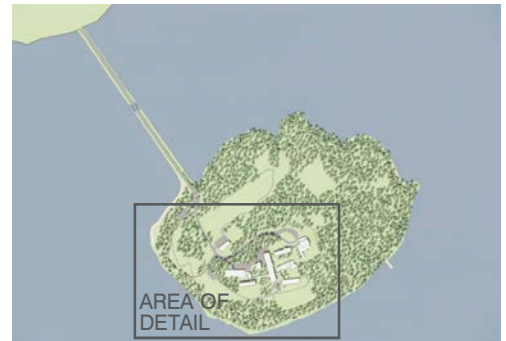
**PHASE 3: KEY PLAN**

Phase 3 accomplishes the final removal of outdated buildings and completes the MECDHH vision for a right-sized campus. Site improvements assist in wayfinding and navigation as well as celebrating the campus as the home for the Deaf Community.

The removal of building K and associated connector. Addition of new building. The addition of site elements including new school drop-off loop entrance and additional site improvements at State Park trail to create a better-defined buffer at the campus edge.

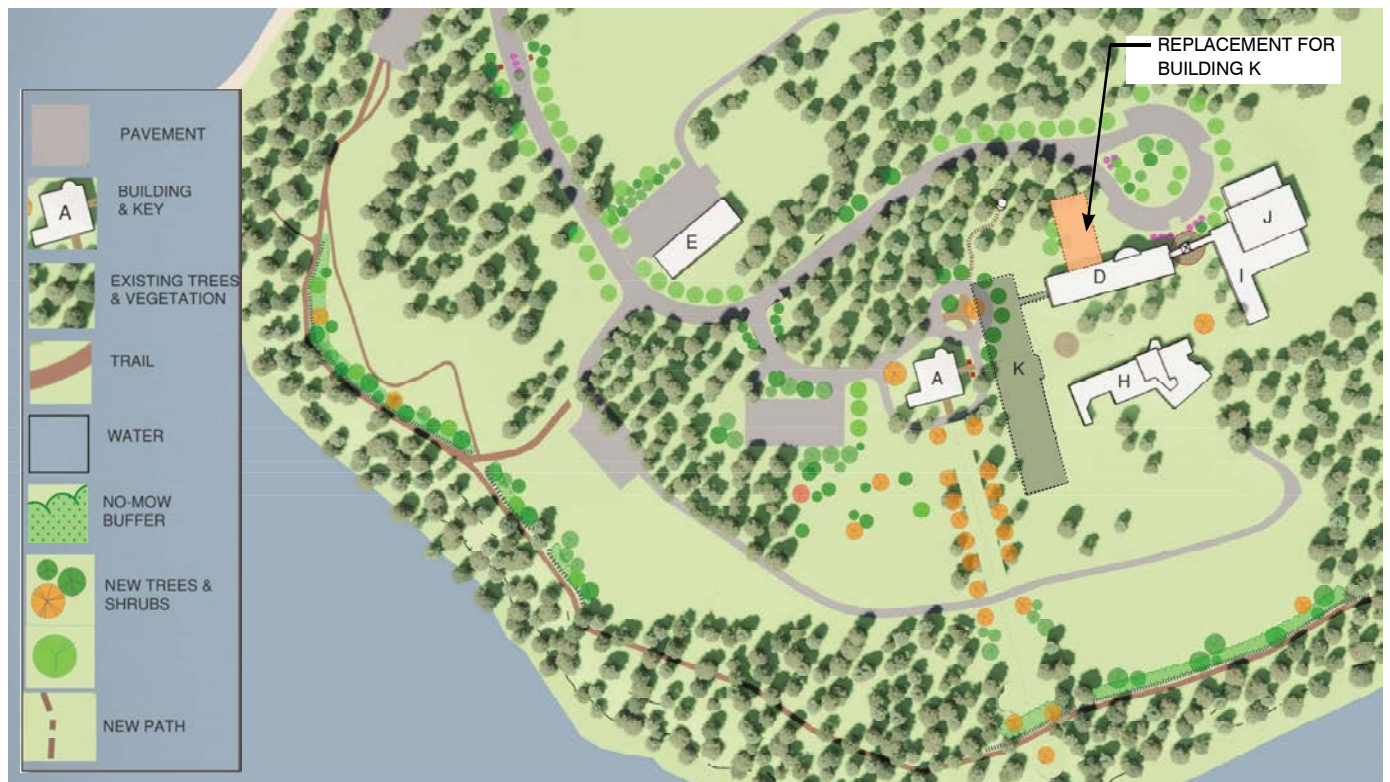
**PHASE 3: REMOVALS AND DEVELOPMENT PLAN**

- Improved Access Driveways and New Loop Road
- New Access Drive to Mansion
- Build new building 'K'
- New Drop-off Loop and Turnaround Building A
- Develop campus building systems to remove central heat
- Plantings to define view corridors and central quadrangle
