PETITION TO SET WATER LEVELS/MINIMUM FLOWS

NAME OF WATER BODY: Montgomery Dam on the Megunticook River

LOCATION OF WATER BODY- TOWN(S): Camden

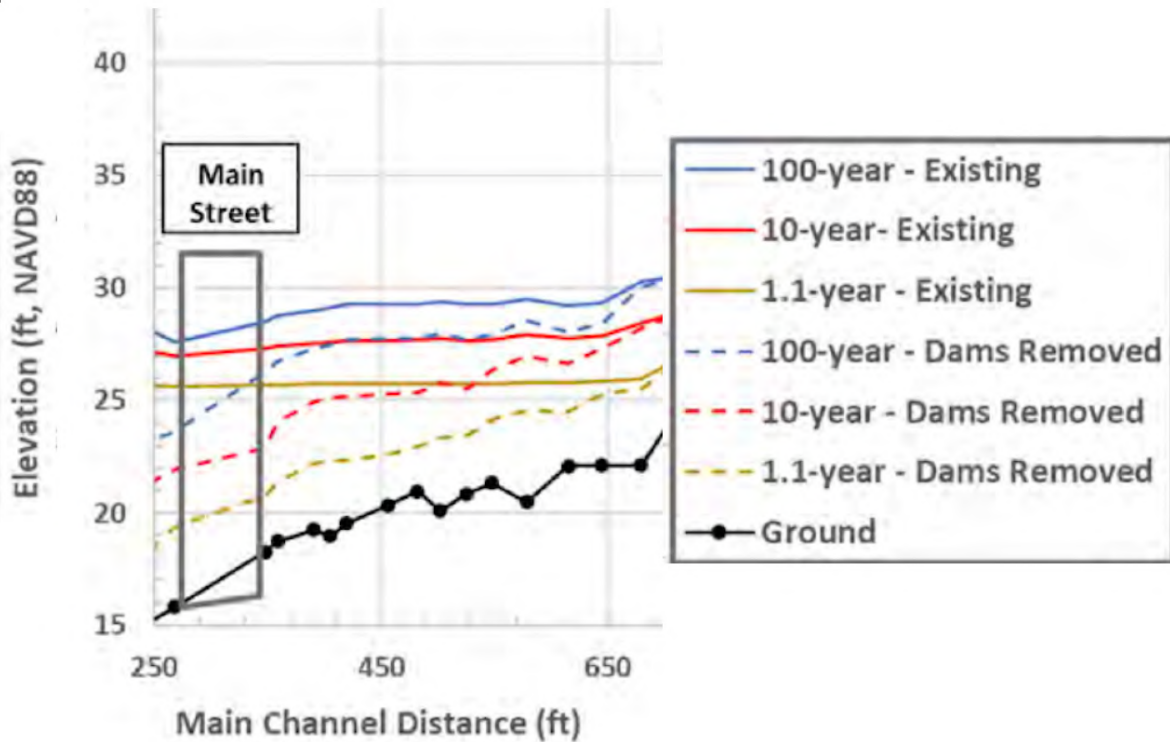
Graph caption: This graph from the joint InterFluve/Gartley & Dorsky report shows that the Montgomery Dam does not influence flooding profiles on Main Street in 100-year annual storm conditions, such as the one we experienced on 31 October of 2021. Main Street is elevated more than 5-feet above 100-year flood conditions.

the town sometimes communicates the message that the sluice gate must be opened for “flood control,” despite input from engineering experts, FEMA, and InterFluve to the contrary. For example, the FEMA 100-year storm flood map shows no overland flooding on Main Street. The joint InterFluve/Gartley & Dorsky 2021 report charts out flood profiles showing that there is no change in flood risk to Main Street in 100-year storm events with or without the dam present. Main Street is 7.5-8 feet above the spillway of the Montgomery Dam and because the dam is at least 23 feet above sea level, even the direst of sea level rise predictions from NOAA, at 10.5 feet, will have no effect on the Dam, or flooding risk of the Main Street businesses.

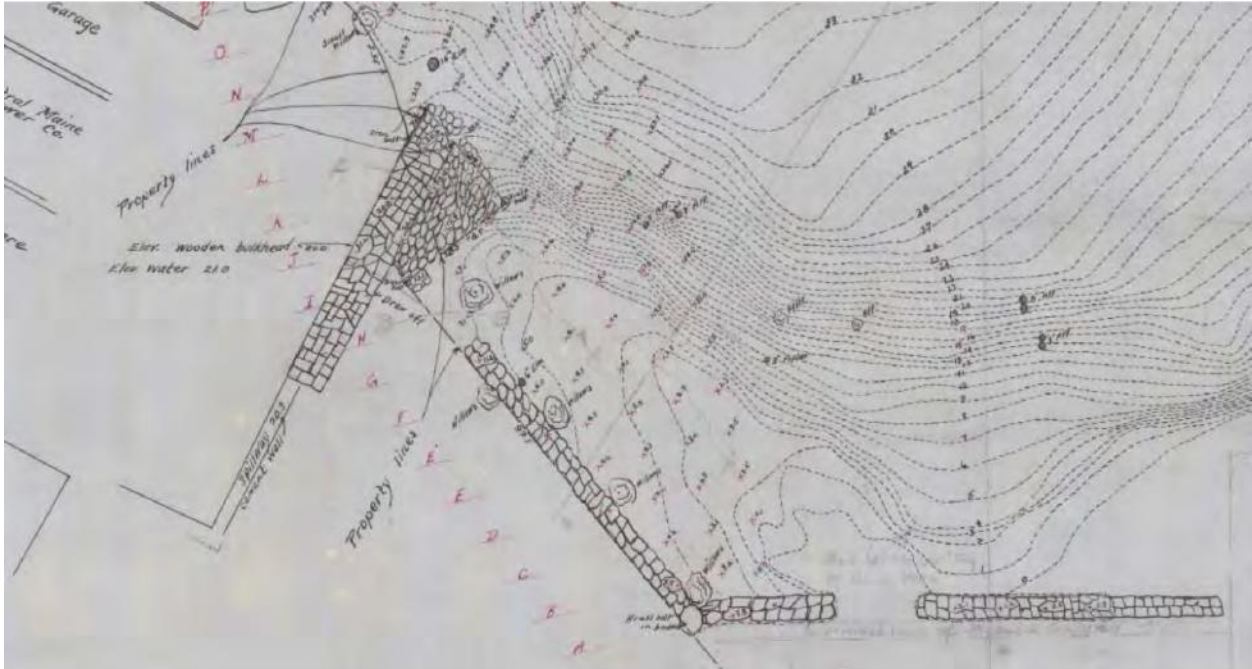
Map courtesy of the National Park Service, Olmsted Archives, Frederick Law Olmsted National Historic Site, Brookline, Massachusetts showing the water level set at 21 feet above high tide /sea level prior to Olmsted's reconstruction that extended the spillway and increased the dam height to 23.66 feet.

During the 1930s the Montgomery Dam was redesigned by Frederick Law Olmsted, Jr., to be a spectacular 100-foot infinity pool, 75-feet on the East side and 25-feet on the South side. Since the 1930s, when the millpond and falls were designed, the water has flowed at this level. The original design below from the Olmsted Brothers firm shows the water level set at the spillway. In addition, the InterFluve/Gartley & Dorsky report states, "Normal pool elevation at spillway crest." The Maine Emergency Management Agency (MEMA) notes in their 2019 report of the Montgomery Dam that, "the water level is maintained with water over the spillway year round."

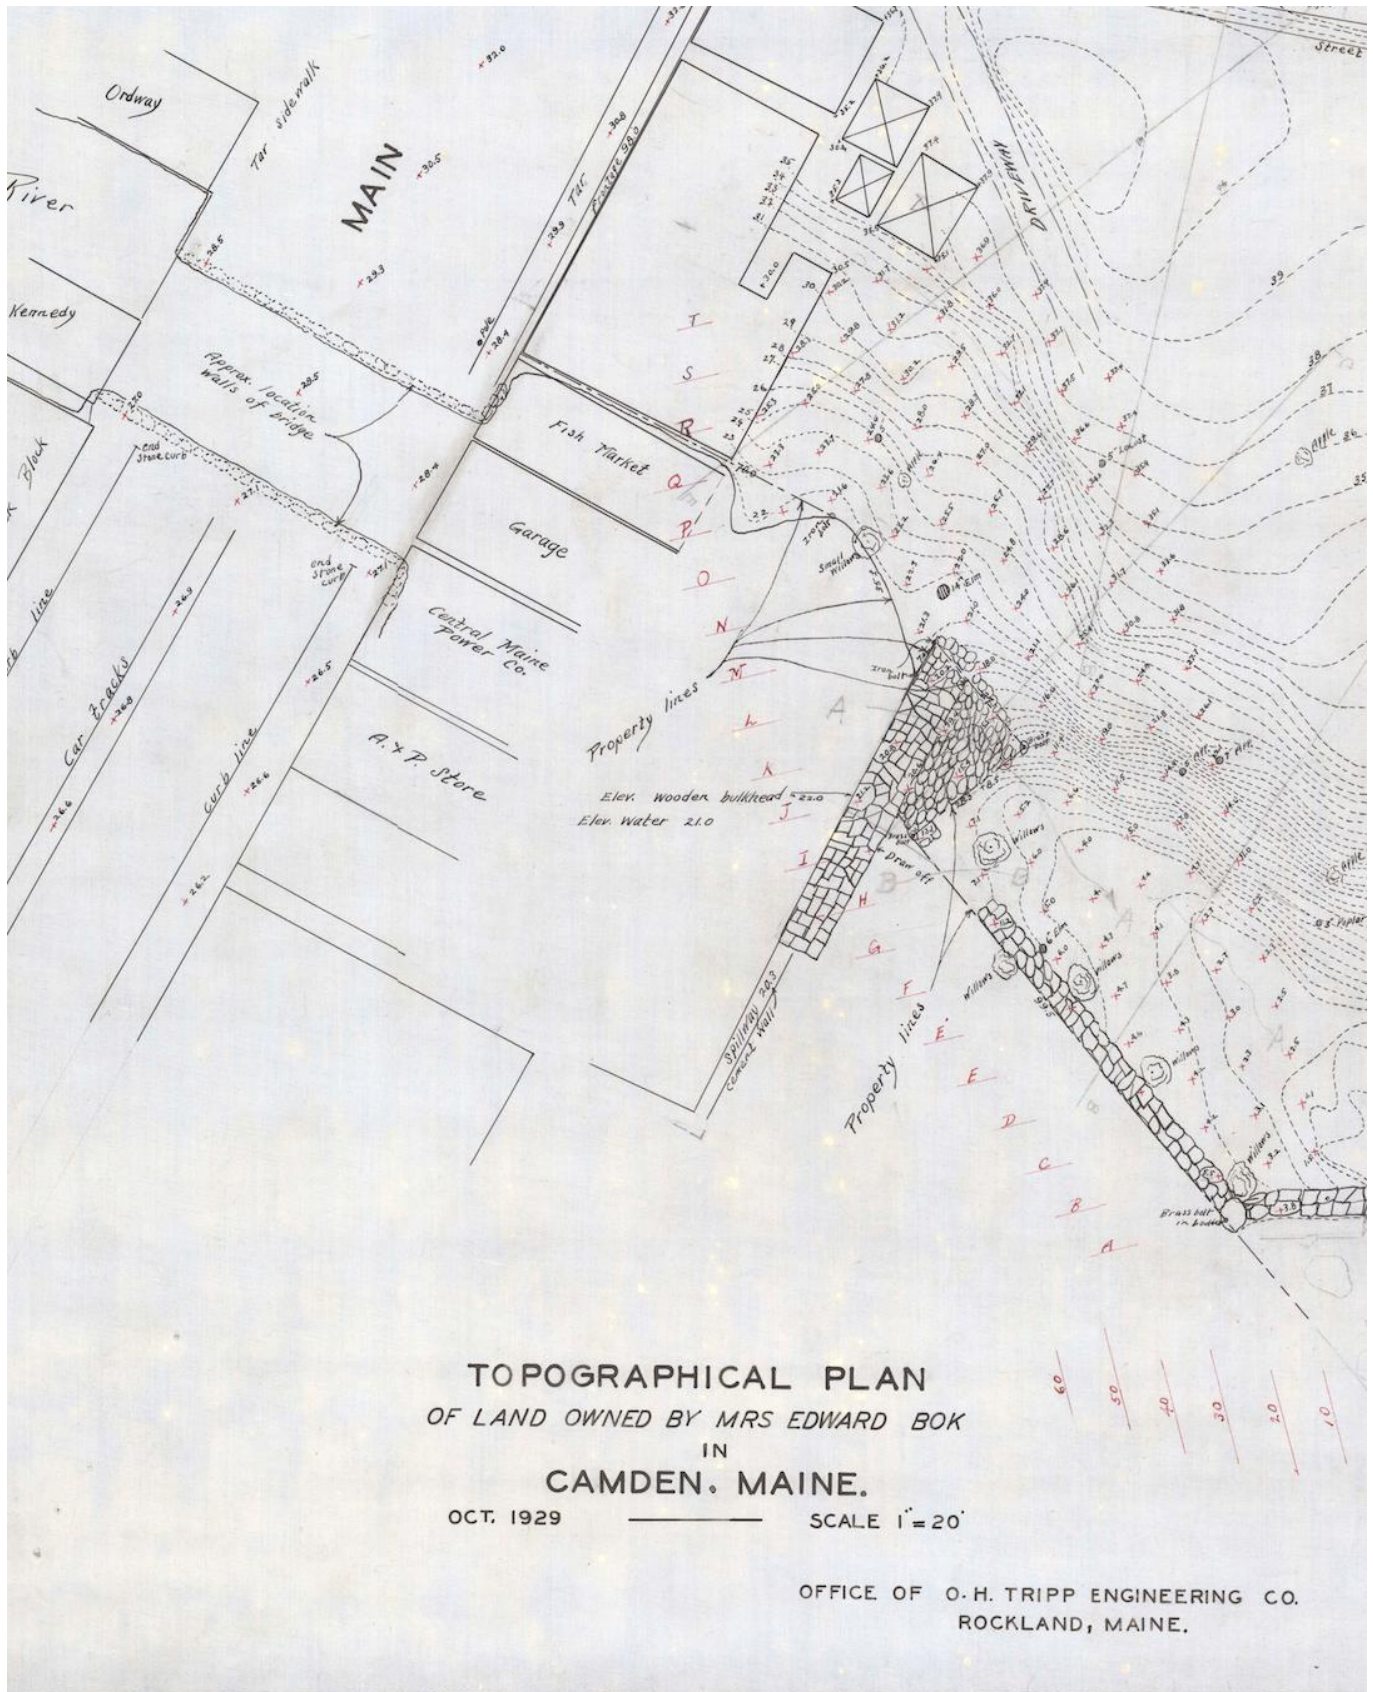
Addendum B: O.H. Tripp Engineering Co.'s Plans of the Existing Stores and Millpond Elevation, Oct 1929 (Pre-Olmsted Redesign)

Please note the water elevation of the millpond in 1929 set to 21 feet above sea level with the spillway observed and the Main Street shops drawn in the plans that continue to exist today as littoral proprietors.

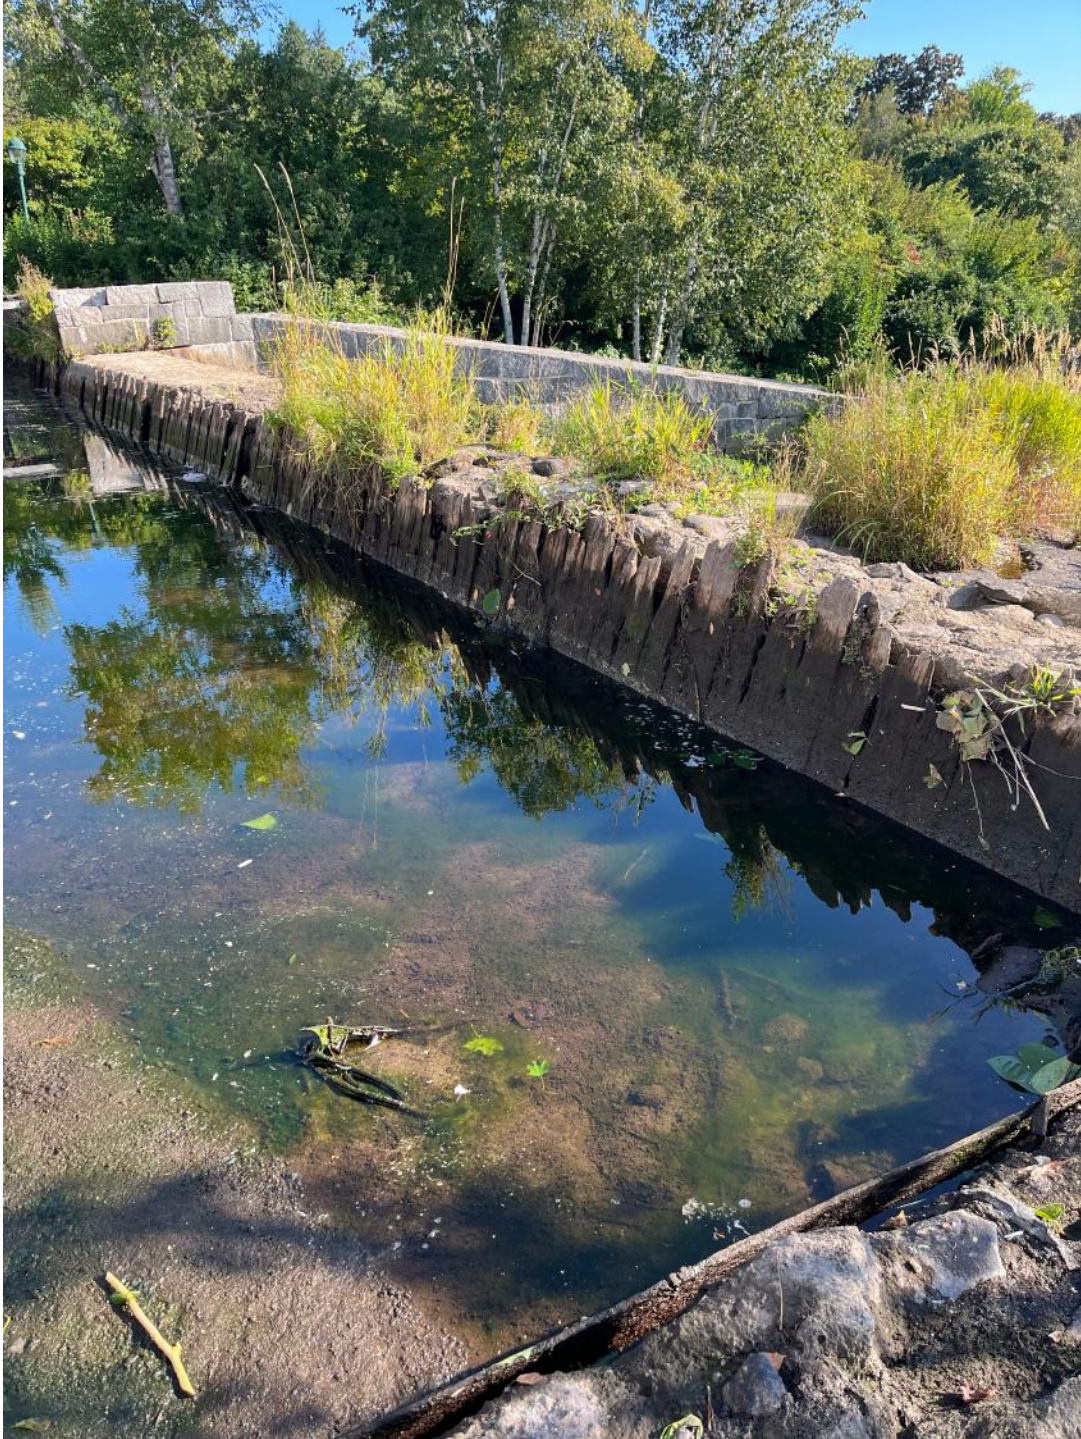
Algal blooms in the millpond and grasses taking root in the dam spillway and bedrock. With the sluice gate open all summer, odors wafted up to our businesses and mosquitoes bred in the stagnant, drawn down pool. This is not the view we purchased with our buildings and businesses and not the promise we make to our customers. Photo taken: August 2022.

Environmental Changes. The millpond must remain full and flowing in order to prevent unwanted mosquito breeding, cattail and other invasive vegetation, plant decay and foul odors. When working as intended with a closed sluice gate, none of these issues occur. This past summer the millpond disappeared with the sluice gate open. This changed the entire ecosystem allowing cattails and tall grasses to grow and eventually decay. Algal blooms developed creating an ideal breeding habitat for mosquitoes, further exacerbating the situation. The bad odors and mosquitoes drifted up to our decks and through our shop windows, creating complaints from customers. The town also allowed trees to grow up in the waterfall bedrock, obstructing the once clear view of the harbor. (Please see the attached photos showing the original, unobstructed views from Main Street businesses to the harbor.)

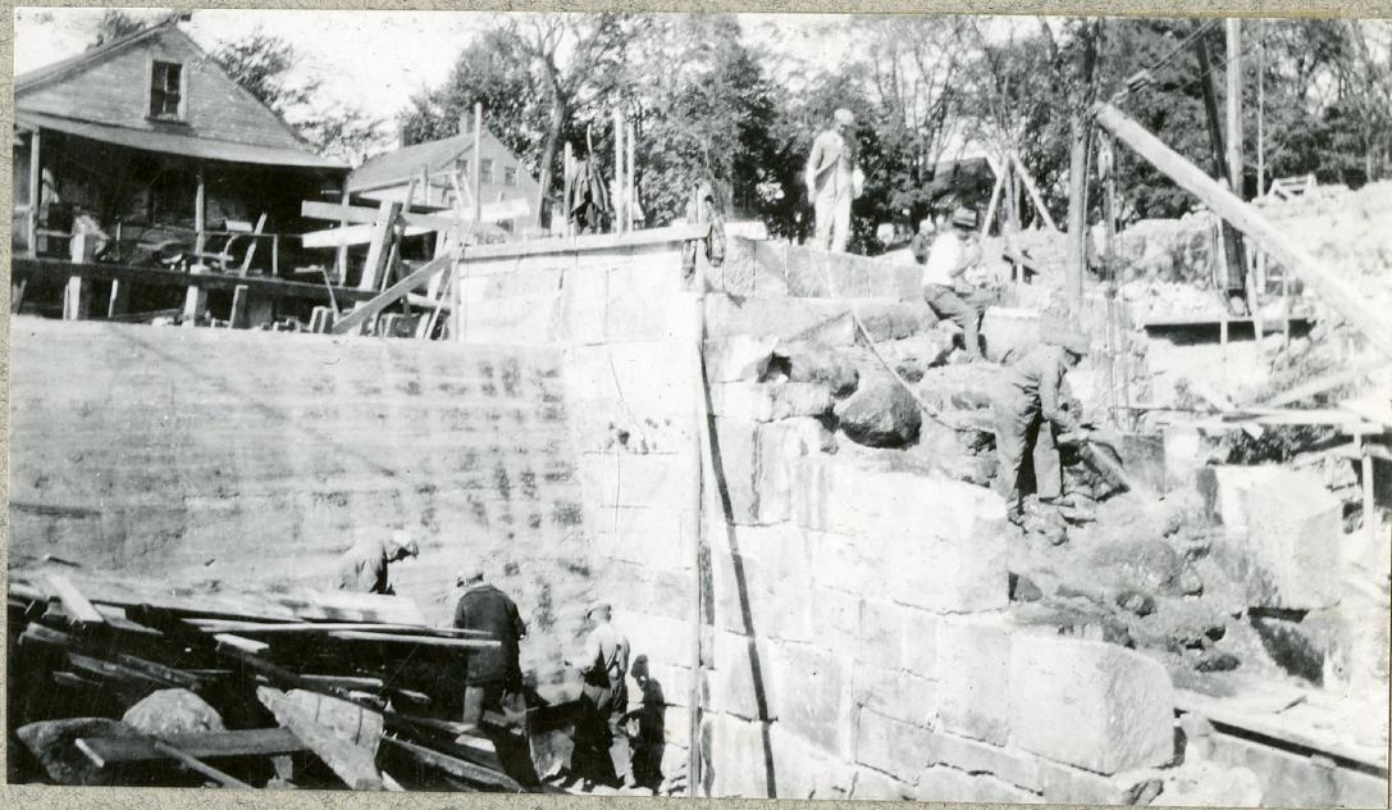
Addendum G: Construction of Montgomery Dam with Cut Stone

Photo from 1930 showing cut stone construction of the dam and the 50-foot chute where water flows under the sluice gate when opened. courtesy of the National Park Service, Olmsted Archives, Frederick Law Olmsted National Historic Site, Brookline, MA

DAM IS MASS GRAVITY CUT STONE DAM FOUNDED ON
BEDROCK AT THE TOP OF THE FALLS ABOVE CAMDEN
HARBOR, DAM FORMS A RIGHT ANGLE TO DISCHARGE
IN TWO DIRECTIONS. HEIGHT OF DAM VARIES
BETWEEN 3'-12'. NO STRUCTURES BELOW
THE DAM AND FALLS, LOW HAZARD,
RUN OF RIVER
