Reference: Bingham Wind Project: Data Request – Salmon Streams

The following information, with the enclosed materials, provides the supplemental data requested for the U.S. Army Corps of Engineers (Corps) Application (application) for the Bingham Wind Project (project). This information supports on-going Section 7 consultation with the U.S. Fish and Wildlife Service (USFWS) on project area streams that occur within designated Critical Habitat for Gulf of Maine Distinct Population Segment (GOM DPS) of Atlantic salmon (*Salmo salar*). This supplemental information provides detail on materials previously submitted in the application.

- Appendix 1: Figures Depicting Streams in Project Area located within Critical Habitat
- Appendix 2: USFWS Streams Package, updated with proposed cover type for Streams with Associated Wetlands (*Updated from original submission in Application, Appendix C-3-5*)
- Appendix 3: Schematic depicting construction methods for temporary access across waterbodies, as described in MDIFW's *Recommended Performance Standards for Riparian Buffers in Overhead Utility ROW Projects* (2012).

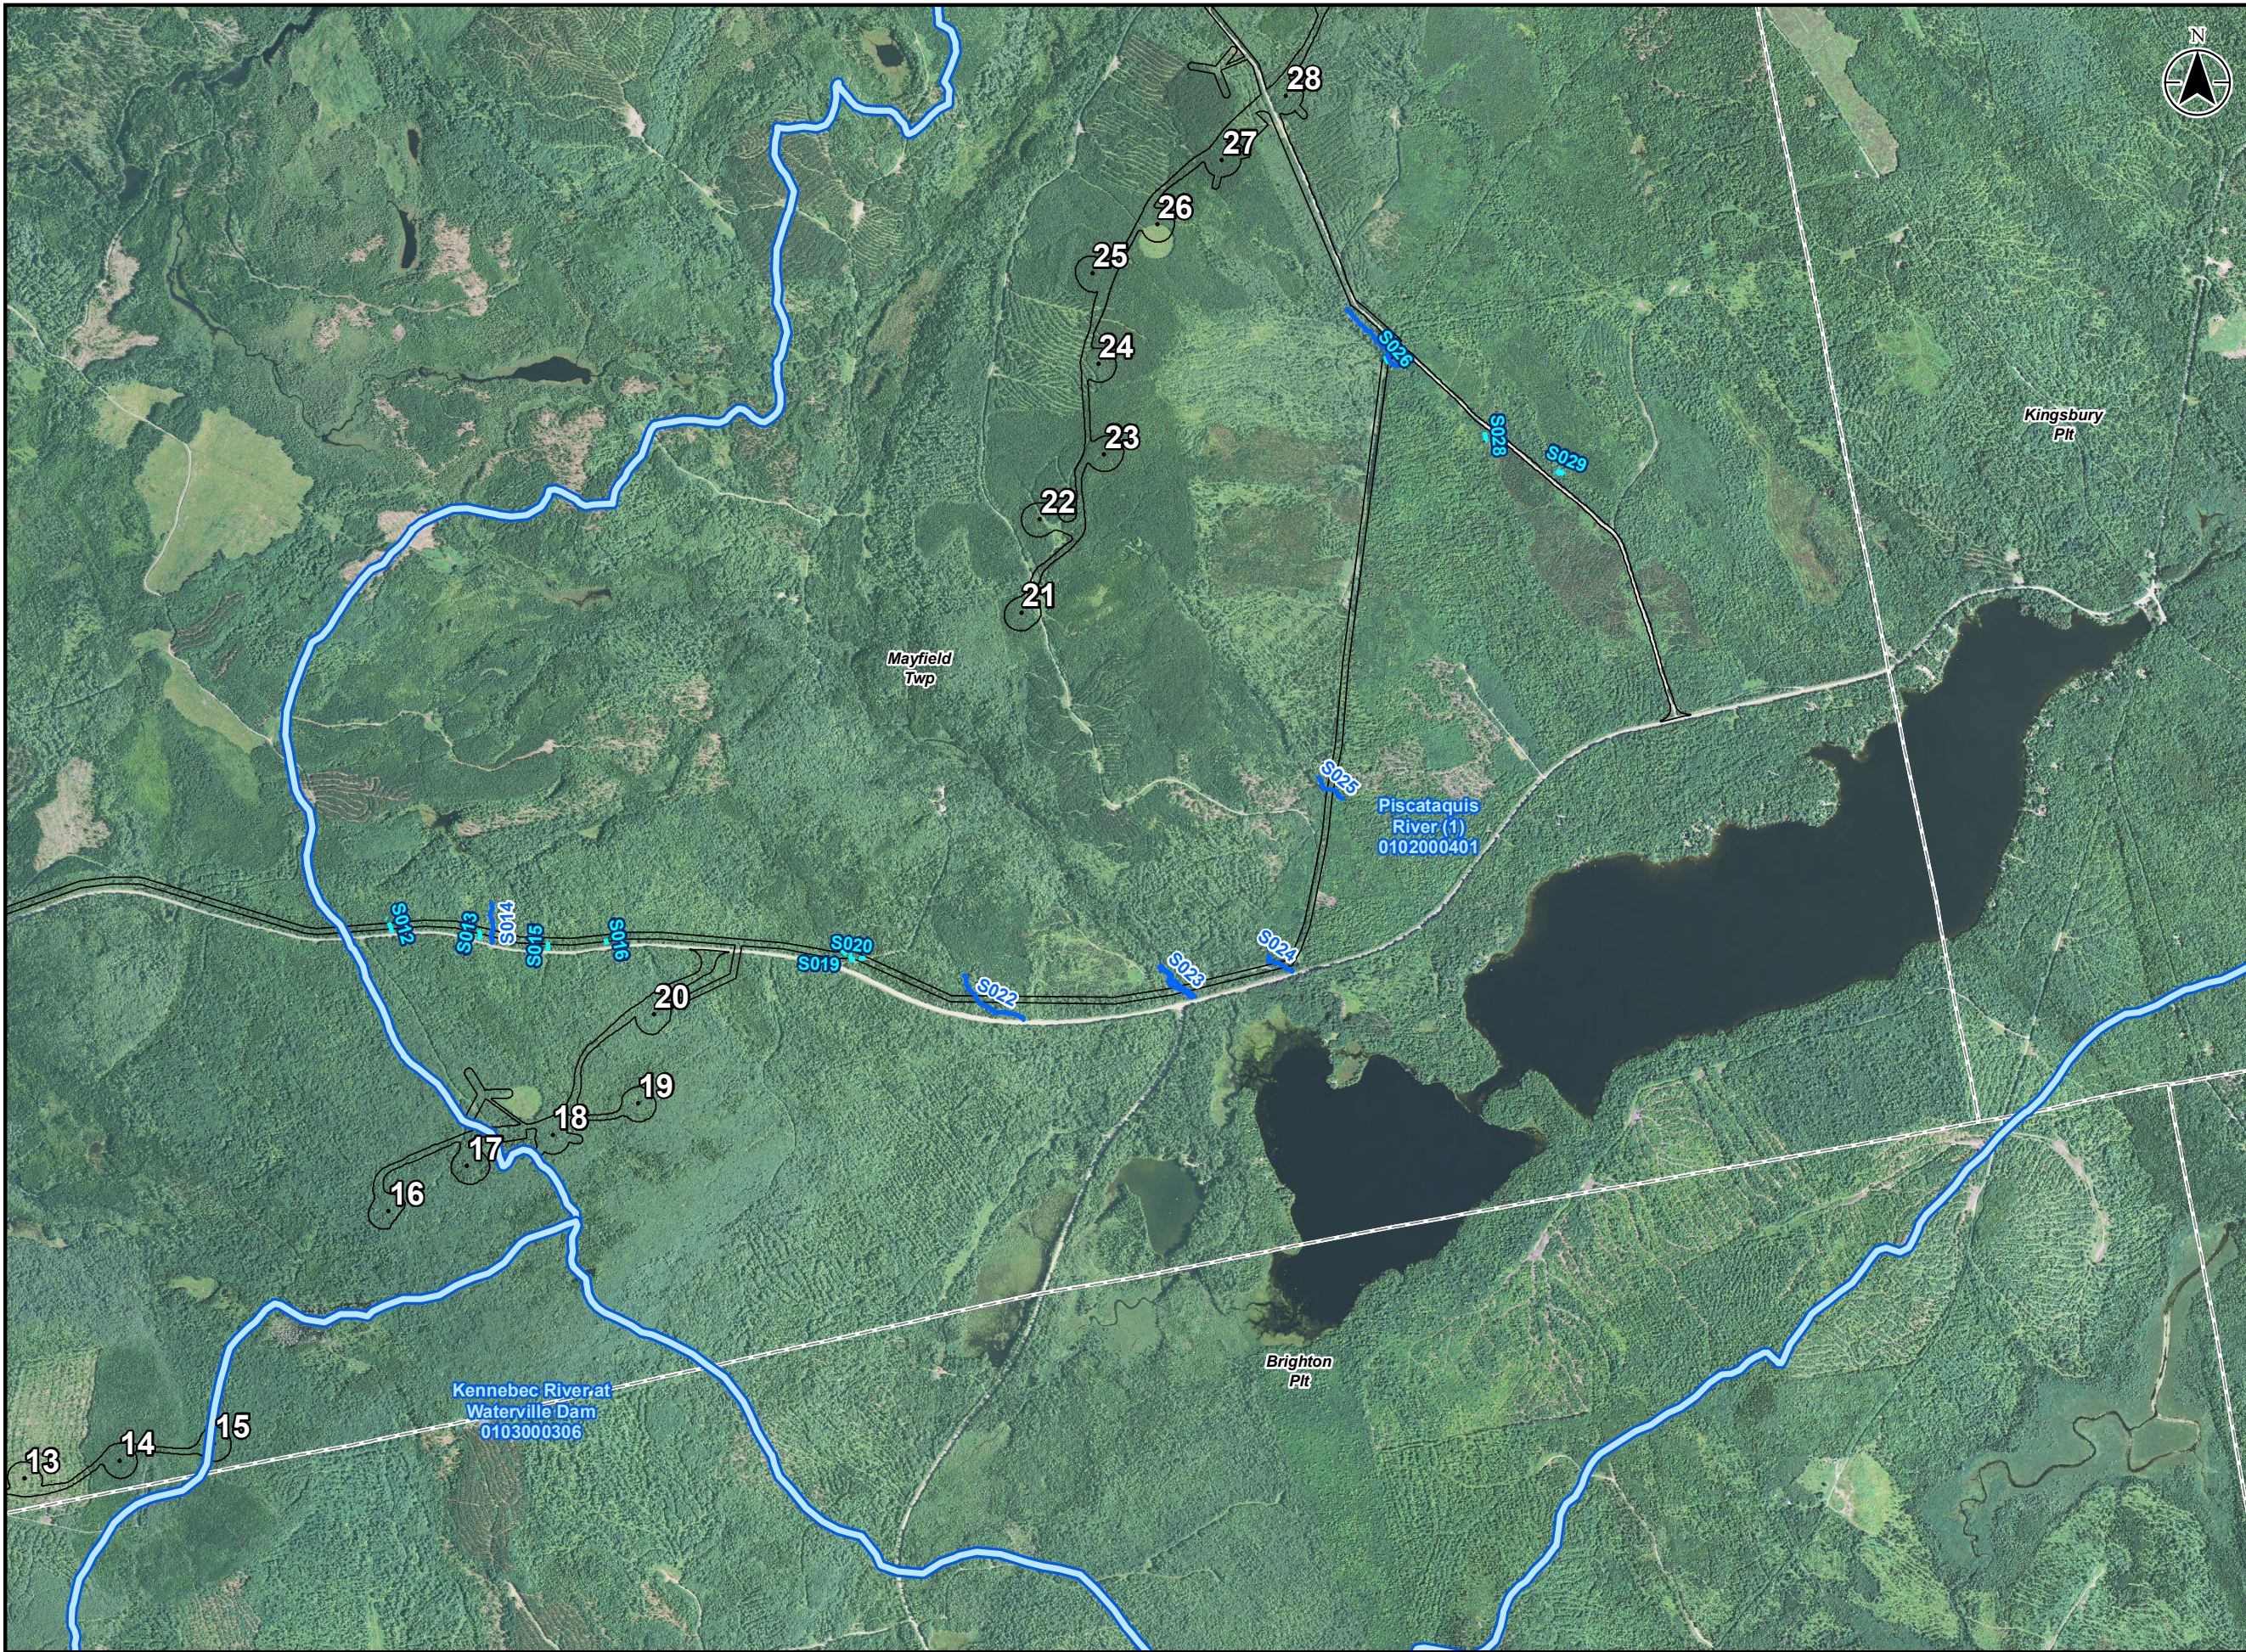
Figure No.: 1
 Title:

Bingham Salmon Stream Habitat

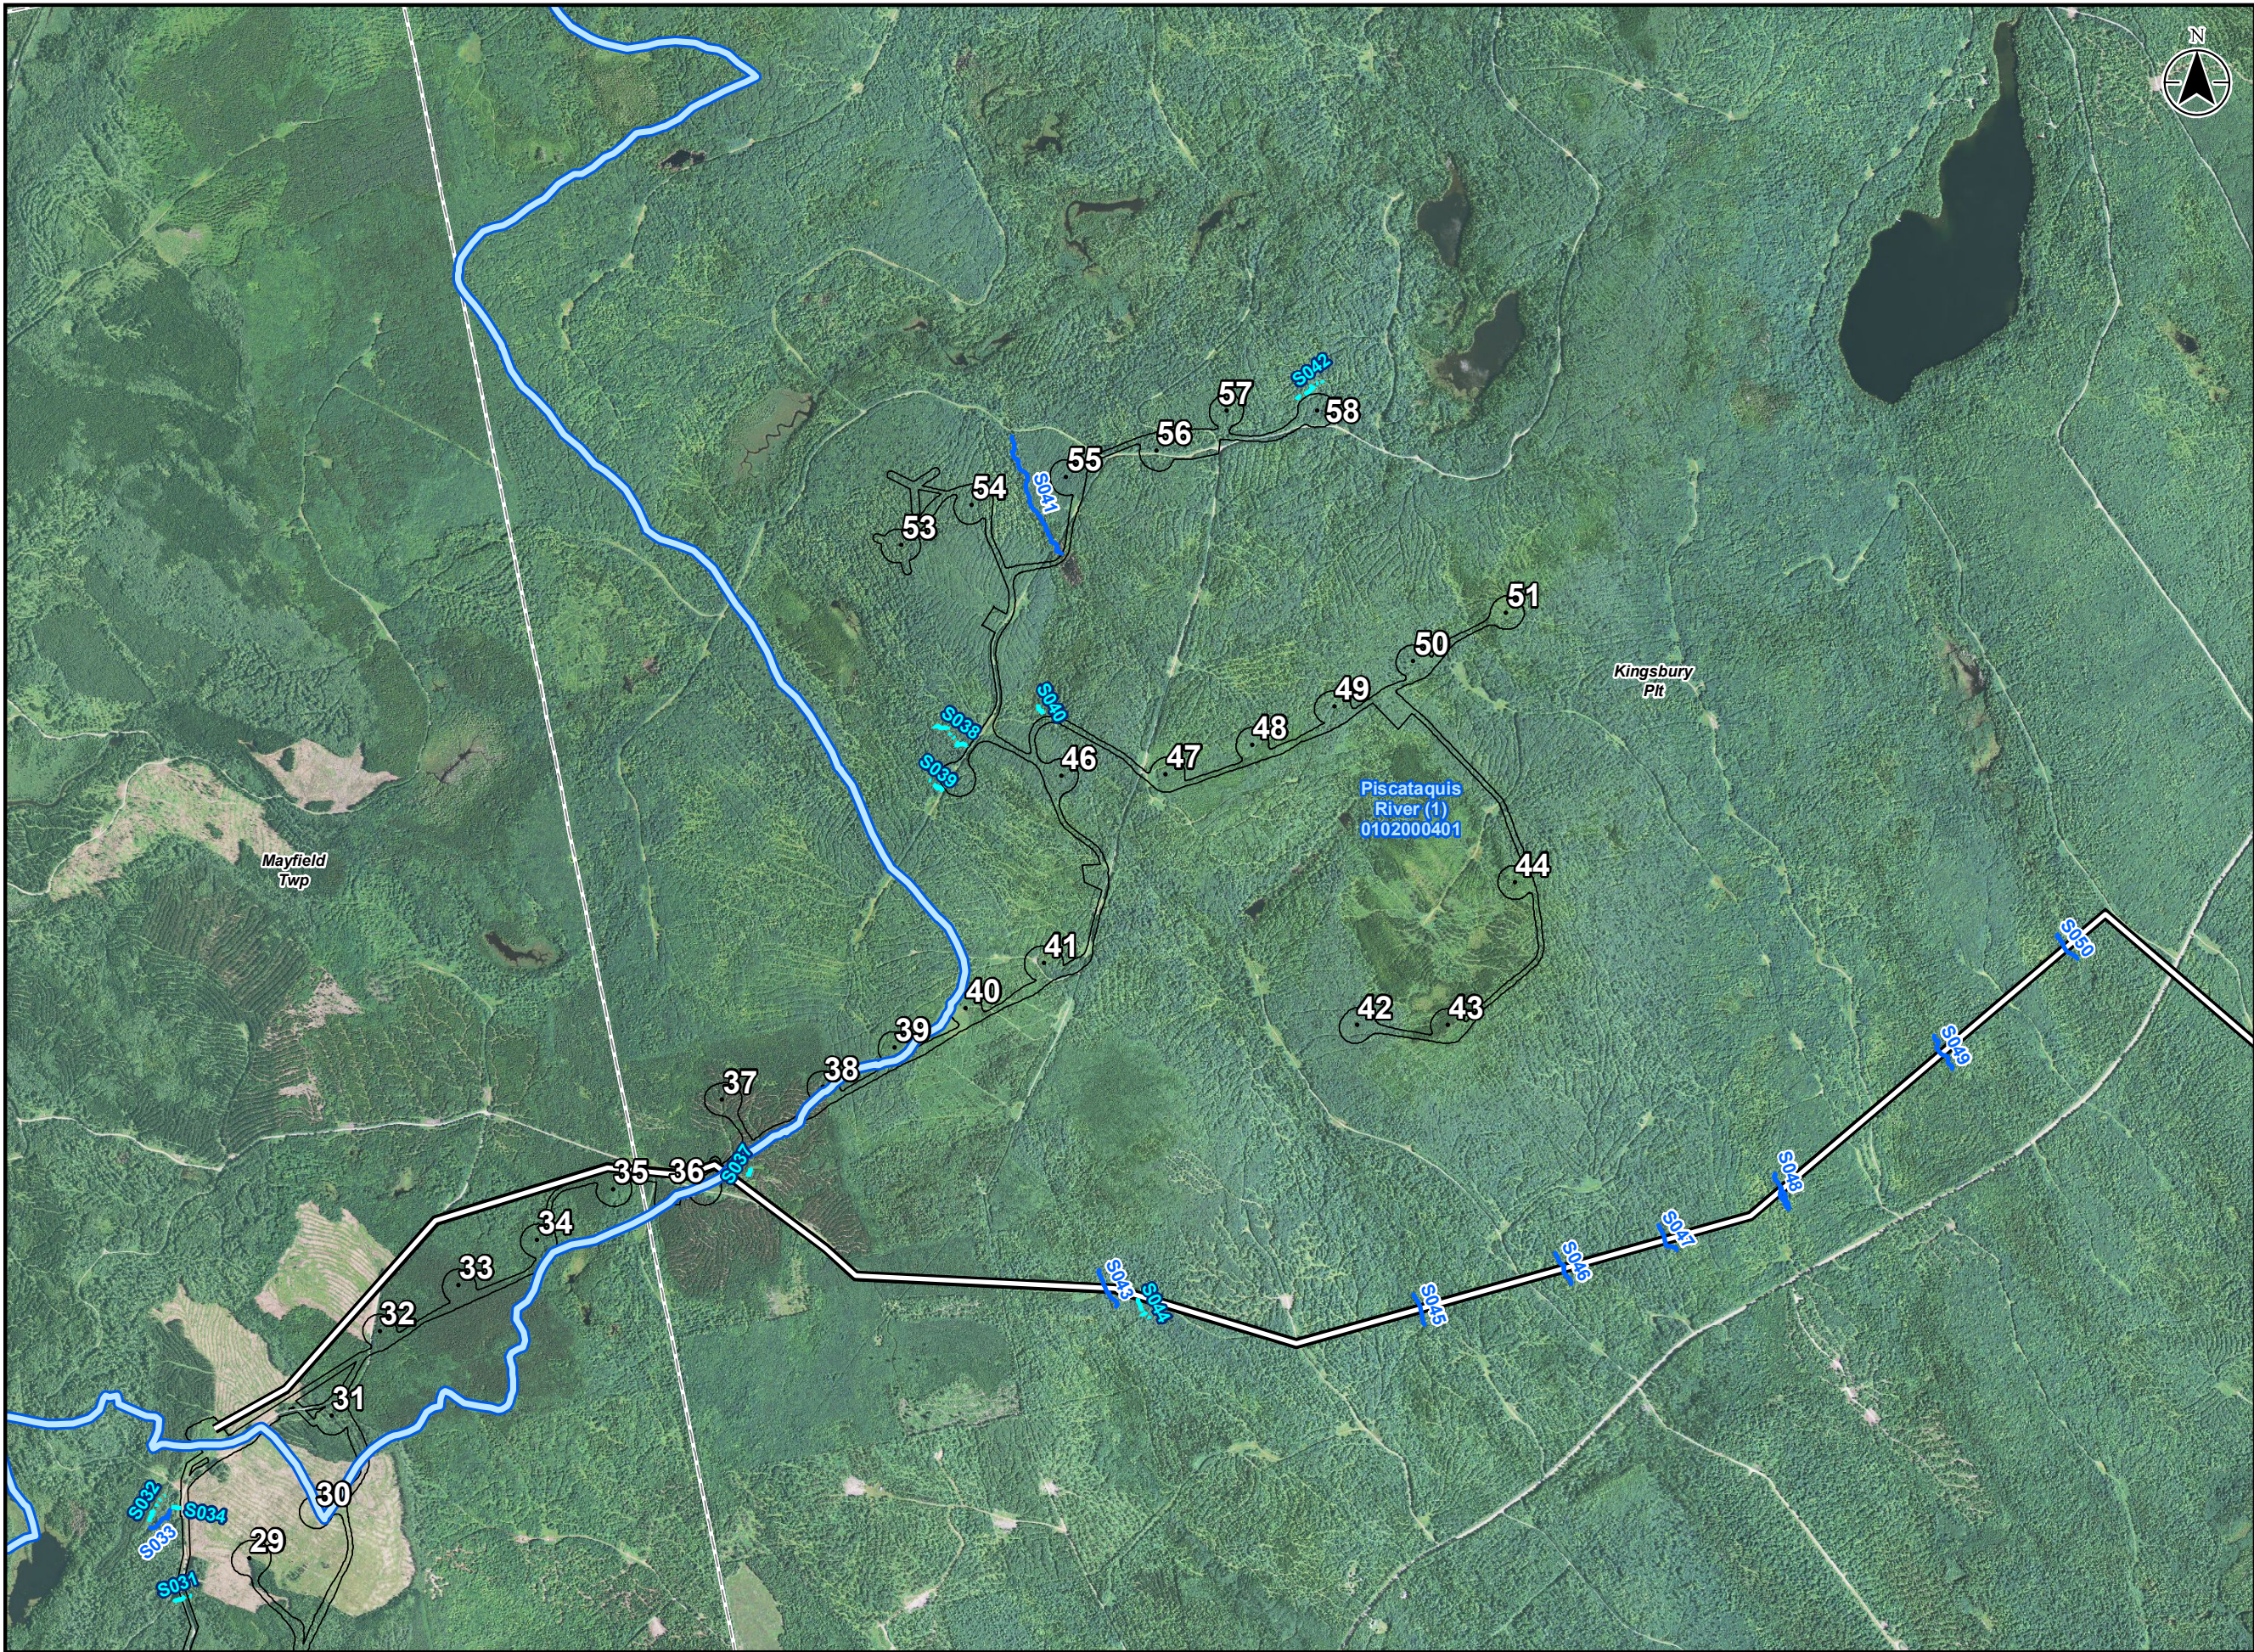
2

**Bingham Salmon
 Stream Habitat**

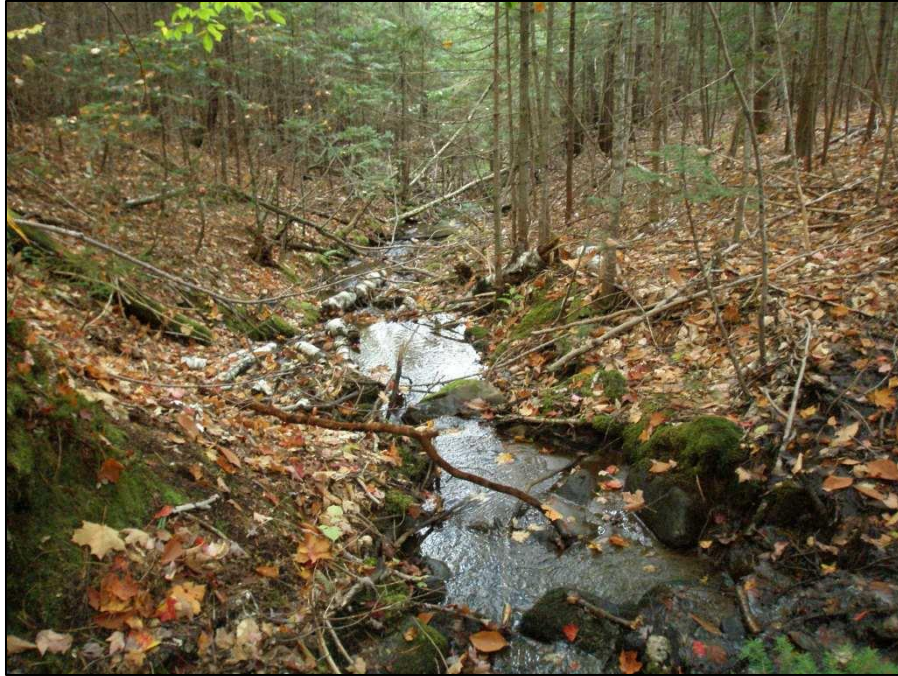
The stream and associated wetland will be crossed by the aboveground portion of the electrical collector. Two poles (structures) will be located within 100 feet of this stream. During construction and maintenance, capable trees (i.e., those that could grow to within 15 feet of a conductor within 3-4 years) will be topped, but no other vegetation will be cut. If topping individual trees will not leave sufficient foliage to sustain the tree, the tree will be cut at ground level. With regard to the poles (structures) located within the 100-foot buffer, the maximum height of vegetation within the corridor is a function of conductor height. The proximity of the poles to this stream will provide a conductor height that will allow for the establishment of taller vegetation near the stream, which will provide maximum shading of the stream. Herbicide use will not be allowed within this buffer. Construction and maintenance access will occur via existing access from adjacent Route 16; therefore, there will be no temporary or permanent access road crossing of the stream or its associated wetland.

Photo 2: Perennial stream S022.
Stantec Consulting, October 3, 2012.

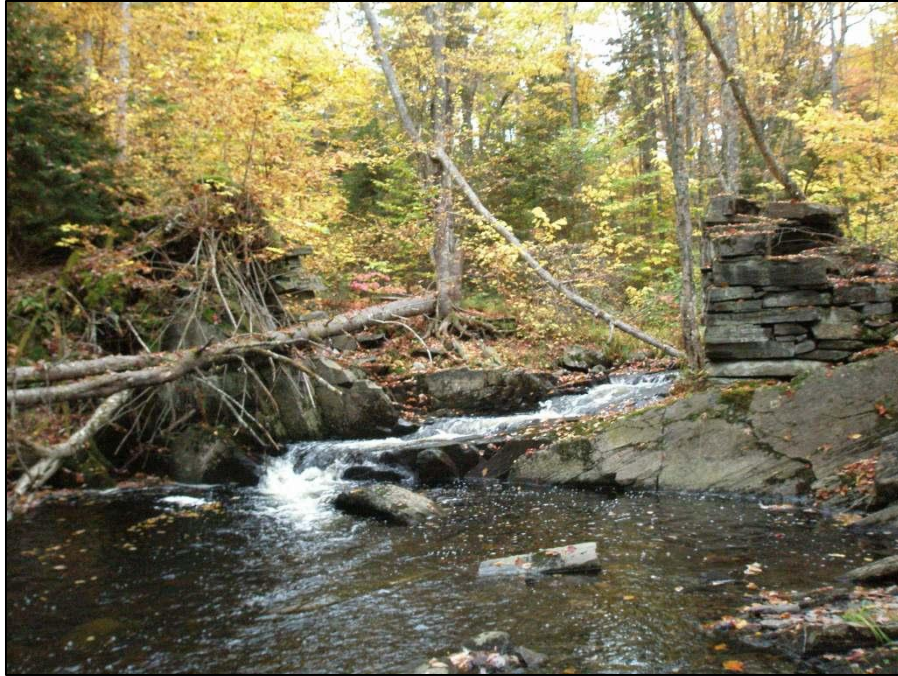
The stream will be crossed by the aboveground portion of the electrical collector. Two poles (structures) will be located within 100 feet of this stream. Northern spring salamanders were documented in this stream during surveys conducted in 2013. Because of the presence of this species, a 250-foot foot buffer will be maintained on each side of the stream. During construction and maintenance, capable trees (i.e., those that could grow to within 15 feet of a conductor within 3-4 years) will be topped, but no other vegetation will be cut. If topping individual trees will not leave sufficient foliage to sustain the tree, the tree will be cut at ground level. Herbicide use will not be allowed within this buffer. Construction and maintenance access will occur via existing access from adjacent Route 16; therefore, there will be no temporary or permanent access road crossing of the stream or its associated wetland.

Photo 3: Perennial stream S023.
Stantec Consulting, October 4, 2012.

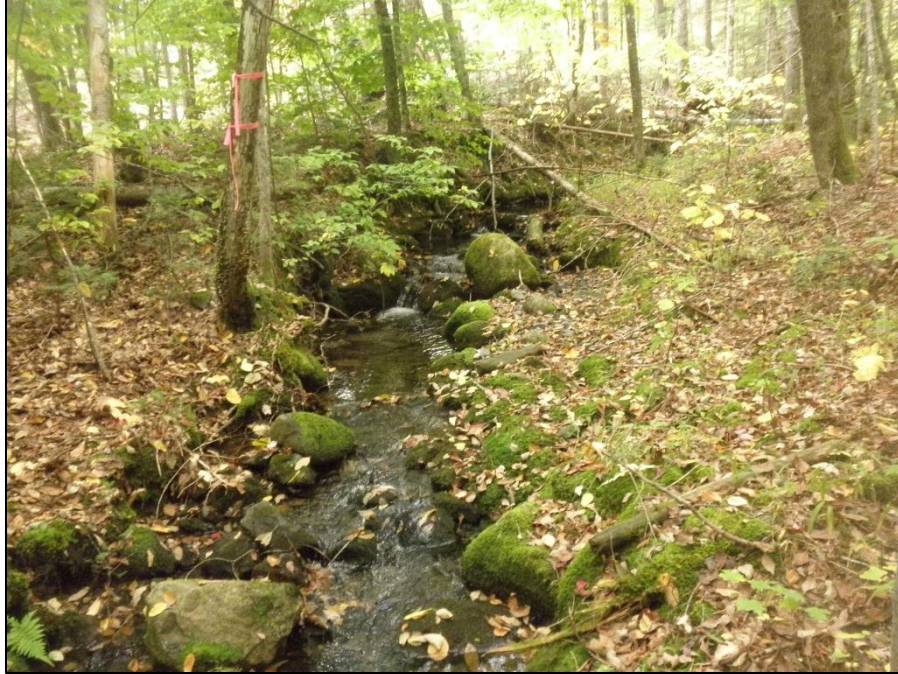
- Perennial stream occurring in a deciduous forest.
- Channel substrate consists of boulders, cobble, gravel, and woody debris.
- Aquatic mosses and brook trout observed.
- Physical characteristics (**Photo 5**):
 - Bankfull width is 5-8 feet (Average 6.5 feet);
 - Water depth in October of 2012 was 3-12 inches;
 - Low to moderate gradient with riffles and pools.

The stream and associated wetland will be crossed by the aboveground portion of the electrical collector. One pole (structure) will be located within 100 feet of this stream. Northern spring salamanders were documented in this stream during surveys conducted in 2013. Because of the presence of this species, a 250-foot buffer will be maintained on each side of the stream. During construction and maintenance, capable trees (i.e., those that could grow to within 15 feet of a conductor within 3-4 years) will be topped, but no other vegetation will be cut. If topping individual trees will not leave sufficient foliage to sustain the tree, the tree will be cut at ground level. With regard to the pole (structure) located within the 250-foot buffer, the maximum height of vegetation within the corridor is a function of conductor height. The proximity of the pole to this stream will provide a conductor height that will allow for the establishment of taller vegetation near the stream, which will provide maximum shading of the stream. Herbicide use will not be allowed within this buffer. Construction and maintenance access will occur via existing access roads; therefore, there will be no temporary or permanent access road crossing of the stream or its associated wetland.

Photo 5: Perennial stream S025.
Stantec Consulting, October 3, 2012.

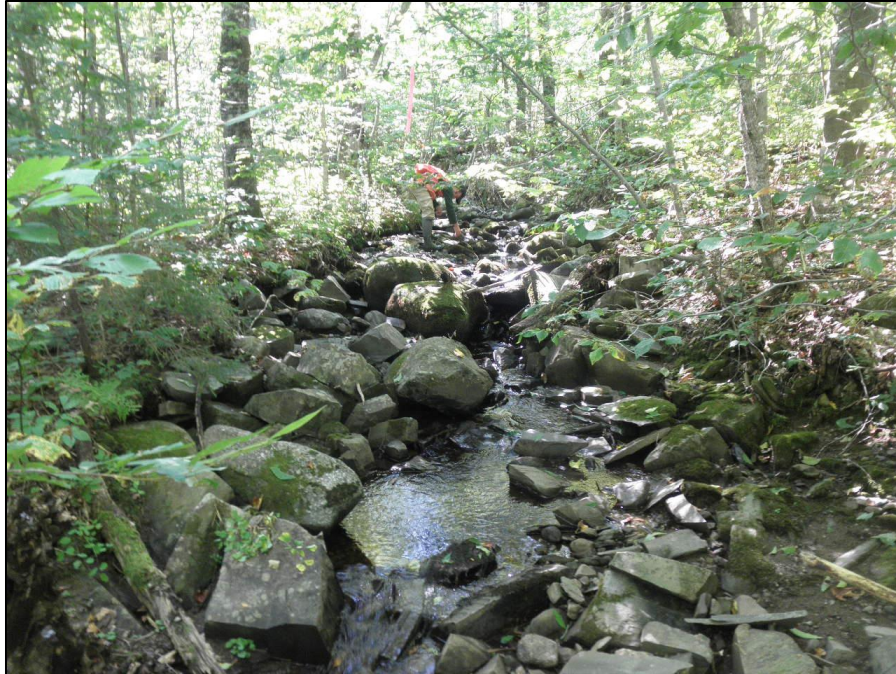
Stream S041 is a perennial stream that flows north out of a beaver impoundment. The stream occurs within a deciduous forested upland and forested wetlands. Within its headwater wetland, this stream is relatively low gradient, but it becomes moderate to high gradient after it exits this wetland. This area has been disturbed by beaver activity and timber harvesting. The stream was previously crossed by an existing gravel road, but the road washed out when the upstream beaver dam failed.

Photo 9: Perennial stream S041.
Stantec Consulting, September 13, 2011.

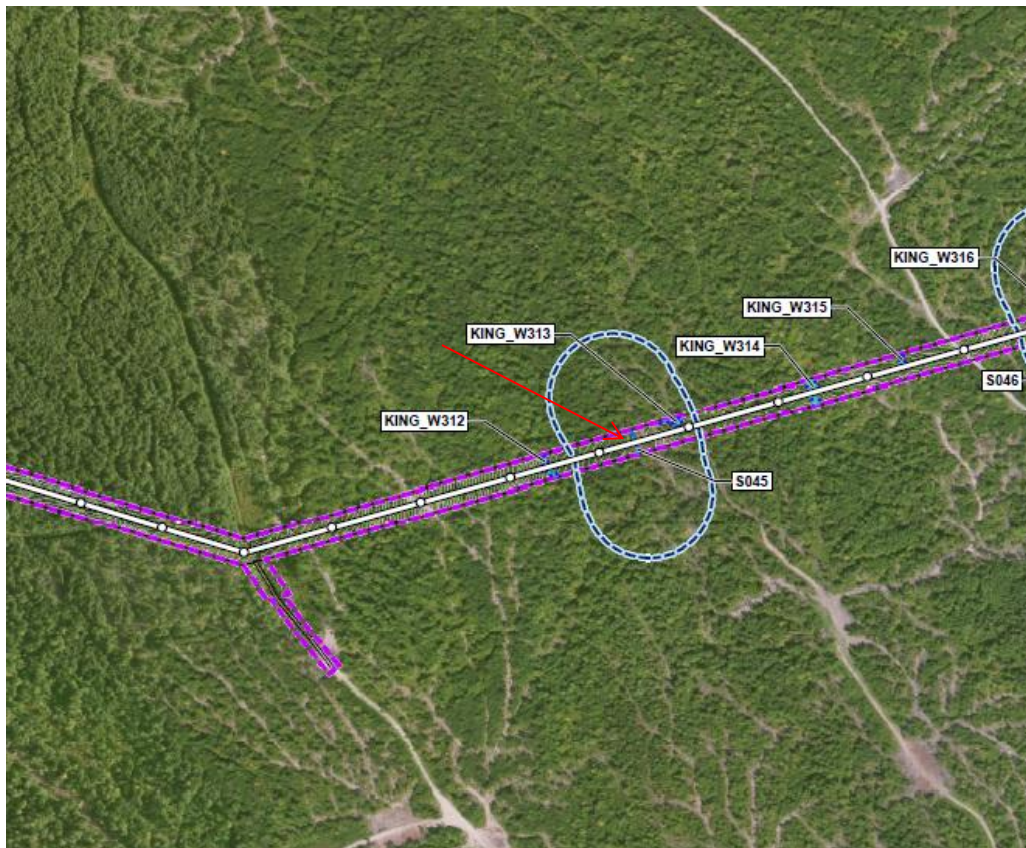
The stream will be crossed by the electrical generator lead corridor. Based upon discussions with Maine Department of Inland Fisheries and Wildlife biologist, this stream will not be crossed during construction. Construction access will occur from the east and west and there will be no need to cross the stream. Northern spring salamanders were documented in this stream during surveys conducted in 2013. Because of the presence of this species, a 250-foot buffer will be maintained on each side of the stream. During construction and maintenance, capable trees (i.e., those that could grow to within 15 feet of a conductor within 3-4 years) will be topped, but no other vegetation will be cut. If topping individual trees will not leave sufficient foliage to sustain the tree, the tree will be cut at ground level. Herbicide use will not be allowed within this buffer.

Proposed generator lead crossing of stream S045.
From Figure 20, Delineated Natural Resource Map by Stantec Consulting.

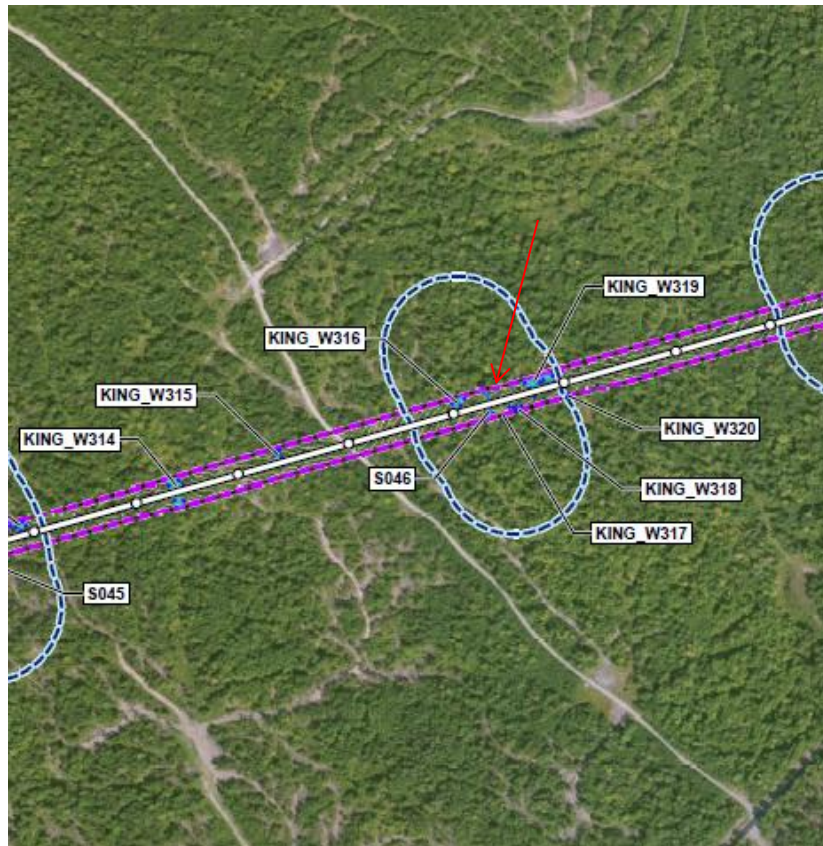
The stream will be crossed by the electrical generator lead corridor. During construction, a temporary timber mat bridge will be used to allow movement of construction equipment across the stream. There will be no direct impact to the stream channel. Northern spring salamanders were documented in this stream during surveys conducted in 2013. Because of the presence of this species, a 250-foot buffer will be maintained on each side of the stream. During construction and maintenance, capable trees (i.e., those that could grow to within 15 feet of a conductor within 3-4 years) will be topped, but no other vegetation will be cut. If topping individual trees will not leave sufficient foliage to sustain the tree, the tree will be cut at ground level. Herbicide use will not be allowed within this buffer.

Proposed generator lead crossing of stream S046.
From Figure 20, Delineated Natural Resource Map by Stantec Consulting.

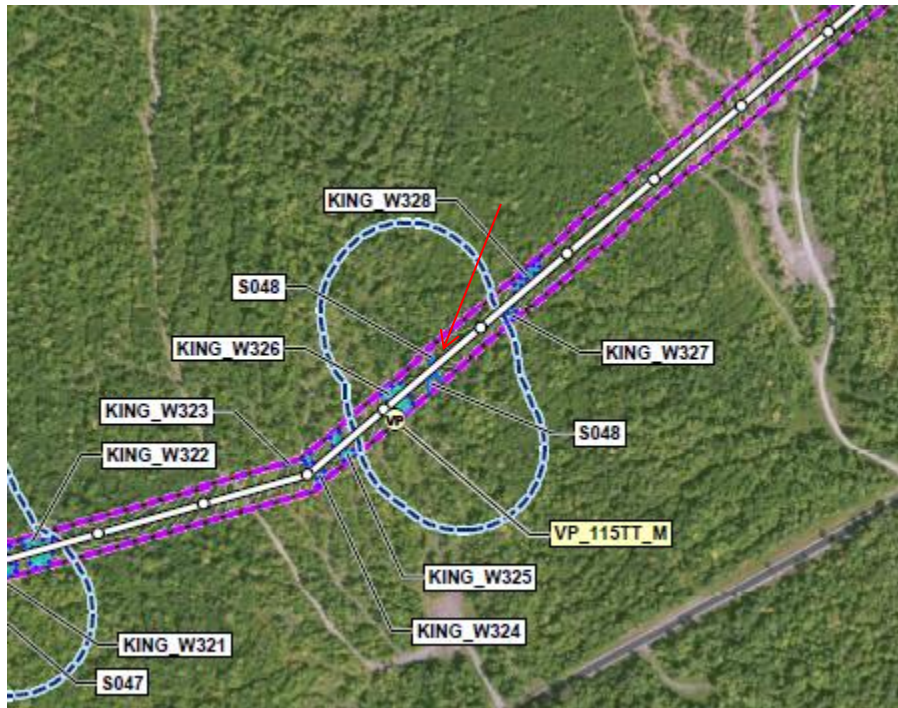
The stream will be crossed by the electrical generator lead corridor. During construction, a temporary timber mat bridge will be used to allow movement of construction equipment across the stream. There will be no direct impact to the stream channel. During construction and maintenance, capable trees (i.e., those that could grow to within 15 feet of a conductor within 3-4 years) will be topped, but no other vegetation will be cut. If topping individual trees will not leave sufficient foliage to sustain the tree, the tree will be cut at ground level. Herbicide use will not be allowed within this buffer.

Proposed generator lead crossing of stream S048.
From Figure 21 Delineated Natural Resource Map by Stantec Consulting.

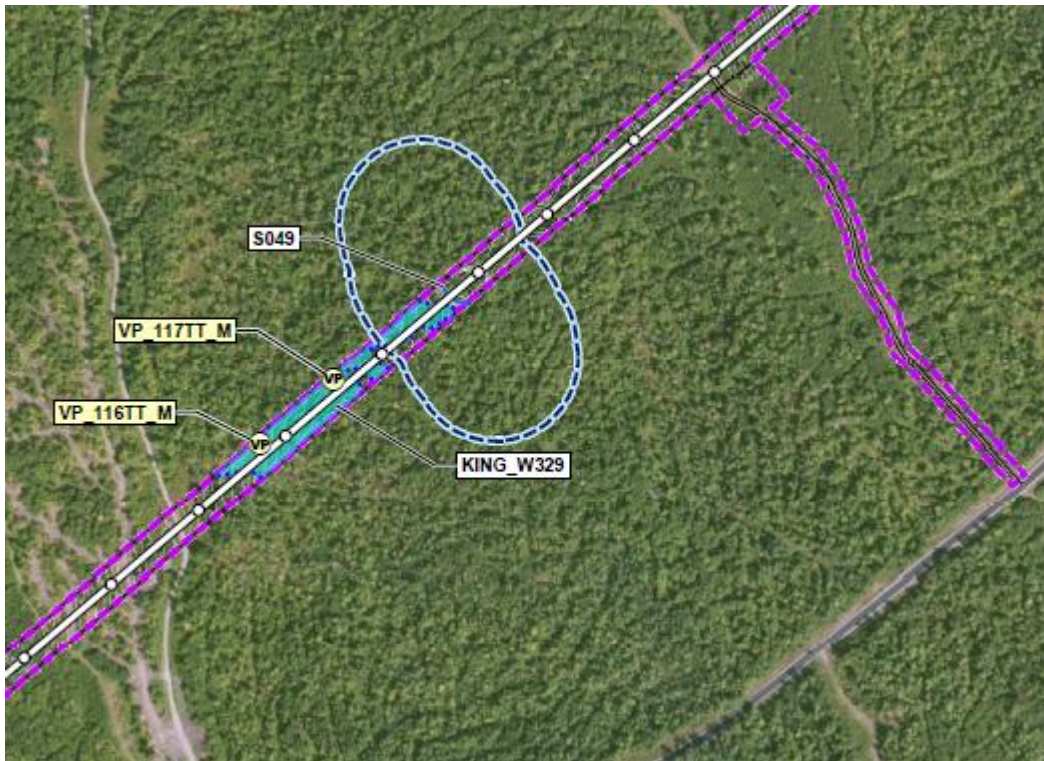
The stream will be crossed by the electrical generator lead corridor. During construction, a temporary timber mat bridge will be used to allow movement of construction equipment across the stream. There will be no direct impact to the stream channel. One pole (structure) will be located within 100 feet of this stream. Northern spring salamanders were documented in this stream during surveys conducted in 2013. Because of the presence of this species, a 250-foot buffer will be maintained on each side of the stream. During construction and maintenance, capable trees (i.e., those that could grow to within 15 feet of a conductor within 3-4 years) will be topped, but no other vegetation will be cut. If topping individual trees will not leave sufficient foliage to sustain the tree, the tree will be cut at ground level. With regard to the pole (structure) located within the 250-foot buffer, the maximum height of vegetation within the corridor is a function of conductor height. The proximity of the pole to this stream will provide a conductor height that will allow for the establishment of taller vegetation near the stream, which will provide maximum shading of the stream. Herbicide use will not be allowed within this buffer.

Proposed generator lead crossing of stream S049.
From Figure 21 Delineated Natural Resource Map by Stantec Consulting.

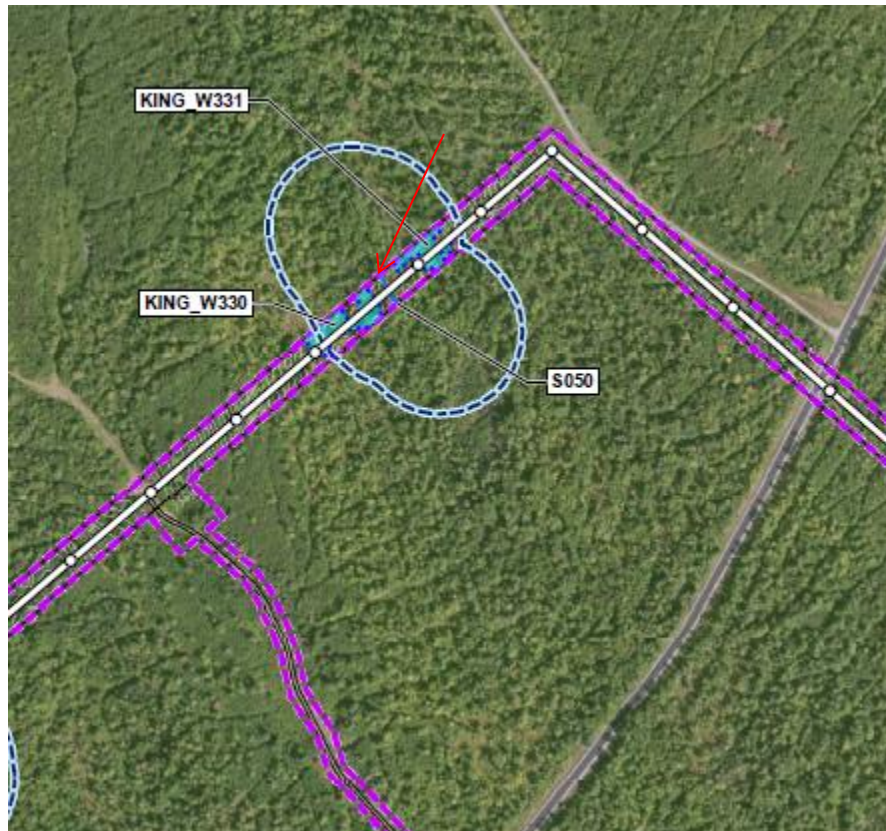
The stream will be crossed by the electrical generator lead corridor. Based upon discussions with Maine Department of Inland Fisheries and Wildlife biologist, this stream will not be crossed during construction. Construction access will occur from the east and west and there will be no need to cross the stream. During construction and maintenance, capable trees (i.e., those that could grow to within 15 feet of a conductor within 3-4 years) will be topped, but no other vegetation will be cut. If topping individual trees will not leave sufficient foliage to sustain the tree, the tree will be cut at ground level. Herbicide use will not be allowed within this buffer.

Proposed generator lead crossing of stream S050.
From Figure 21 Delineated Natural Resource Map by Stantec Consulting.

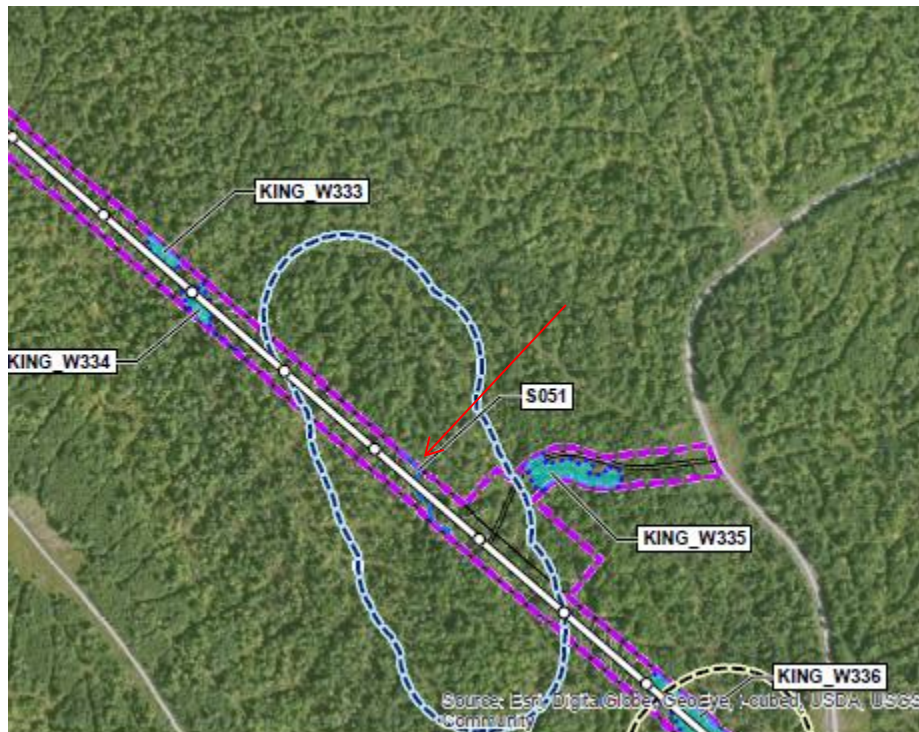
The stream will be crossed by the electrical generator lead corridor. During construction, a temporary timber mat bridge will be used to allow movement of construction equipment across the stream. There will be no direct impact to the stream channel. Two poles (structures) will be located within 100 feet of this stream. During construction and maintenance, capable trees (i.e., those that could grow to within 15 feet of a conductor within 3-4 years) will be topped, but no other vegetation will be cut. If topping individual trees will not leave sufficient foliage to sustain the tree, the tree will be cut at ground level. With regard to the poles (structures) located within the 100-foot buffer, the maximum height of vegetation within the corridor is a function of conductor height. The proximity of the poles to this stream will provide a conductor height that will allow for the establishment of taller vegetation near the stream, which will provide maximum shading of the stream. Herbicide use will not be allowed within this buffer.

Proposed generator lead crossing of stream S051.
From Figure 22 Delineated Natural Resource Map by Stantec Consulting.

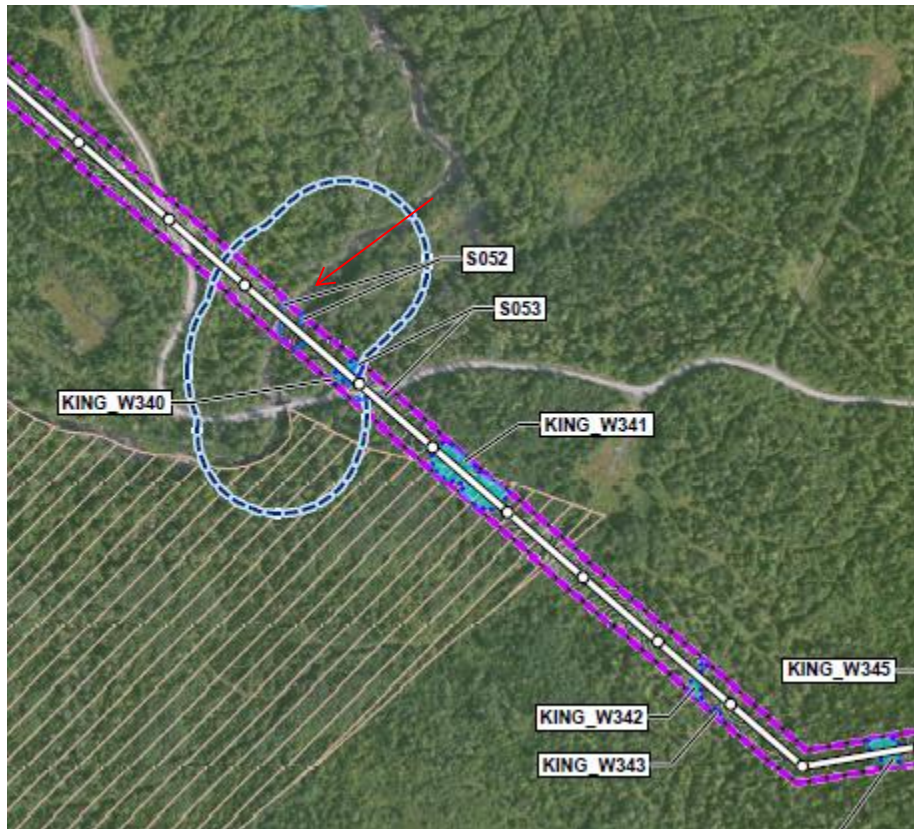
Construction activities will utilize the existing road to transport construction equipment. During construction and maintenance, capable trees (i.e., those that could grow to within 15 feet of a conductor within 3-4 years) will be topped, but no other vegetation will be cut. If topping individual trees will not leave sufficient foliage to sustain the tree, the tree will be cut at ground level. Herbicide use will not be allowed within this buffer.

Proposed generator lead crossing of stream S052.
From Figure 23 Delineated Natural Resource Map by Stantec Consulting.

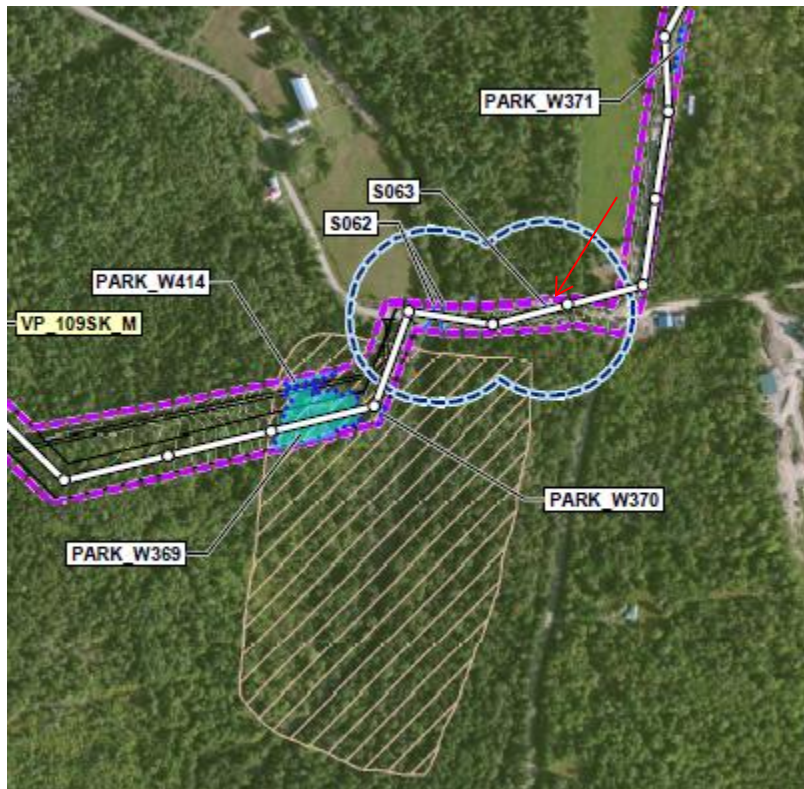
Proposed generator lead crossing of stream S063.
From Figure 26 Delineated Natural Resource Map by Stantec Consulting.

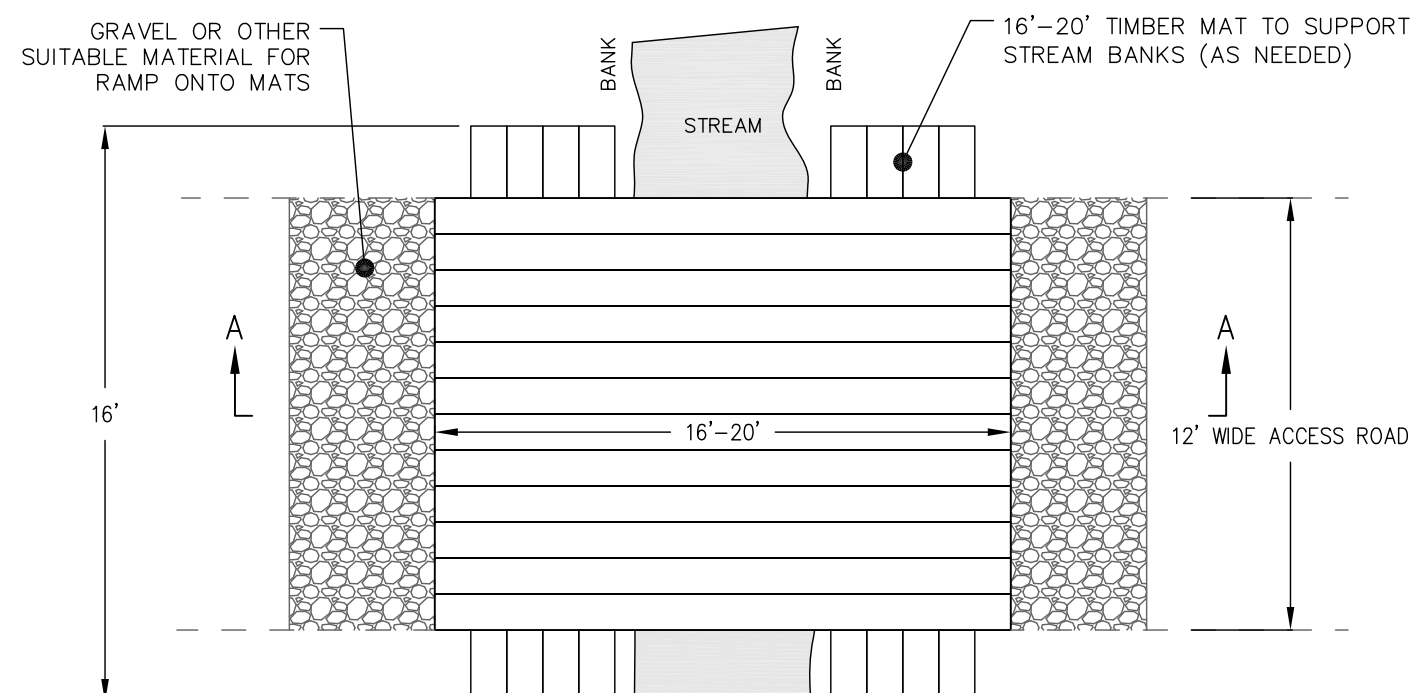
Appendix 3: Schematic depicting construction methods for temporary access across waterbodies, as described in MDIFW's *Recommended Performance Standards for Riparian Buffers in Overhead Utility ROW Projects* (2012).

4. POSITION MATS TO CROSS STREAMS AT RIGHT ANGLES TO THE CHANNEL AT A LOCATION WITH FIRM BANKS AND LEVEL APPROACHES AS SITE CONDITIONS DICTATE.
5. MATS LAID PERPENDICULAR TO THE STREAM CAN BE SUBSTITUTED WITH PRE-FABRICATED BRIDGE STRUCTURES AS SPAN LENGTHS DICTATE OR AT THE PREFERENCE OF THE CONTRACTOR.

streams is mats or timber bridges, as described in MDIFW's *Recommended Performance Standards for Riparian Buffers in Overhead Utility ROW Projects* (2012). The temporary mat detail based upon these standards is provided in Appendix 3.

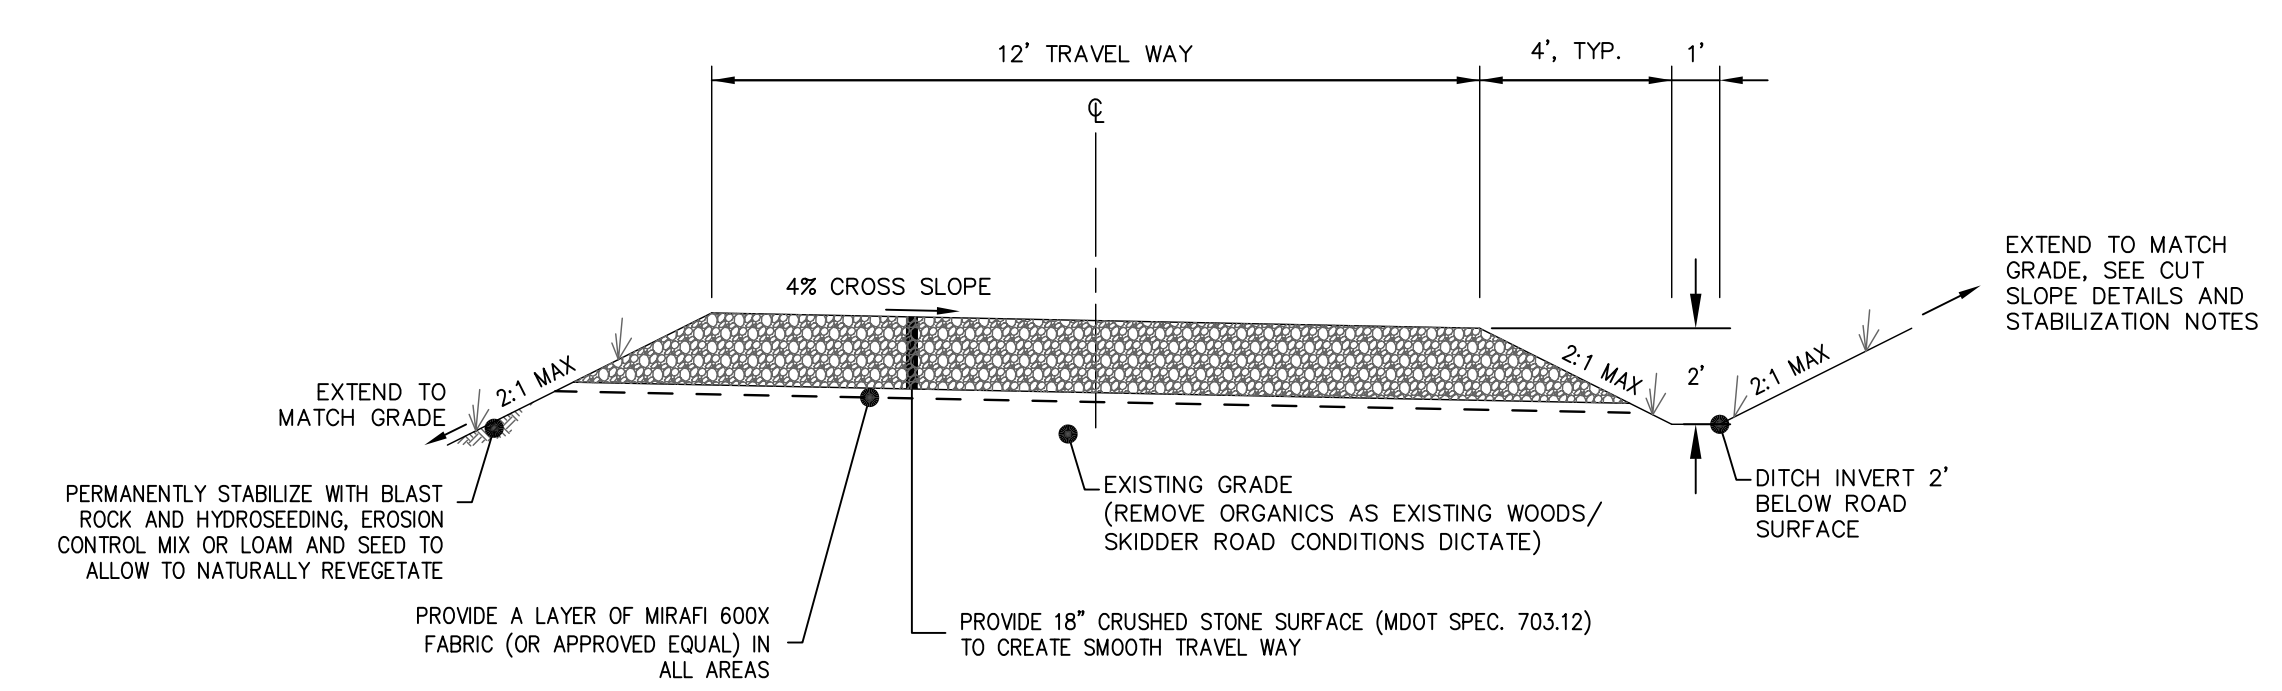
12' TRANSMISSION LINE ACCESS ROAD CROSS-SECTION DETAIL
NOT TO SCALE
