Section 4
Environmental Impacts

ROXBURY WIND DEVELOPMENT NATURAL RESOURCE INVENTORY

ROXBURY WIND DEVELOPMENT VERNAL POOL SURVEY REPORT

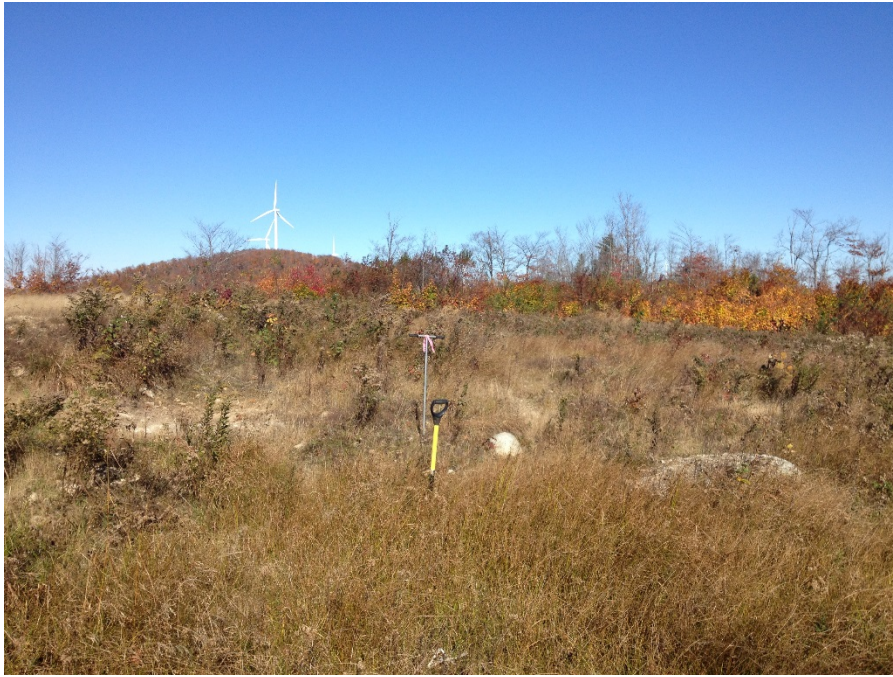
PHOTO 1 EMERGENT WETLAND NN LOOKING NORTH ACROSS WETLAND

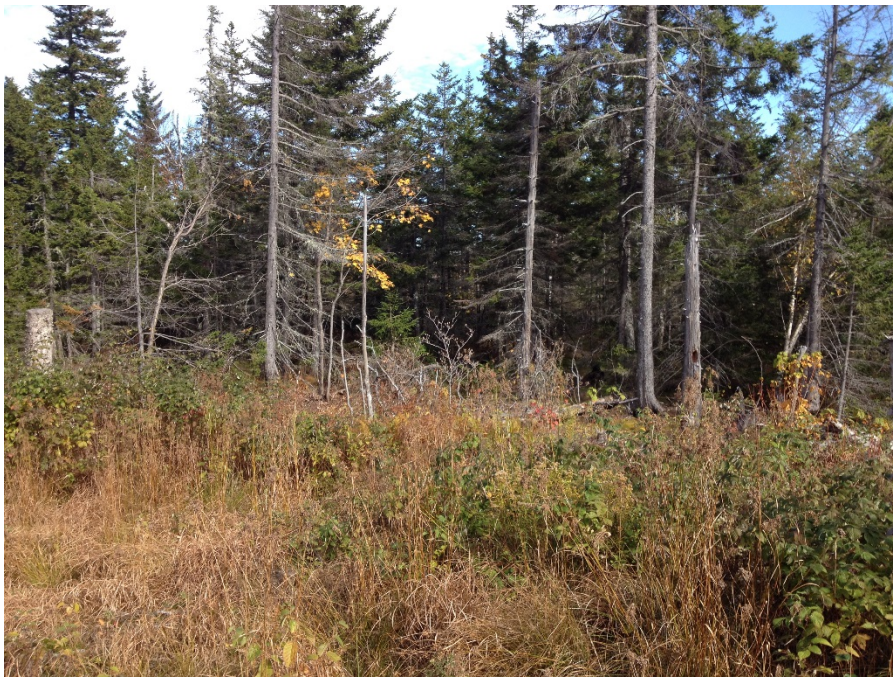
PHOTO 2 VIEW FORESTED WETLAND GG

Principle functions of the majority of the wetlands identified in the survey area are: wildlife habitat, streambank stabilization, and production export. The highest quality wetland habitat is found within wetland GG, the black spruce bog found on the ridge top. Wetland GG provides good wildlife habitat, although recent timber harvesting has removed upland forest around portions of this wetland. Water quality improvements are a common principle function of many of the wetlands identified within the survey area, many wetlands occur as small pockets associated with groundwater and spring activity. Most of the wetlands provided some, but limited, water quality functions as the systems are all located in headwaters and there is no development or agriculture within the drainage area for these wetlands and stream systems. Wetland services provided by mapped wetlands in the survey area are limited, as the wetlands occur on private property which limits access by the general public for recreation or observation.

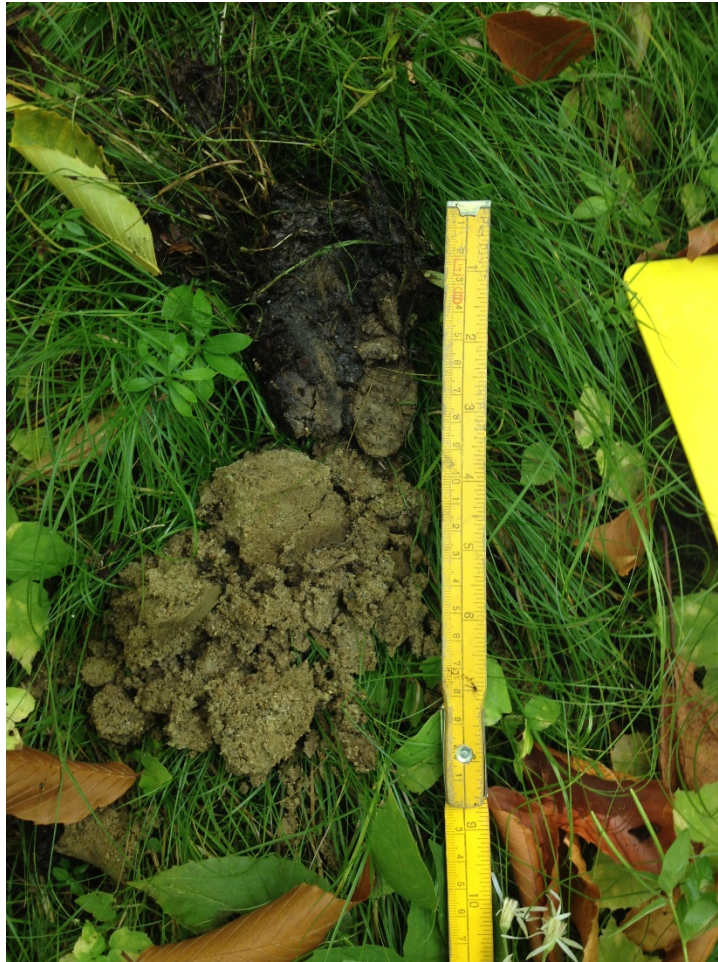
PHOTO 3 REPRESENTATIVE WETLAND SOIL (DEPLETED MATRIX) FOUND IN WETLAND C

Most wetlands on the ridgetop were located in areas where shallow bedrock conditions resulted in perched water and soils here were histosols or mineral soils with histic epipedons (thick, dark, organic horizon at the surface) with organic material ranging from 0-12 inches. For wetlands identified in areas of Lyman-Tunbridge-Becket or Lyman-Tunbridge-Becket the most common hydric indicator was a reduced matrix and the presence of redoximorphic features indicating an elevated water table within the surface horizons. A full general soil report for the survey area is included as Appendix C.

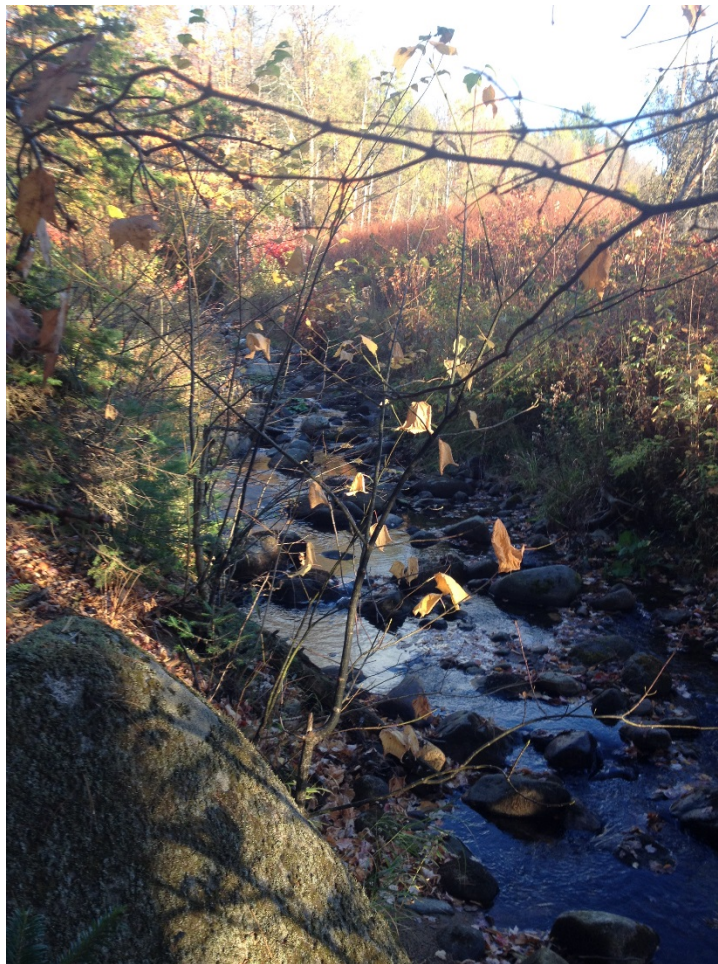
PHOTO 4 REPRESENTATIVE VIEW OF PERENNIAL STREAM EE

Several streams were identified within the survey area; the majority of these streams are intermittent drainages (Table 3-6). Two small, unnamed perennial streams (Photo 4 and Photo 5) are mapped on the site. The larger stream (Stream EE) is a direct tributary to the Swift River. Both of these streams are dominated by cobble, boulder and bedrock. Intermittent streams, of which there are several, generally convey flows from spring seeps and run-off (Photo 6). Substrates within the intermittent streams vary, but are commonly dominated by sand, gravel, and occasional cobbles.

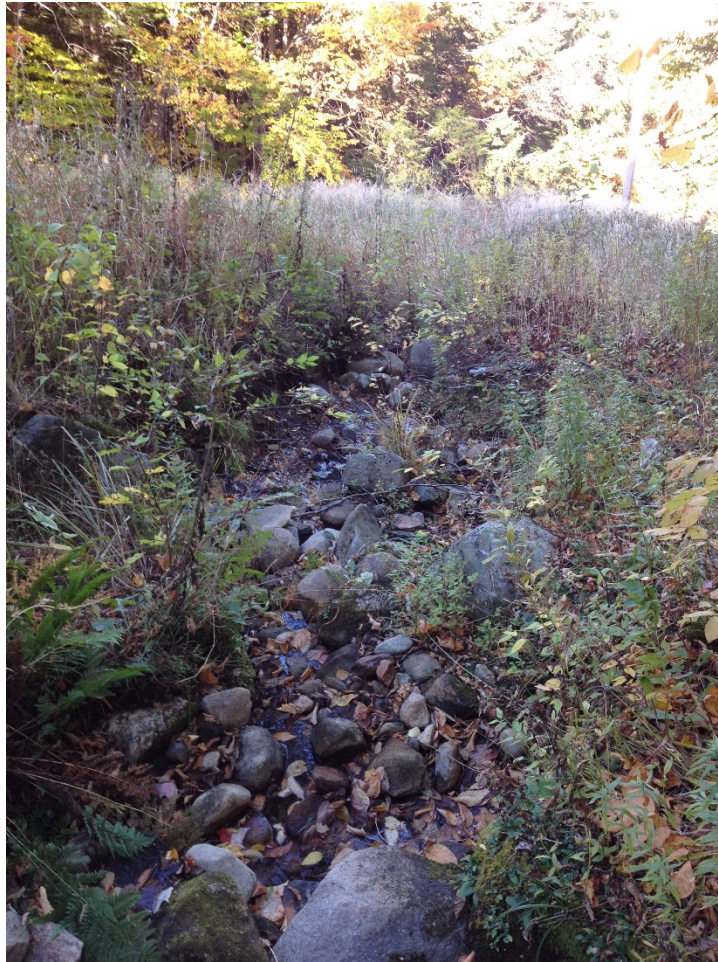
PHOTO 5 **REPRESENTATIVE VIEW OF PERENNIAL STREAM KK**

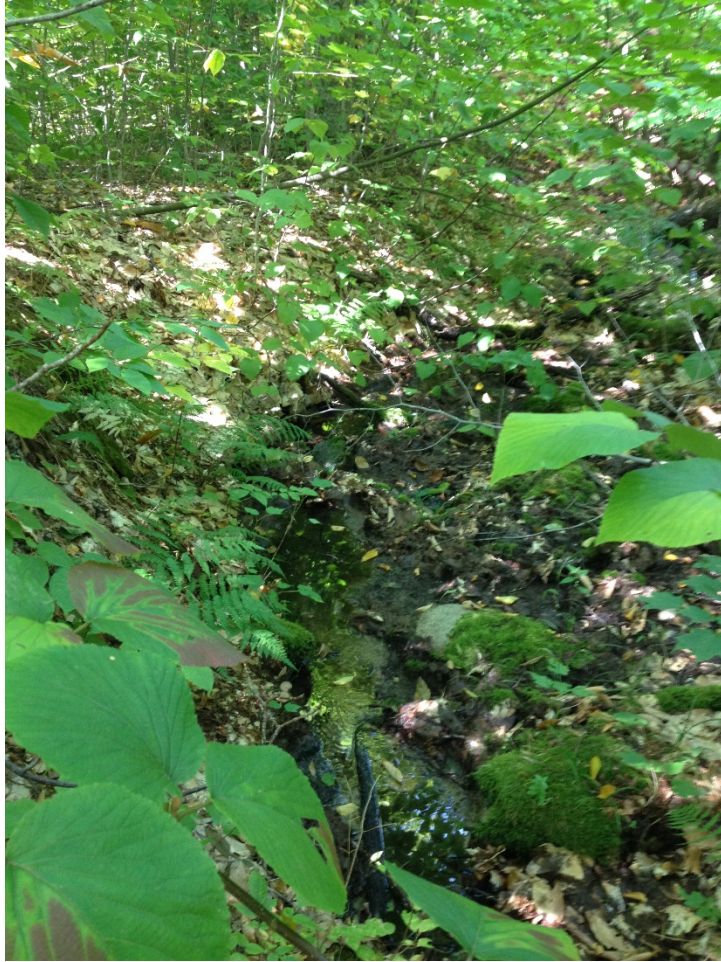
PHOTO 6 **VIEW OF REPRESENTATIVE INTERMITTENT STREAM (STREAM D)**

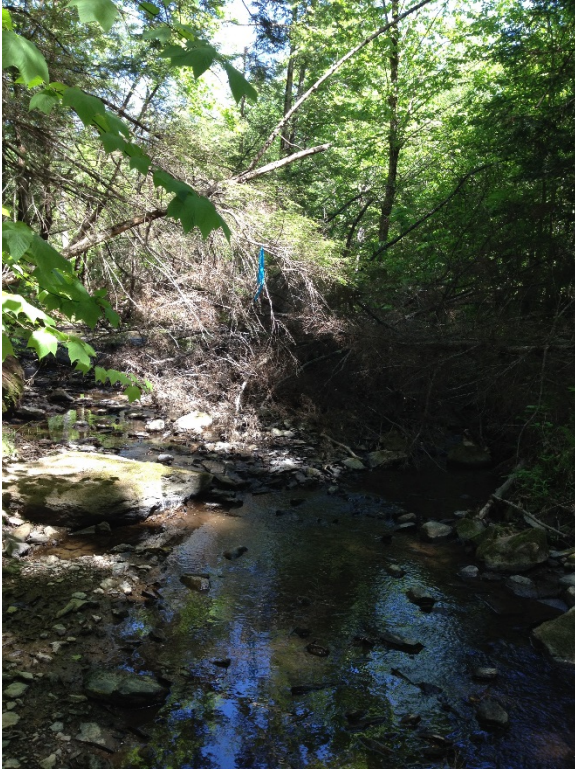
PHOTO 7 REPRESENTATIVE VIEW OF UNNAMED BROOK

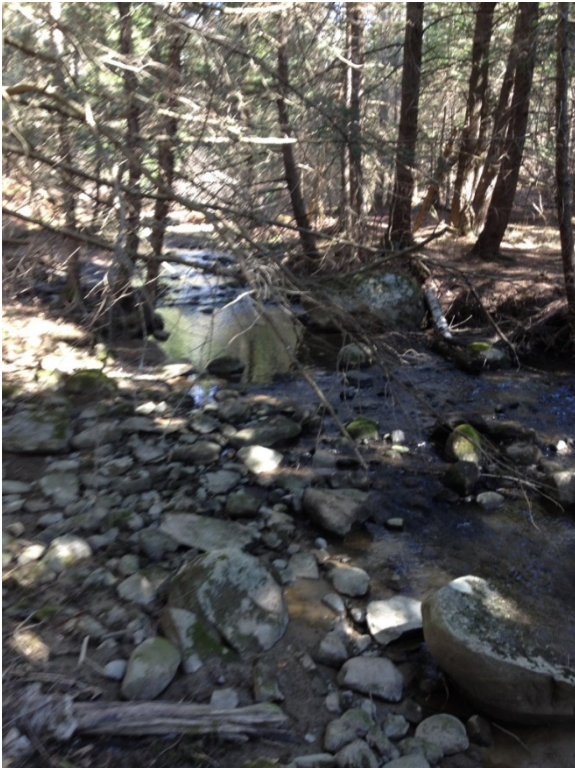
**PHOTO 8 REPRESENTATIVE VIEW, LOOKING UPSTREAM, OF UNNAMED STREAM
(STREAM A)**

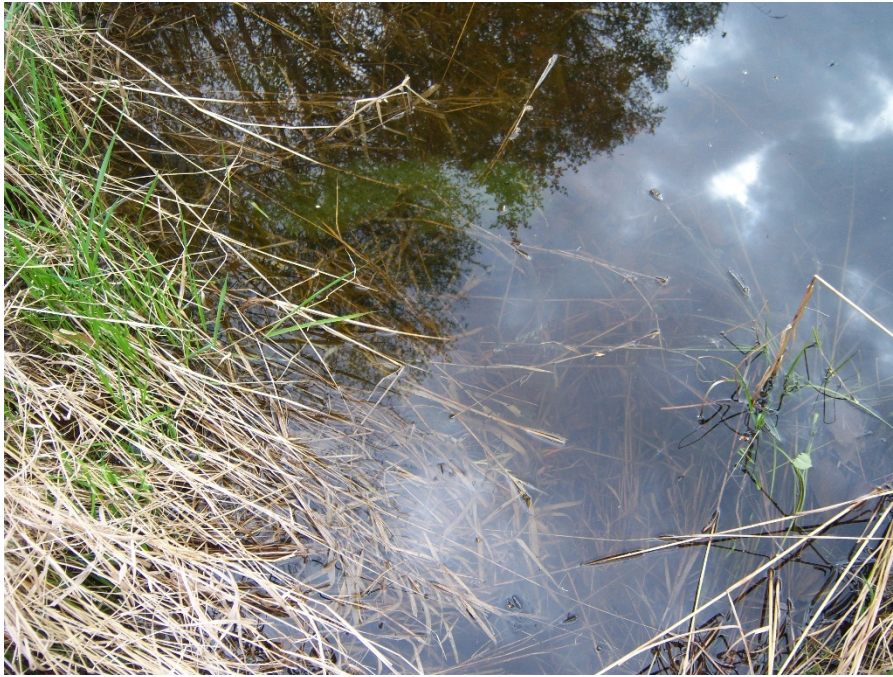
PHOTO 3-1 WOOD FROG EGG MASSES, BREEDING AREA A

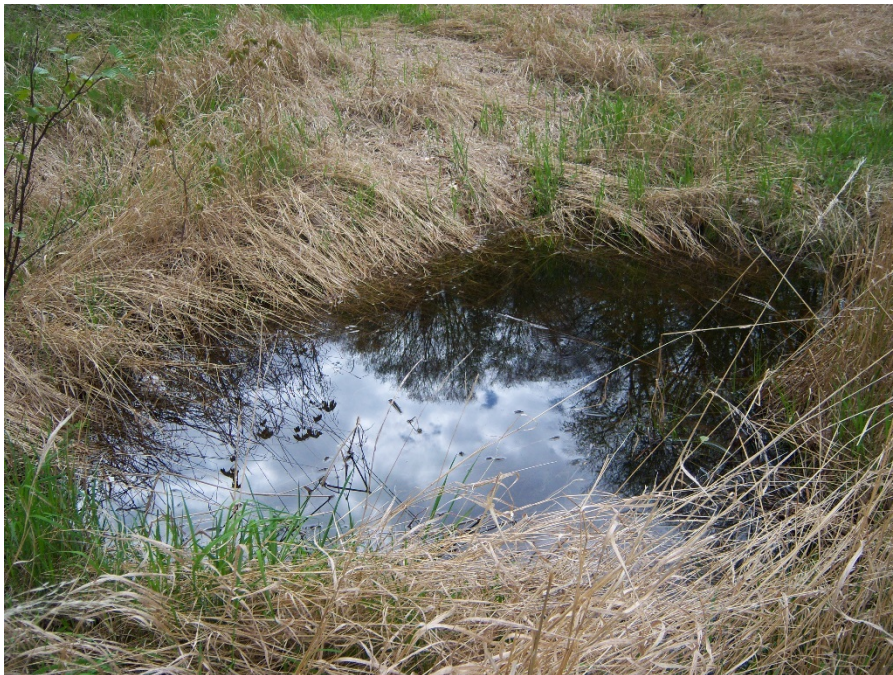
PHOTO 3-2 VIEW OF BREEDING AREA A

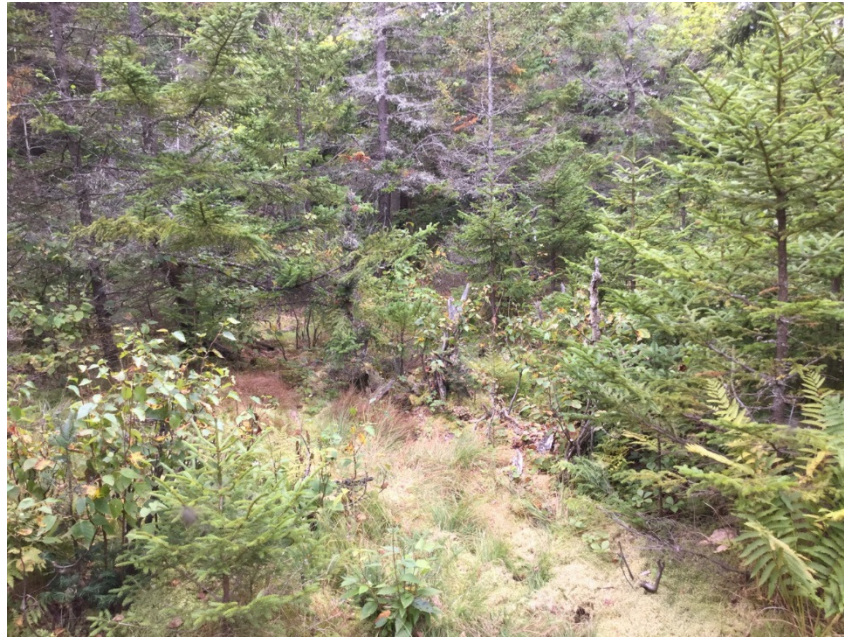
Photo 1. Wetland Area 1 northern bog lemming survey area. Stantec. September 8, 2016.

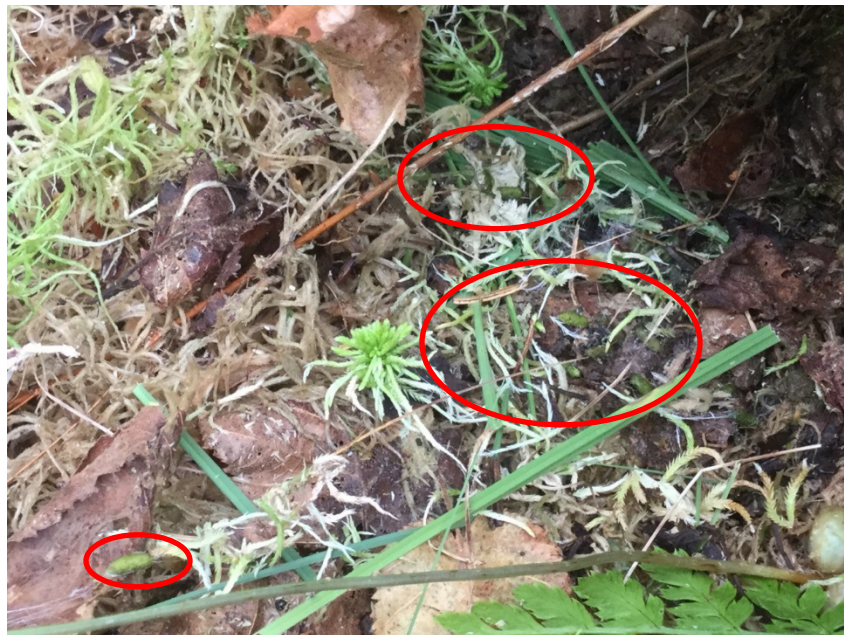
Photo 2. Green fecal pellets (circled in red) collected for genetic analyses in Wetland Area 1. Stantec. September 8, 2016

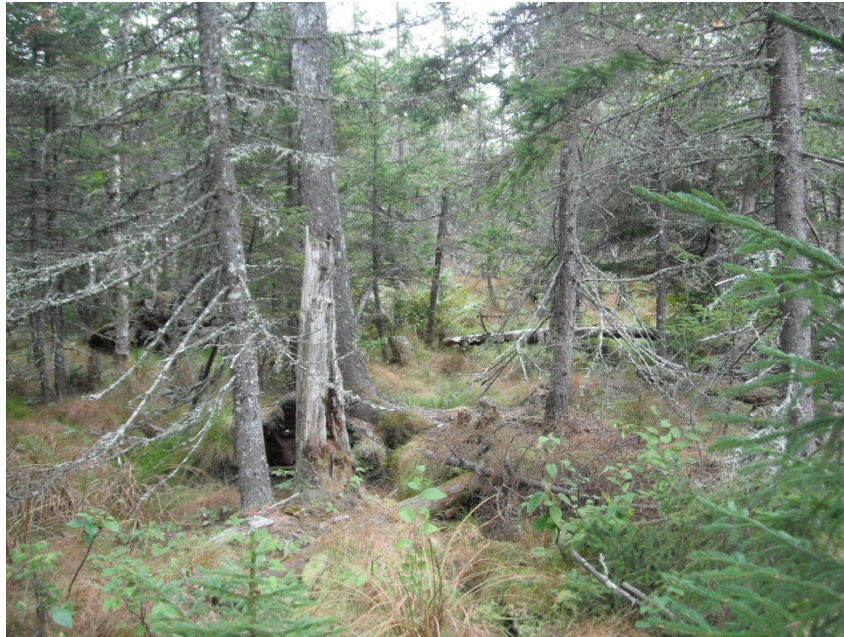
Photo 3. Wetland Area 2 northern bog lemming survey area. Stantec. September 8, 2016.

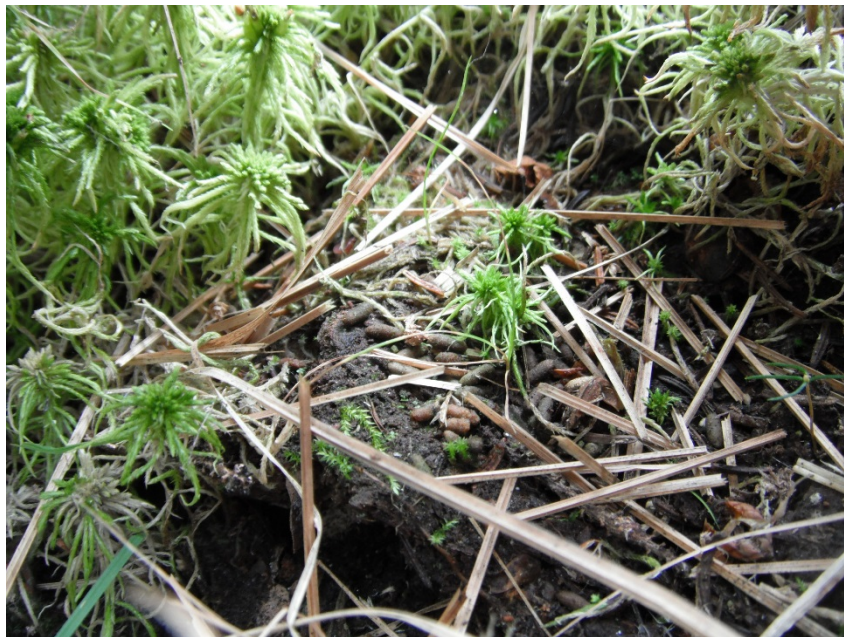
Photo 4. Non-bog lemming activity in Wetland 2. Stantec. September 8, 2016.

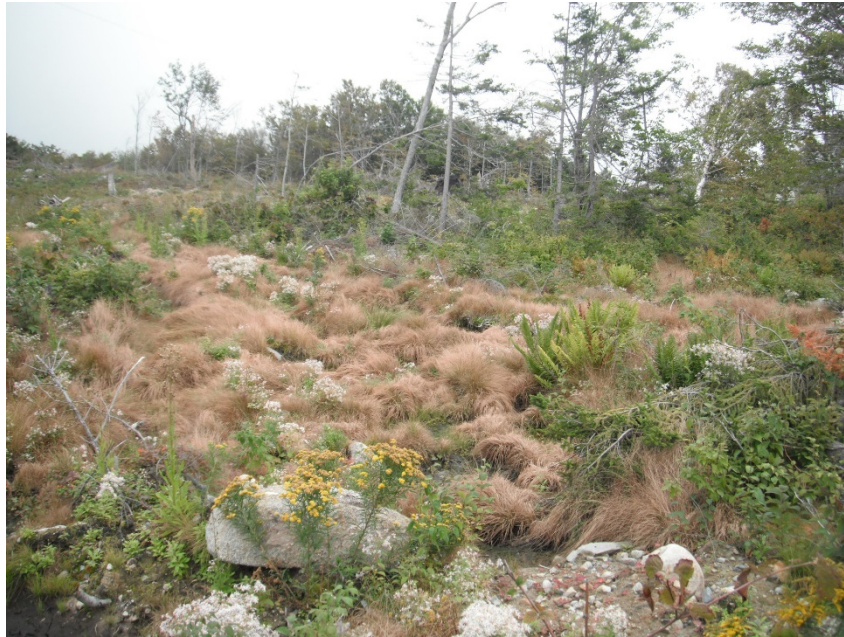
Photo 5. Wetland with unsuitable northern bog lemming habitat. Stantec. September 8, 2016.

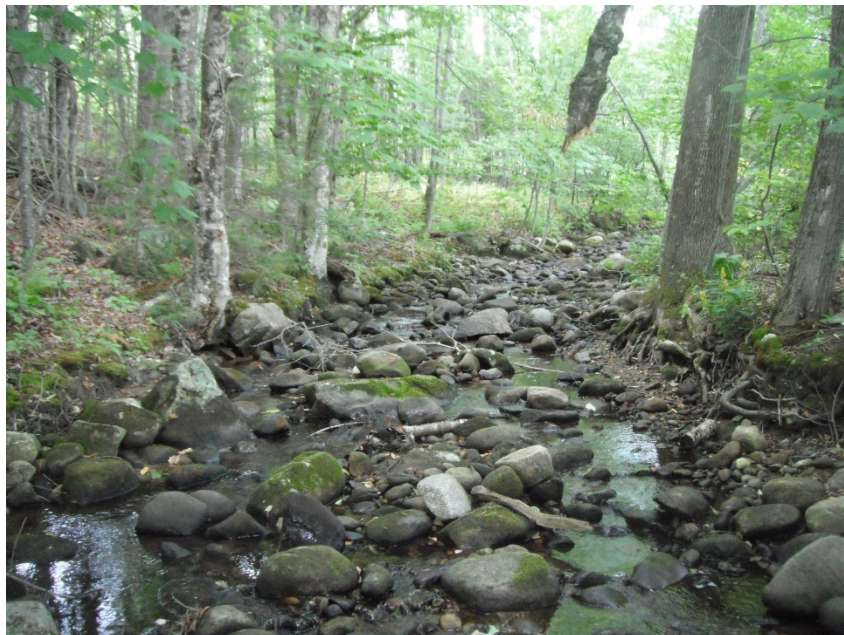
Photo 6. Unnamed perennial tributary of Swift River surveyed for northern spring salamander. Stantec. September 8, 2016.

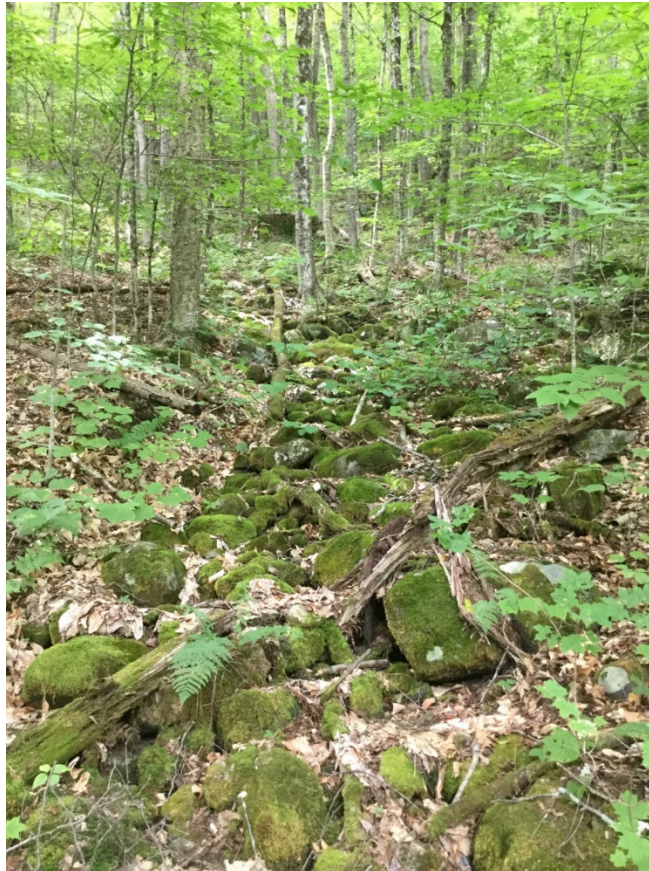
Photo 7. Intermittent stream with unsuitable habitat for northern spring salamander or Roaring Brook mayfly. Stantec. September 8, 2016.

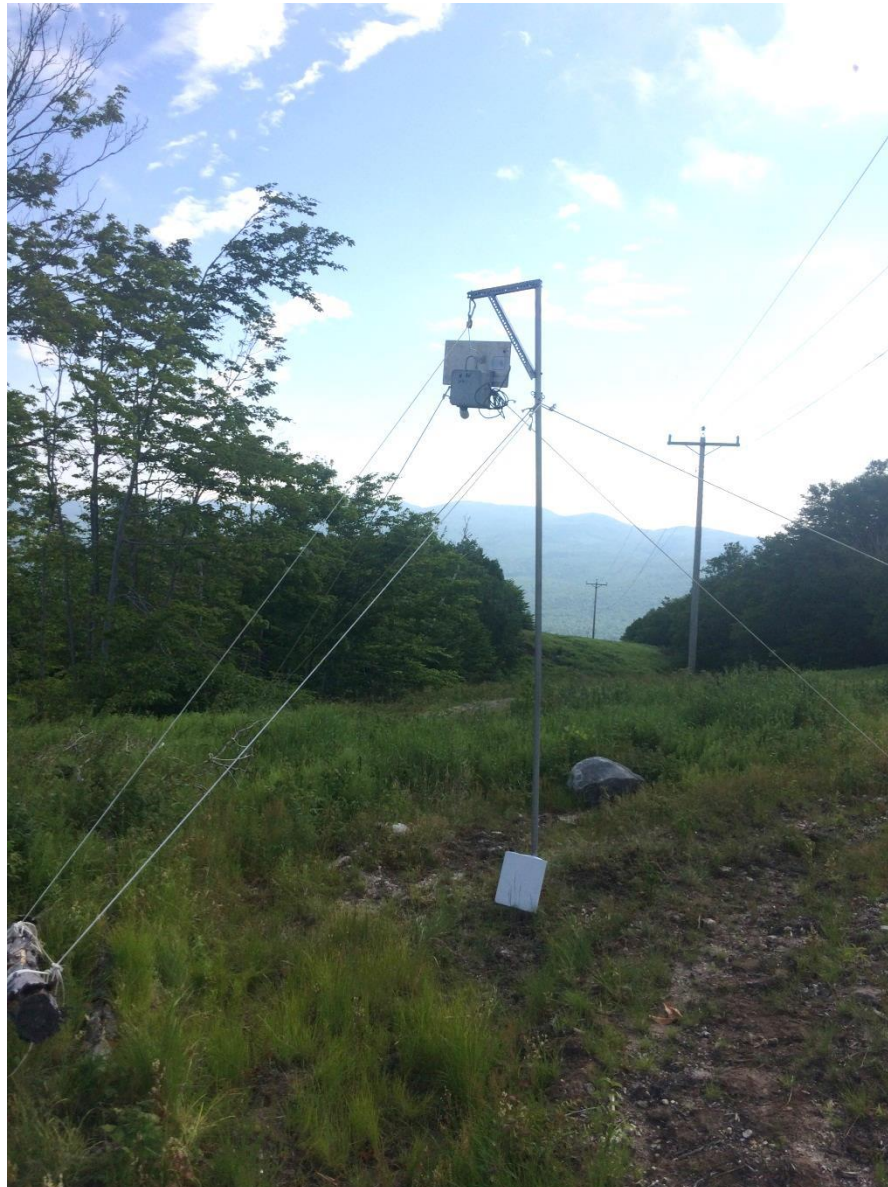
Photo 1: Anabat SD1 detector in weather proof casing deployed in the transmission corridor at the Horseshoe Valley Wind Project for northern long-eared bat surveys in June 2016. The detector is located approximately 3 m above vegetation height, oriented horizontally to the ground, and facing 67°. A 3-ring binder is placed at the bottom of the detector for scale.

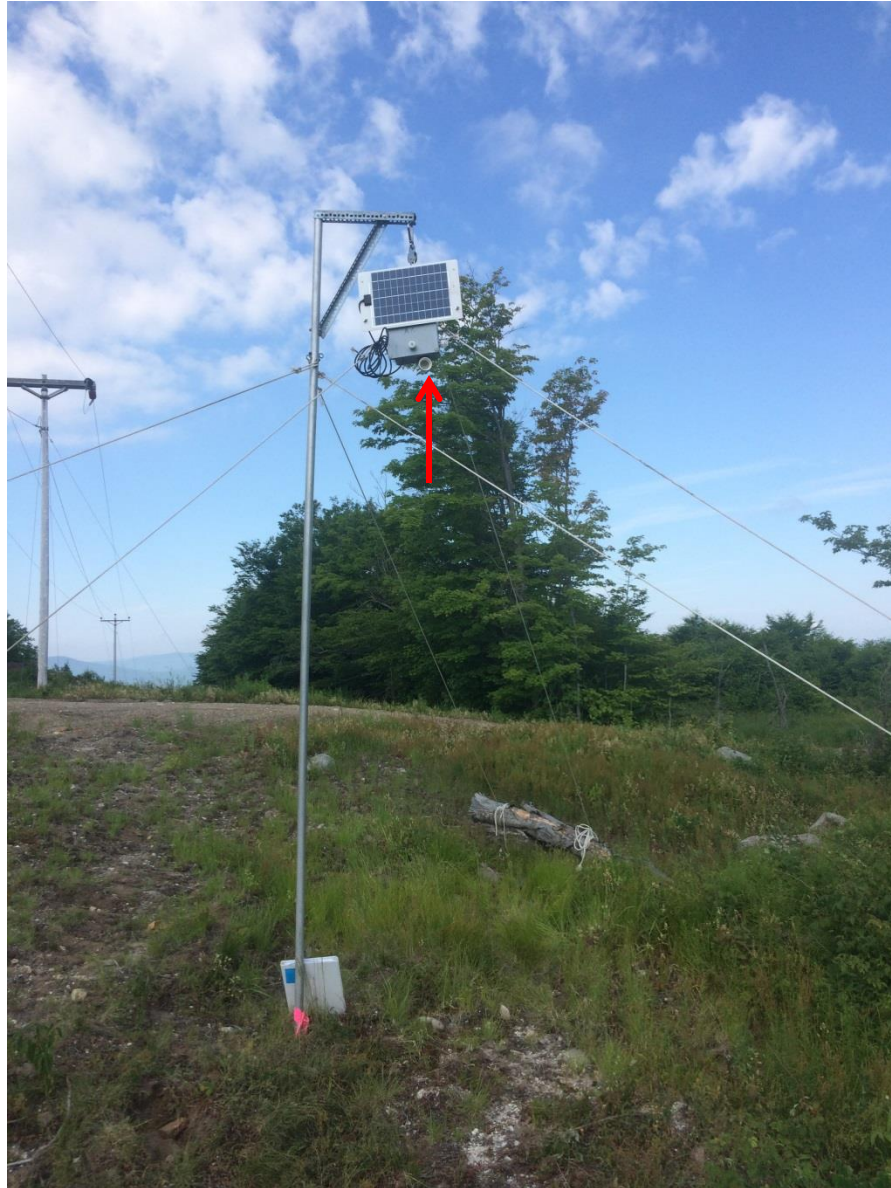
Photo 2: Anabat SD1 detector in weather proof casing deployed in the transmission corridor at the Horseshoe Valley Wind Project for northern long-eared bat surveys in June 2016. The arrow indicates the 90-degree angle PVC-elbow attached to the weather proof casing over the detector, protecting to microphone from adverse weather conditions and funneling sound from the potential flight corridor to the microphone.
