# **Phillips Lake**

## **Watershed-based Protection Plan**

**April 2014**

# Phillips Lake Watershed Survey Report

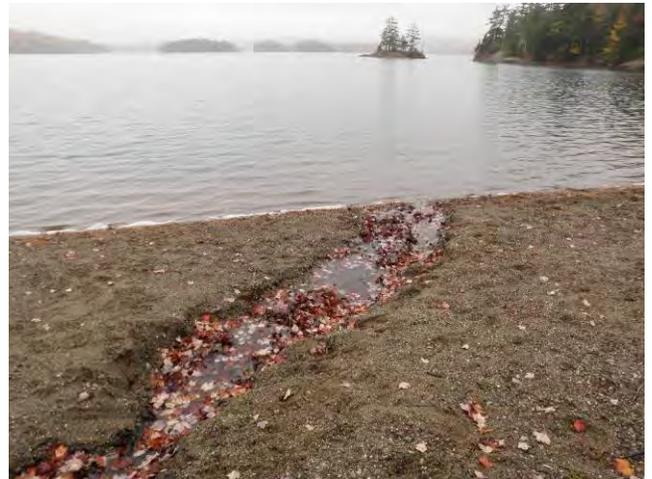
*Erosion along the shore of Phillips lake*

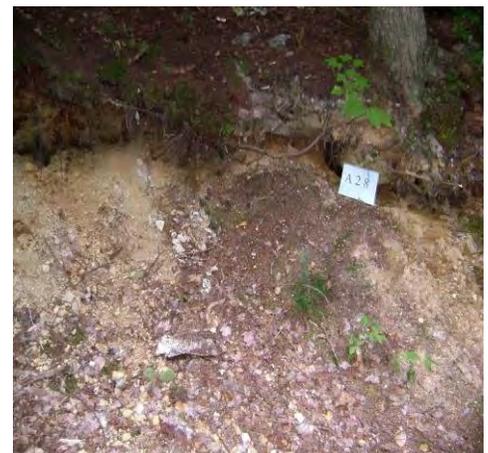
These sites often were found to have other problems as well, such as lack of buffers, which would help to hold soils in place and prevent erosion. Unstable or clogged culverts were also common on these sites. Culverts that are not

working properly cause water to pool and form new runoff pathways. These alternative paths are often the site of moderate to severe soil erosion. *Fifty-eight percent of all sites that recorded ditch erosion and 50% of all sites that recorded road surface erosion also had clogged or unstable culverts.*

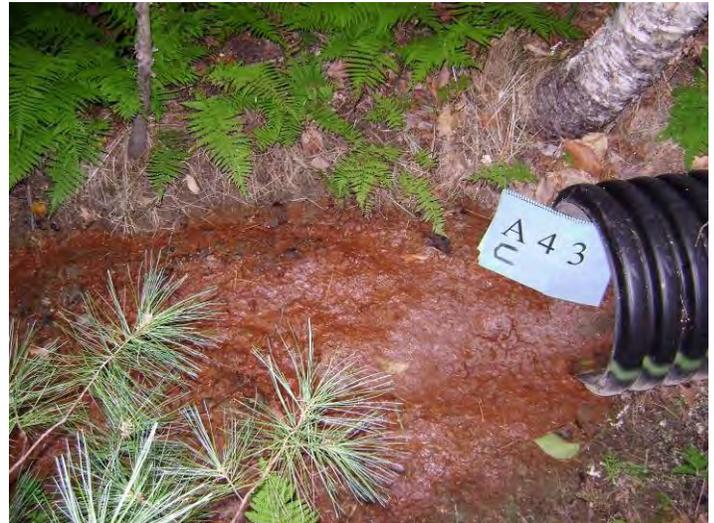
### Unstable/Clogged Culverts

Of all problem sites documented, 21% had unstable or clogged culverts. The majority of these sites (67%) were located on Town Roads. All but two of the 27 recorded unstable/clogged culverts also showed evidence of other problems, such as ditch and road surface erosion. This suggests that the repair or replacement of dysfunctional culverts could drastically reduce stormwater pollution in the Phillips lake watershed.

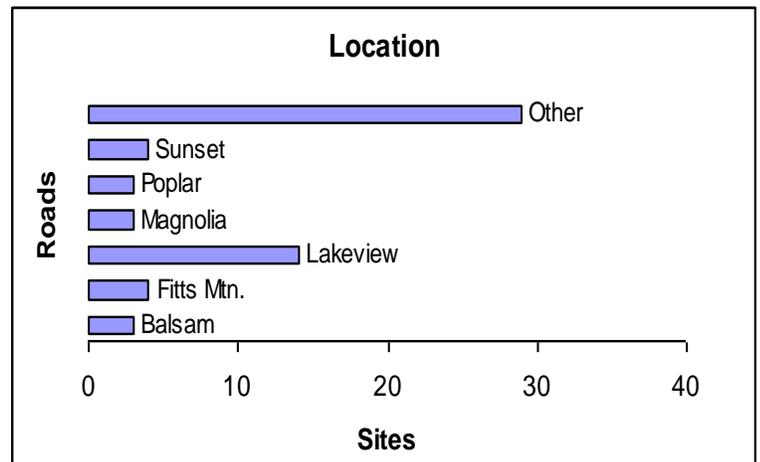
This graph depicts the number of sites that were recorded for each road. “Other” refers to any road that had less than three reported sites. Roads included in “Other” are: Larkspur, Maple, Oak, Hemlock, and Clear Lake.

Lakeview road accounted for fifteen (or roughly 25%) of the reported sites. The most common reported issues were unstable/clogged culverts and moderate to severe ditch erosion. The most common sites on Sunset road were unstable culverts and inadequate ditch size/ditch bank failure. On Fitts Mountain road, surveyors found a construction site that had no evident erosion control.

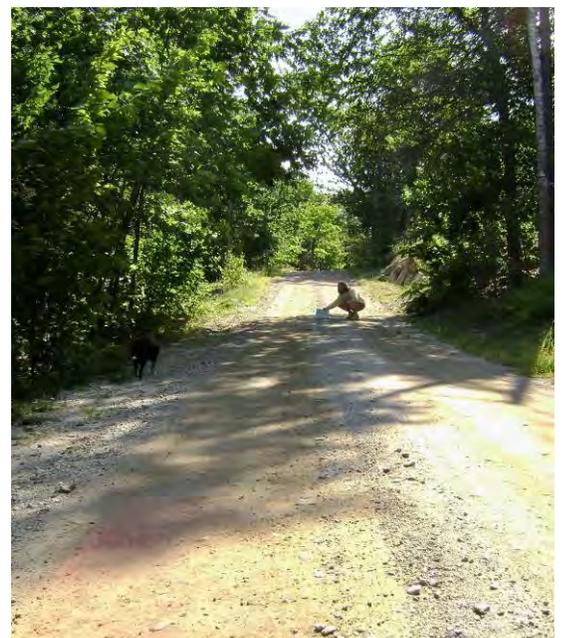
### Issues with Town and Private Roads:

- ◆ Ditch erosion
- ◆ Road surface erosion
- ◆ Unstable/clogged culverts
- ◆ Bare soil
- ◆ Roadside berms

### Recommendations for Town and Private Roads:

- ◆ Unclog culverts
- ◆ Stabilize culverts
- ◆ Build up or crown road
- ◆ Vegetate ditch
- ◆ Remove roadside berms
- ◆ Armor ditch

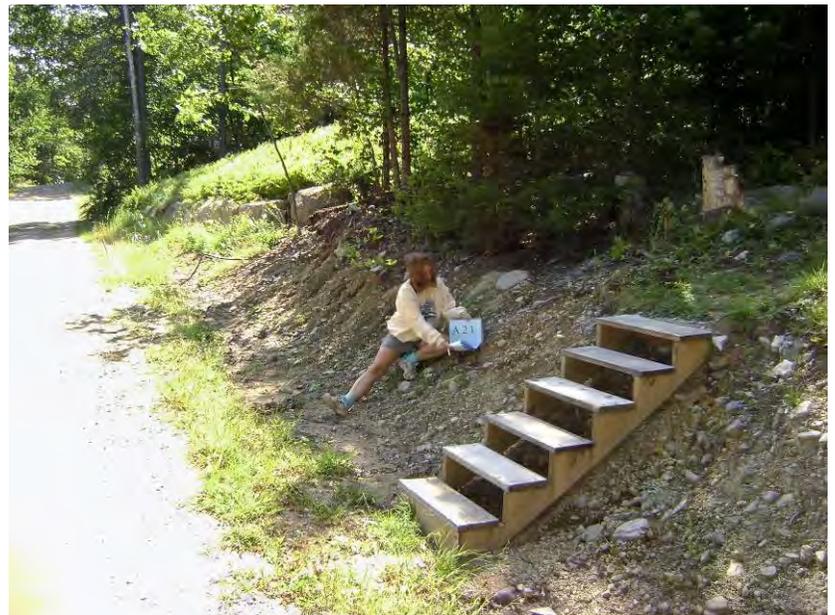
### Issues with Residential Properties:

- ◆ Bare soil
- ◆ Unstable/clogged culverts
- ◆ Ditch erosion
- ◆ Road surface erosion
- ◆ Lack of buffer

### Recommendations for Residential Properties:

- ◆ Install runoff diverters
- ◆ Establish buffers
- ◆ Stabilize/unclog culverts
- ◆ Replace culverts
- ◆ Vegetate/reshape ditches
