TMDL Assessment Summary

Thatcher Brook

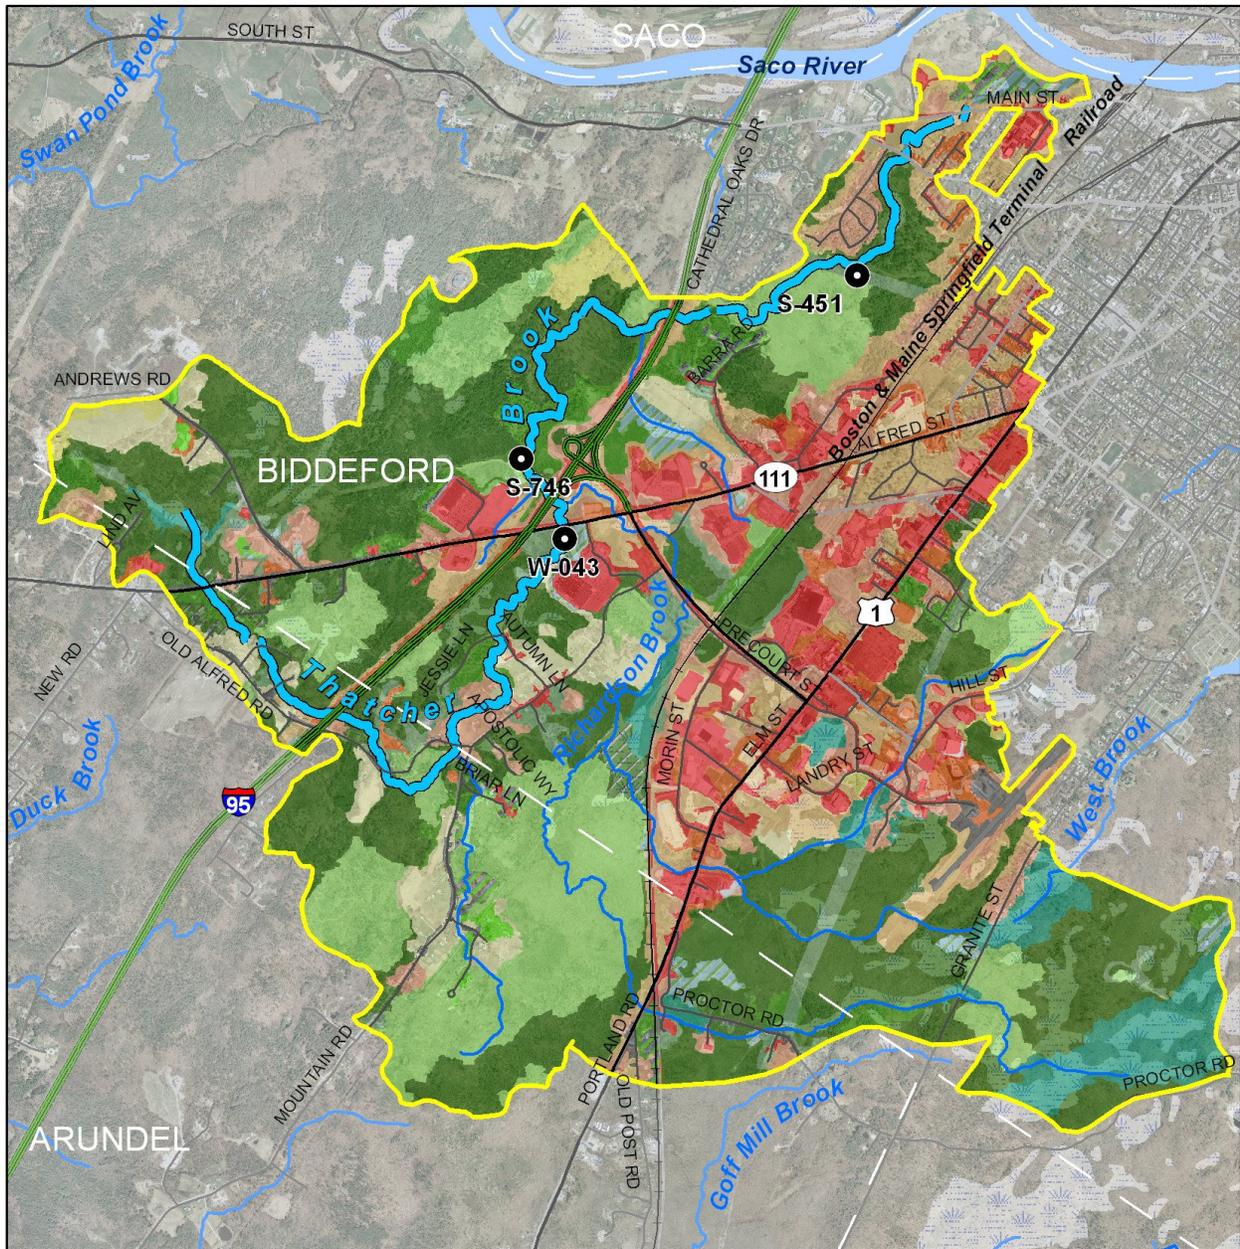
Figure 2: Map of Thatcher Brook watershed land cover.

Thatcher Brook, Biddeford (ME0106000211_616R05)

- Maine DEP Sampling Station
- ~ Impaired Segment
- Watershed Boundary (7.1 sq. mi.)
- High Intensity Development (10%)
- Medium Intensity Development (4%)
- Low Intensity Development (8%)
- Developed Open Space (10%)
- Cultivated Land (1%)
- Pasture/Hay (4%)
- Grassland/Herbaceous (<1%)
- Deciduous Forest (15%)
- Evergreen Forest (4%)
- Mixed Forest (31%)
- Scrub/Shrub (3%)
- Wetland Forest (4%)
- Wetlands (1%)
- Roads/Runway (2%)
- Unconsolidated Shore (<1%)
- Bare Land (<1%)
- Light Partial Cut (1%)
- Heavy Partial Cut (1%)

The Impervious Cover Calculations are based on analysis of GIS coverage's presented in Figure 2. In Thatcher Brook these maps were derived from a detailed field assessment conducted by DEP Staff, as described in the TMDL.
