# Maine Statewide Bacteria TMDL:2013 Freshwater Addendum

## Appendix A: Duck Brook Bacteria Sampling Project Reports

# Restoration of Streams Impaired by NPS Bacteria

# 2011 Data Report Duck Brook - Arundel, Maine

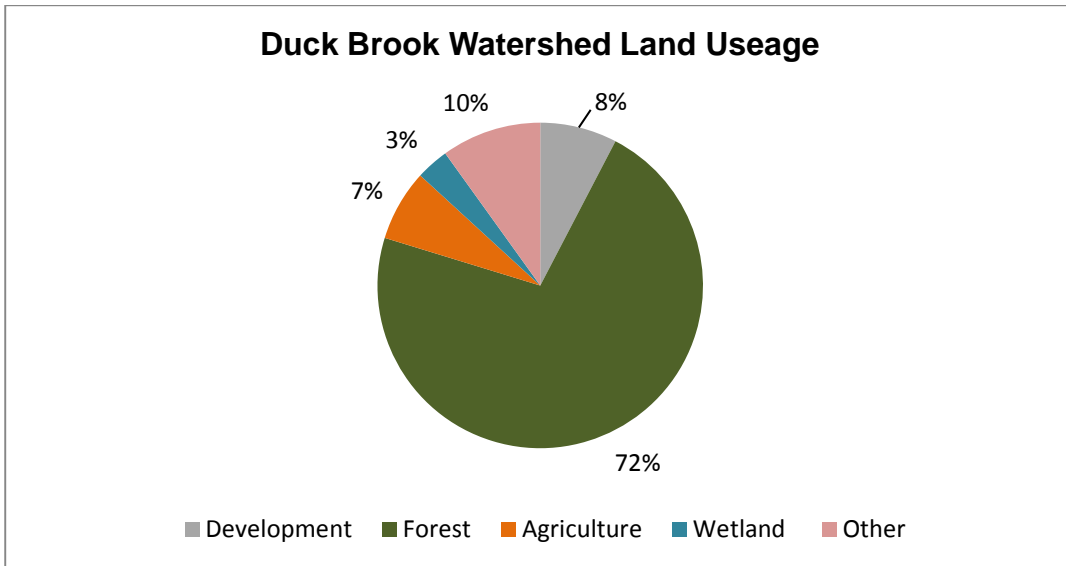
**Figure 2.** Forest covers the majority of the Duck Brook watershed.

The Duck Brook watershed is primarily defined by natural drainage divides resulting from topography and elevation contours. Watershed drainage is also subject to development, land use, and impervious surface. The Duck Brook watershed has 6.0% impervious surface nested within a land cover mosaic of: 7.6% development including developed open spaces; 72.1% coniferous, deciduous, or mixed forest vegetation; 7.1% agriculture characterized as pastures, crops, or blueberry fields; 3.3% wetland cover; and 9.9% classified as other with herbaceous plants and shrubs (Figure 2).

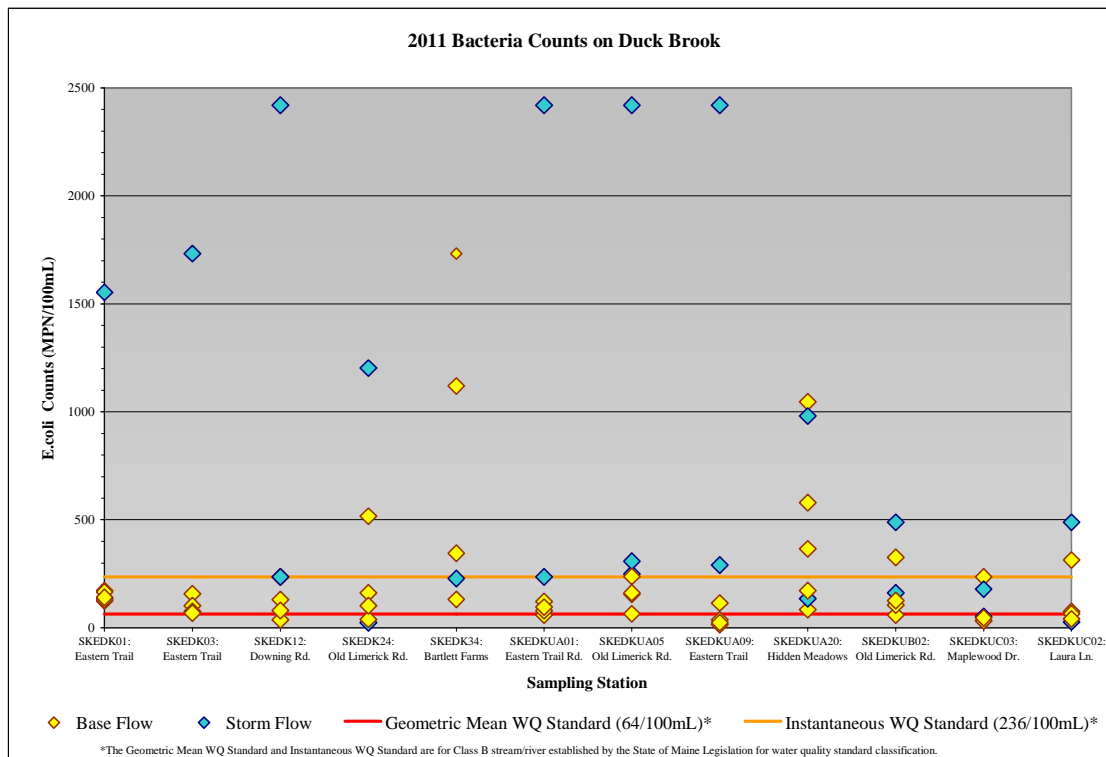
**Figure 1.4: Below is a graph summary of the 2011 bacteria counts on Duck Brook. The original sampling station Eastern Trail (SKEDK01) is in the bottom left hand corner of the graph.**

There are three major sources: agricultural runoff and domestic animal fecal contamination, malfunctioning septic systems, and wildlife fecal contamination. Of the twelve sampling stations on the brook, two are influenced by agricultural runoff and/or domestic animals with a possible third; three are influenced by malfunctioning septic systems; three are influenced by wildlife with a possible fourth; and two remain unknown. Additionally, the bacteria contamination is restricted to discrete sections of the watershed, as defined by, its four unnamed tributaries. (The unnamed tributaries will be referred as Tributary A, B, C, or D – with Tributary A being the farthest downstream in the watershed and Tributary D being the farthest upstream in watershed) (see Figure 1.4 or Figure 1.6).

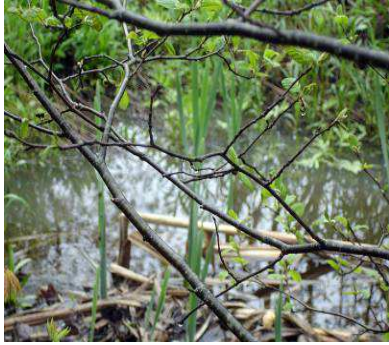
**Figure 1.6. A picture of water with the “grayish water” appearance near Limerick Rd (SKEDKUA05) sampling station.**

The portion closest to the mouth of Duck Brook is Tributary A. While sampling during both storms events, water with a “grayish water” appearance was observed near the Limerick Rd (SKEDKUA05) sampling station (see Figure 1.7). There are a few houses to the right (while looking upstream from the road) of the station on Skyview Acres Dr., as well as the small subdivision just above the station on Talbot Dr. Both are candidates for sanitary surveys. The bacteria contamination in this portion of the watershed is confined to this particular stream segment; limiting the scope of work. The Eastern Trail (SKEDKUA09) sampling station is directly above the subdivision and attains water quality standards. However, farther up on Tributary A, malfunctioning systems were detected at Hidden Meadows. There are few houses on Hidden Meadows that are above the Hidden Meadows (SKEDKUA20) sampling station and after that it is a forested area. Sanitary surveys and additional investigation will be needed in the area.
