1998 Peat System Assessment

Department of Health and Human Services, Division of Environmental Health

Drinking Water Program, Subsurface Wastewater Unit

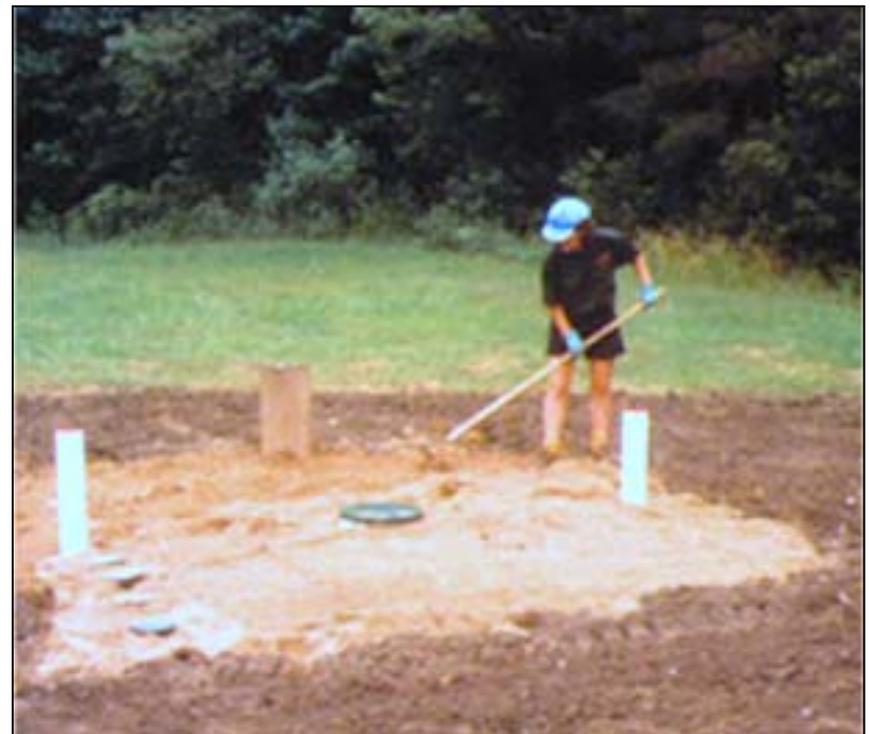
However, Appendix C also advised in a distinctly non-technical manner, that proper compaction levels can be achieved “... by an adult walking on (the peat) with snowshoes...” to reach a predetermined density of 6.2 to 9.4 pounds/cubic foot.

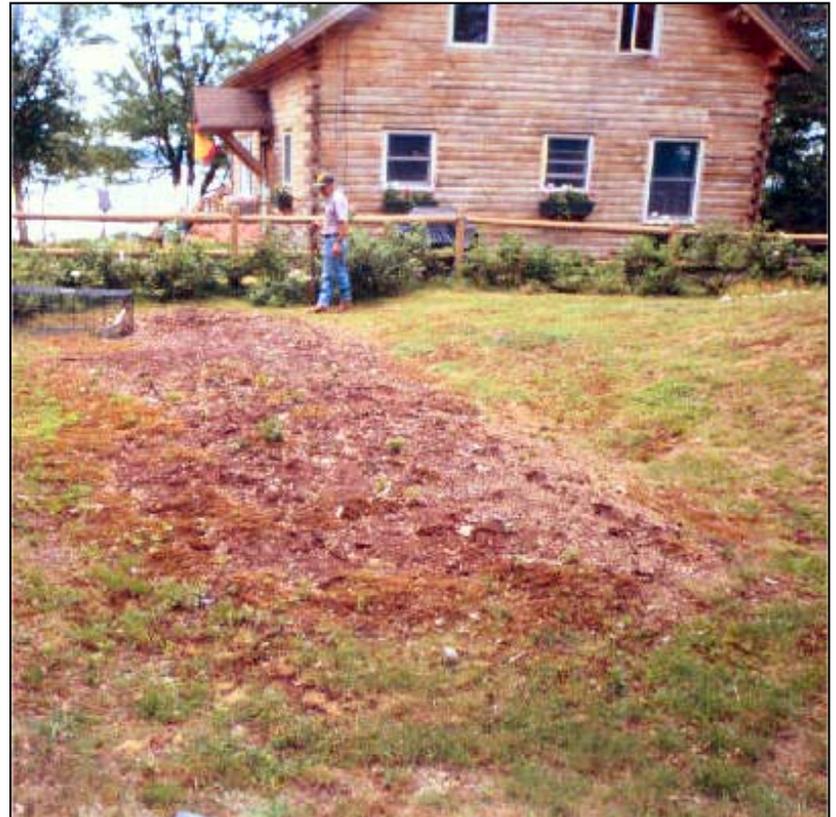
Inspections consisted of questioning the homeowners (if present) about their use habits, a visual inspection of the property and siting, and a physical inspection of the actual peat system.

If the homeowners were not present, inspections were restricted to visual inspections only, for signs of malfunction, absent consent of the Local Plumbing Inspector.

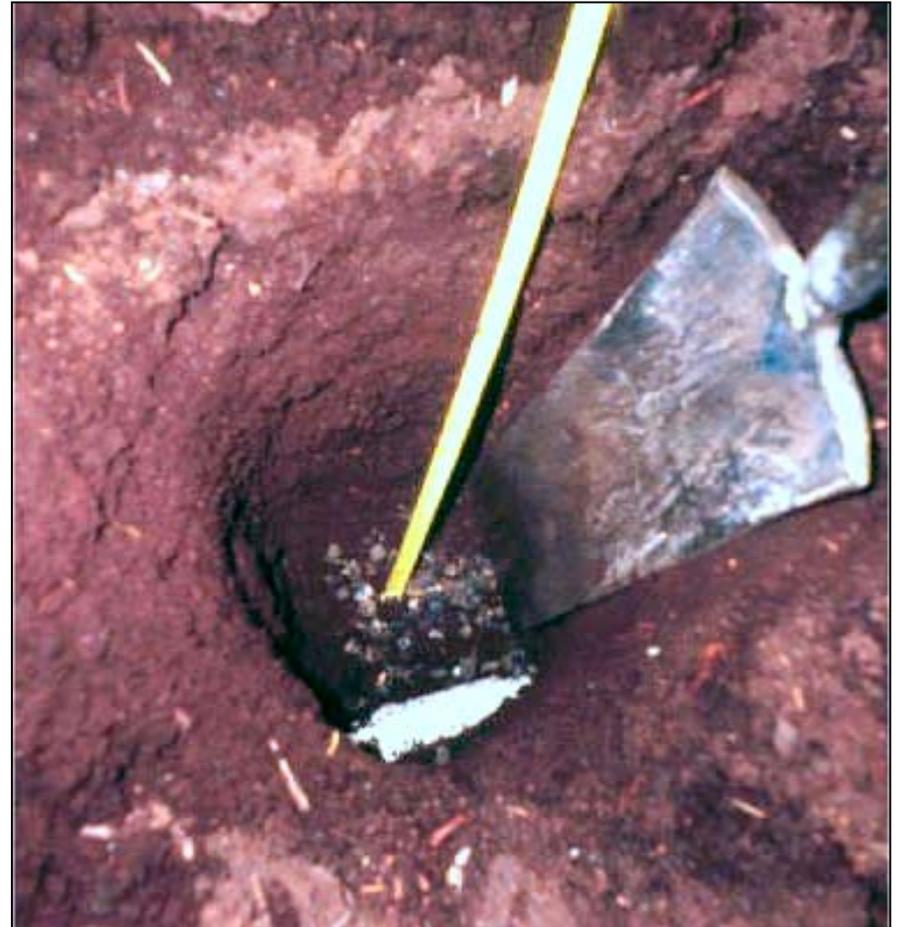
The physical inspections consisted of excavating one or more inspection pits in and adjacent to the peat bed, occasionally core or other materials sampling, and examination of the septic tank outlets and/or effluent distribution boxes when possible. Intrusive examinations were not conducted without owner permission.

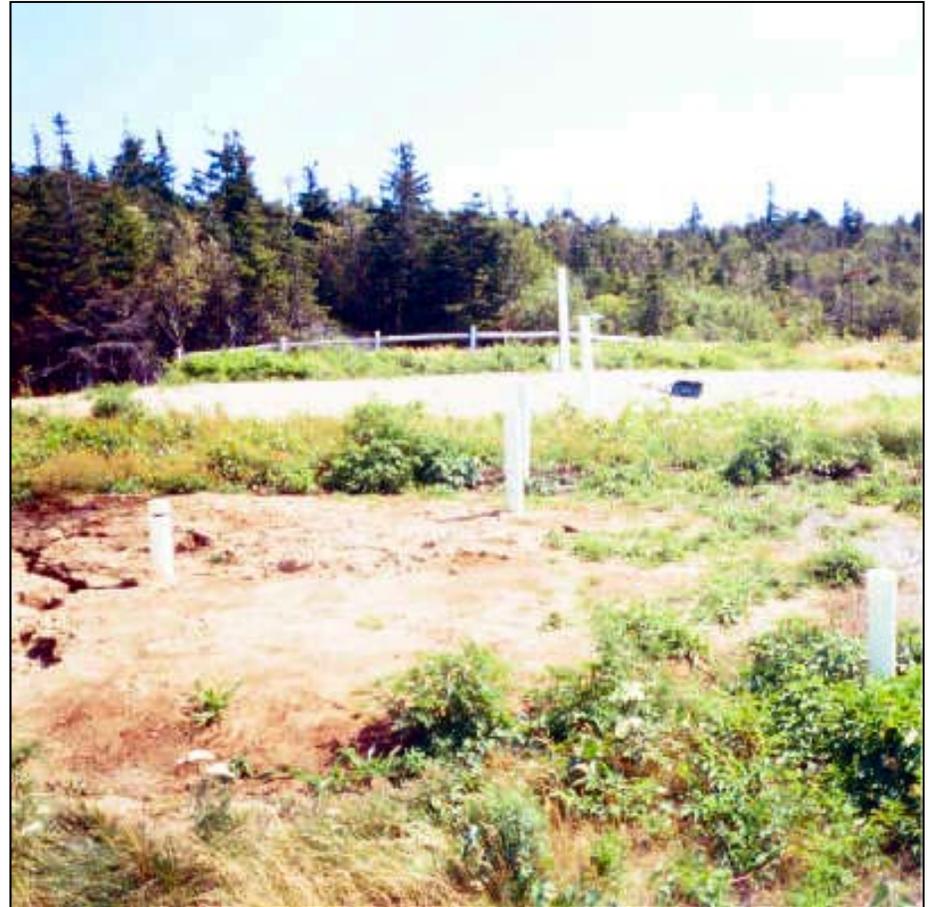
These systems mostly served single family dwelling units, with the following exceptions: one two-family apartment unit in Stockton Springs, and a large system serving the Cadillac Mountain Visitor Center at Acadia National Park. Of the peat systems inspected, all but manufactured module installations in Stockton Springs were built on site. The photo at right shows the Acadia national Park system.

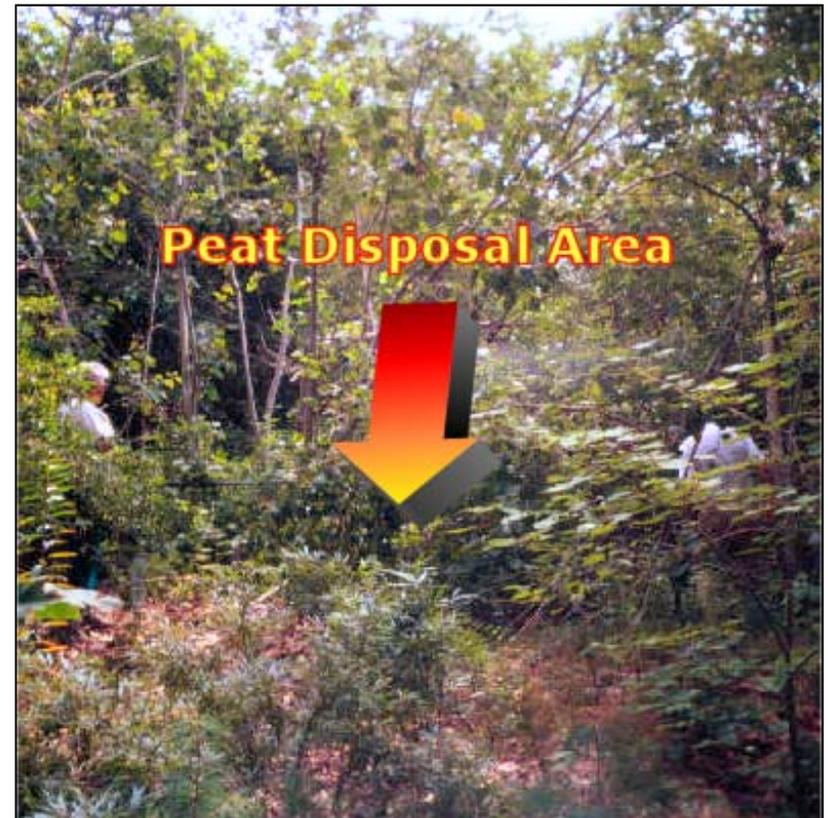
Lack of owner maintenance was observed at several sites, evidenced by a proliferation of woody shrubs and small trees in the peat beds, contrary to generally accepted practice for any type of disposal area. An extreme example of this observation is the system at right, which was functioning well despite the presence of numerous saplings and shrubs in the peat medium.

Lack of owner maintenance appears to be a secondary contributory factor to the malfunctions compared to improper installation, in some cases.

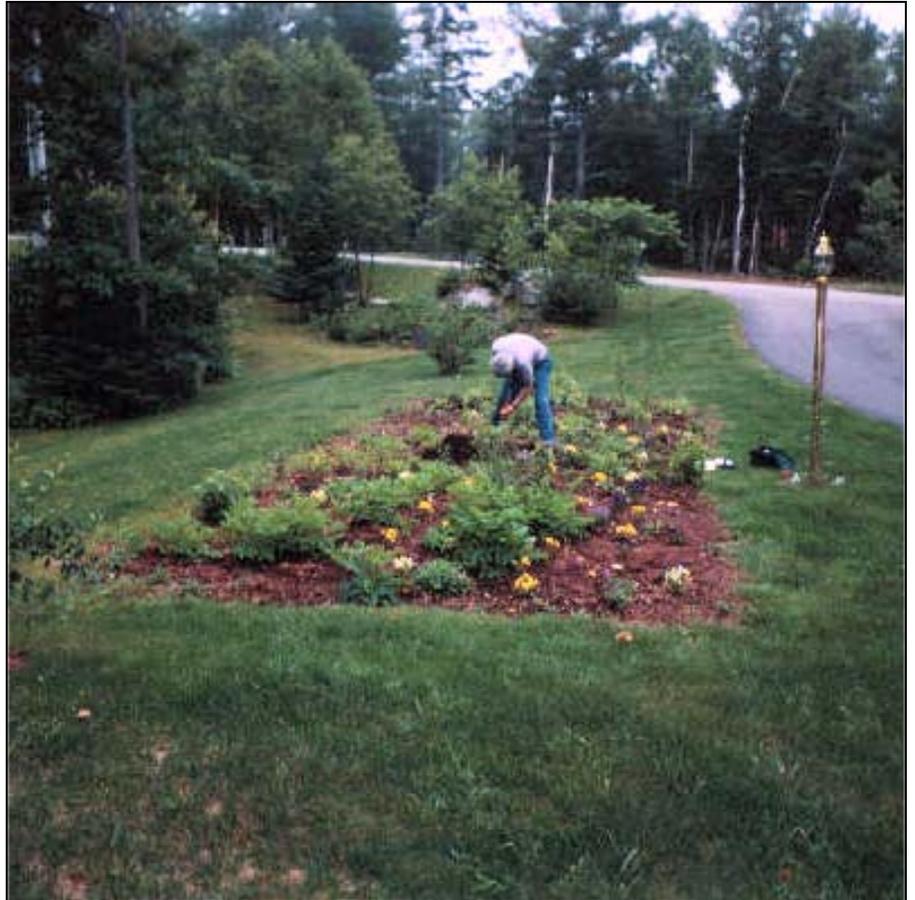
In the majority of inspected malfunctions where the information was available, it appears that designer oversight of the installations was either on an intermittent "spot check" basis, or upon completion of the installation. In the majority of the observed properly functioning systems, it appears that the designer provided oversight of the peat system installations during most of the installation process.

The installations which included a high level of designer oversight of the installation process, also are those which were found to be in the best physical and operating condition. In fact, the eight year old system in Windham previously noted received such oversight and it continues to function well, even though it had been neglected in terms of bed maintenance. This trend strongly suggests that designer oversight during installation is beneficial, perhaps necessary.

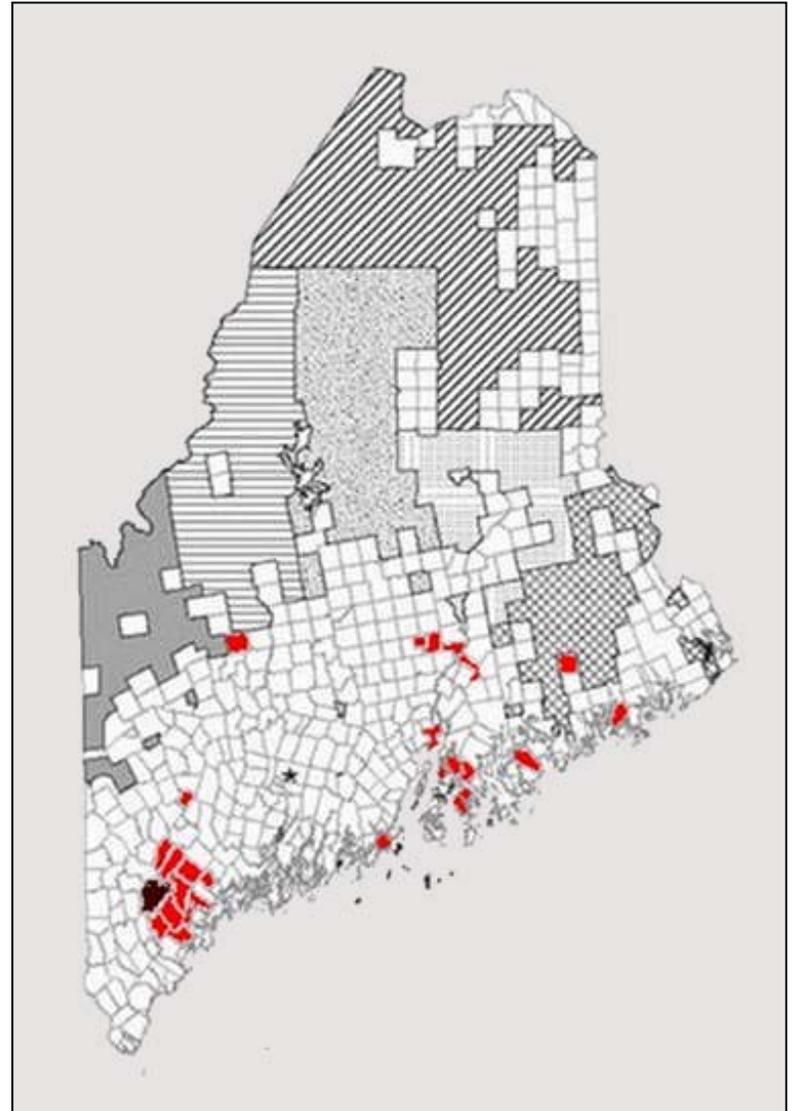
It is also in these communities that the largest number of non-conforming installations were found, including the systems with layered stone and peat.

Of particular note, those systems which were found to have alternating layers of stone and peat, clearly not in conformance with the specifications in the Rules, were all located in this area.
