Heron Island Oyster Company - Fitch Cove, Damariscotta River, South Bristol

**Location:** Fitch Cove, Damariscotta River, South Bristol, Lincoln County, Maine

**Purpose:** Standard lease for bottom and suspended culture of American/Eastern Oysters (*Crassostrea virginica*)

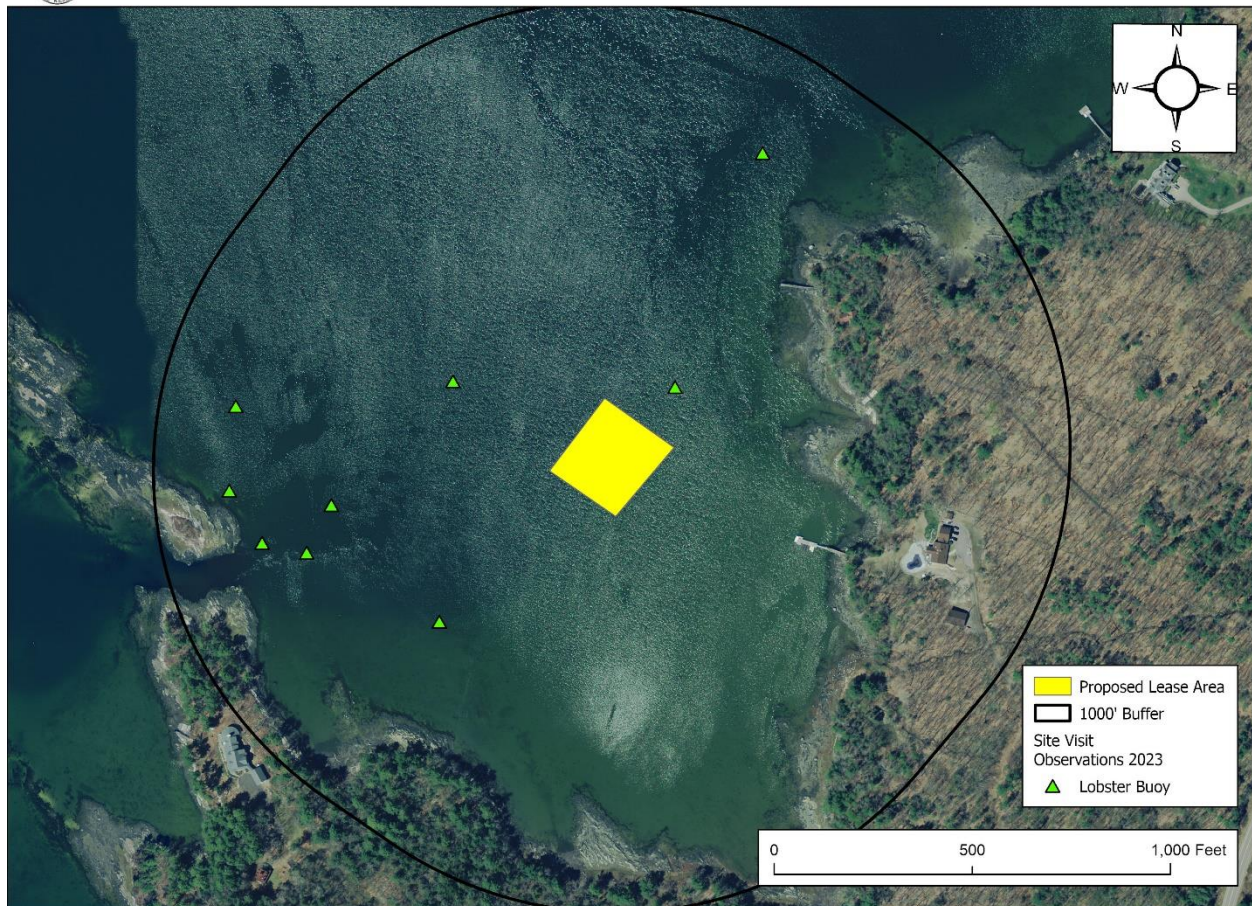
During MDMR's site assessment on October 25, 2023, dense lobster buoys were observed in the main channel of the Damariscotta River. Nine lobster buoys were observed within 1,000 feet of the proposed lease. The closest lobster buoy was approximately 125 feet north of the proposal (Figure 4).

Figure 4. Lobster buoys observed during MDMR's site visit in the vicinity of the proposal.

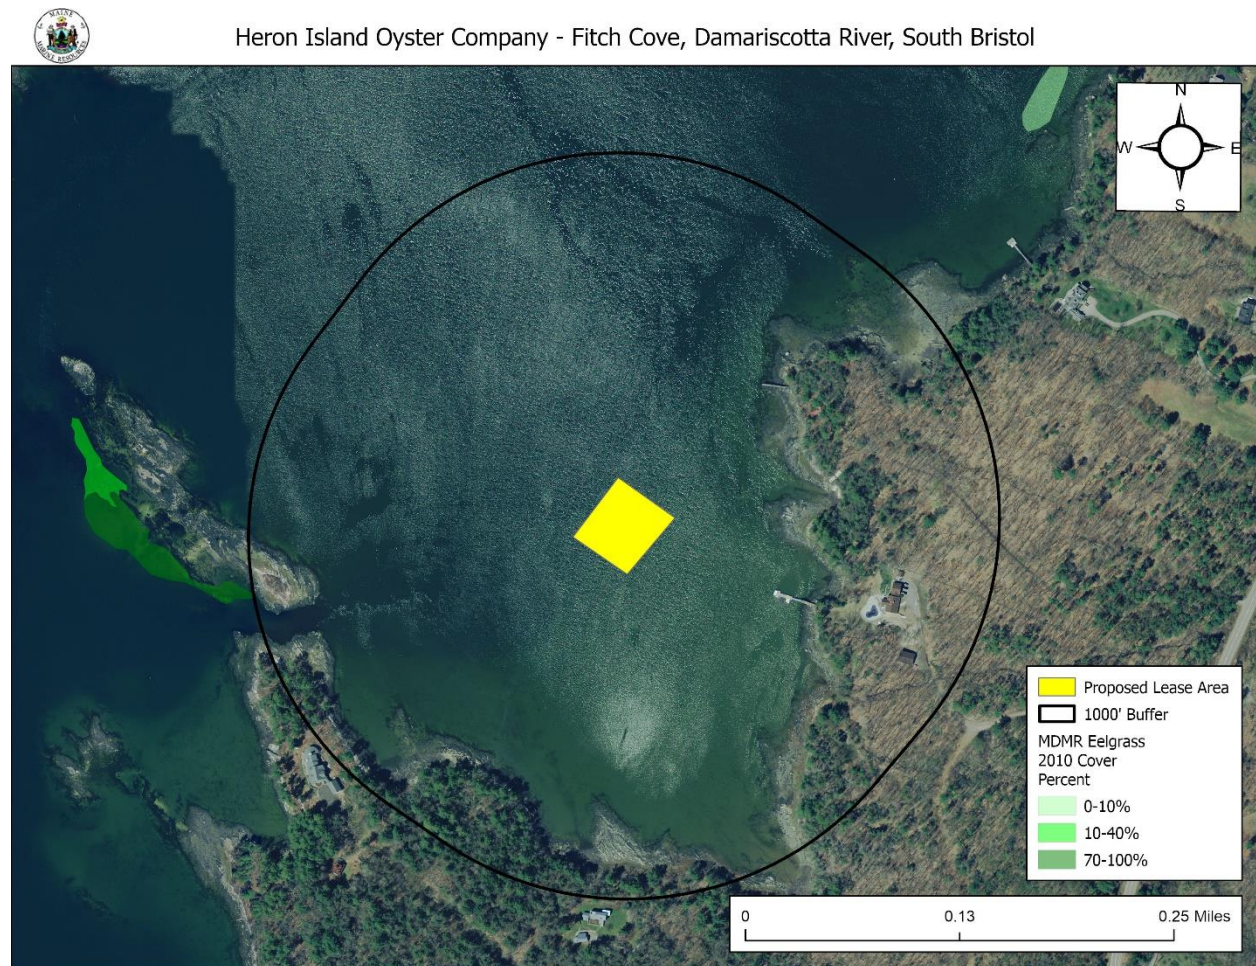
Historical records of eelgrass collected by MDMR in 2010<sup>5</sup> indicate no mapped eelgrass presence in the vicinity of the proposal (Figure 6). No eelgrass was observed within the proposal boundaries during MDMR’s site assessments.

**Figure 6.** Mapped eelgrass (*Z. marina*) in the vicinity of the proposed lease area.

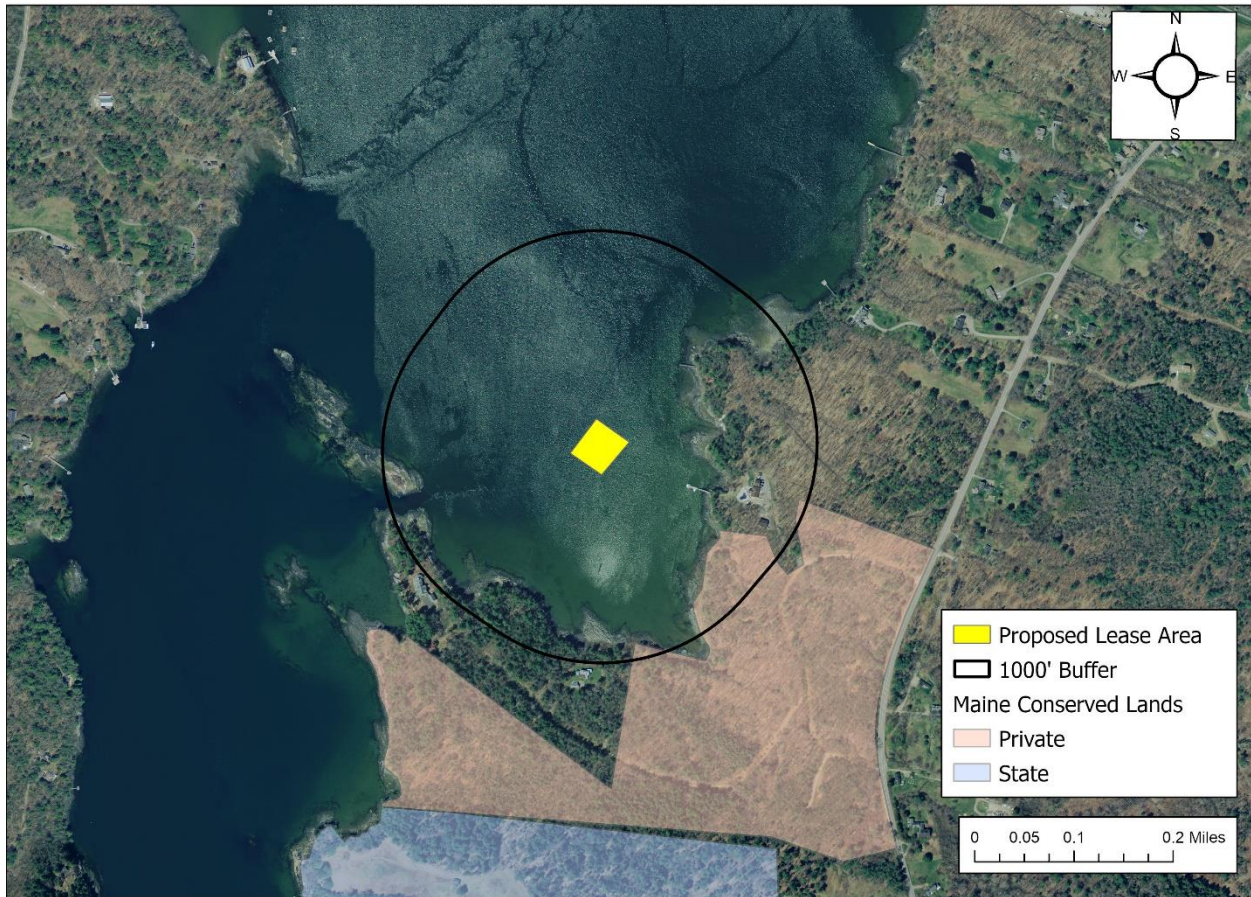
The proposed lease is not within 1,000 feet of any beach, park, docking facility, or conserved lands owned by federal, state, or municipal governments (Figure 8).

Figure 8. Public facilities near the proposed lease site.<sup>7</sup>
