Maine Coastal Erosion and Hazards

Stephen M. Dickson, Ph.D.

Maine Geological Survey

October 2004

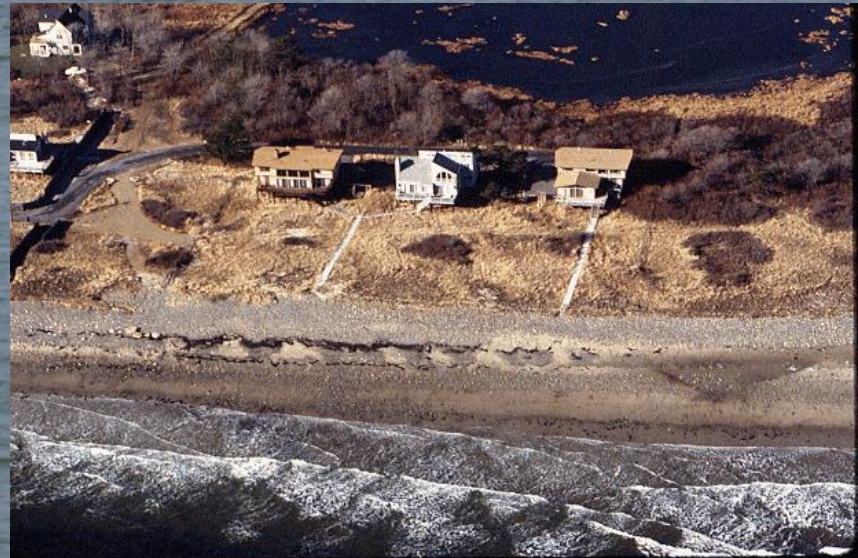
Long-Term Beach Erosion

Erosion is a consequence of shoreline recession - the inland migration of the shoreline. Not all Maine beaches are eroding.

Long-term erosion results from gradual changes in the local beach sand budget and sea level.

Many beaches are eroding
1 foot per year.

Some beaches have
eroded up to 3 feet per
year.

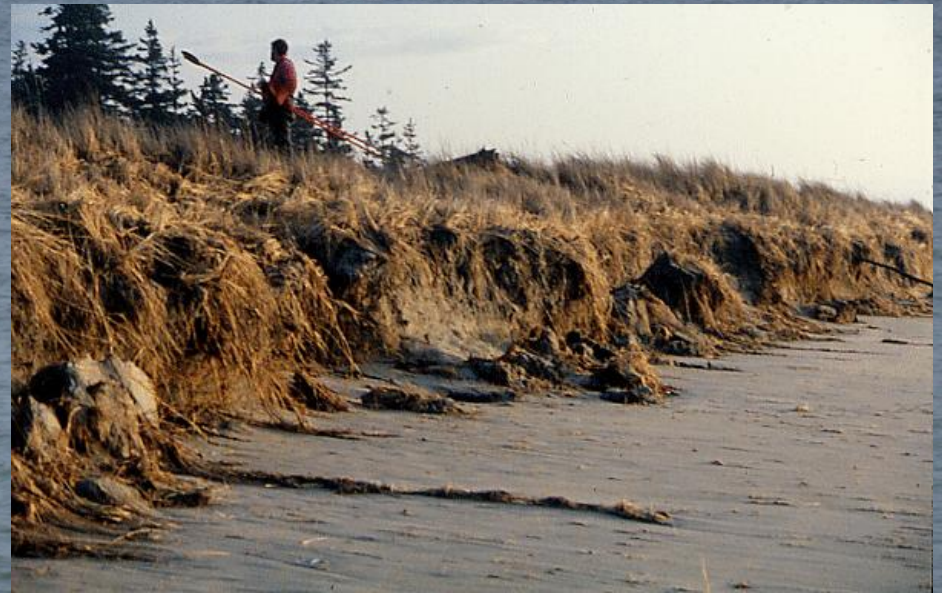
Short-Term Beach Erosion

Short-term erosion results from storms that produce coastal flooding and surf.

Sand dunes can erode 10s of feet horizontally in a single storm.

Flooding can erode dunes several feet down and move sand more than 100 feet inland.

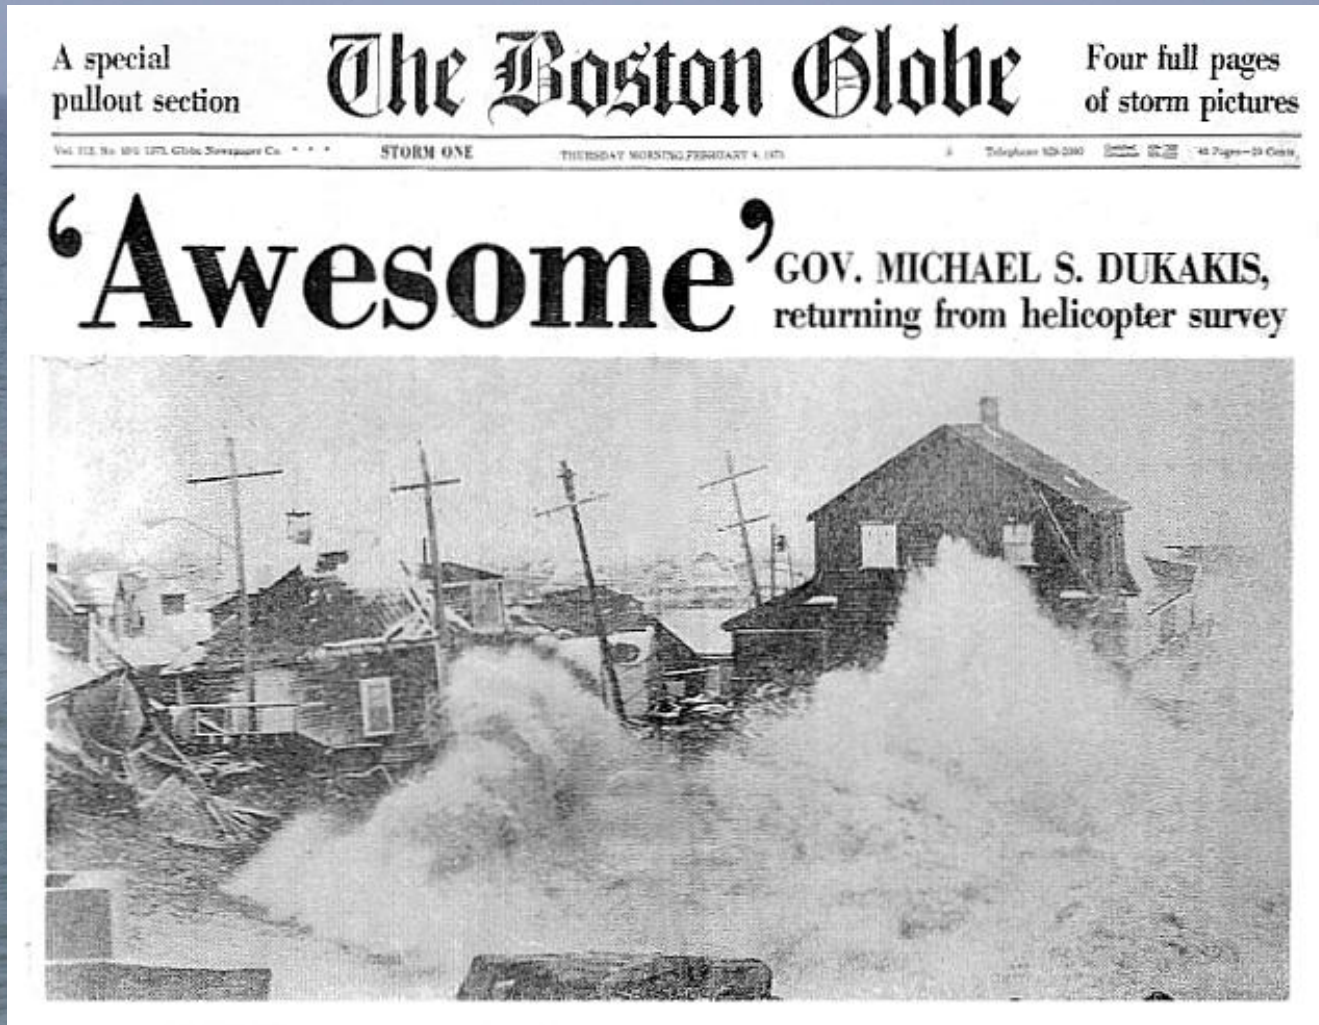
1978 Winter Storms

Coastal erosion, wave action, and flooding in January and February blizzards cause \$47M in Maine property damage.

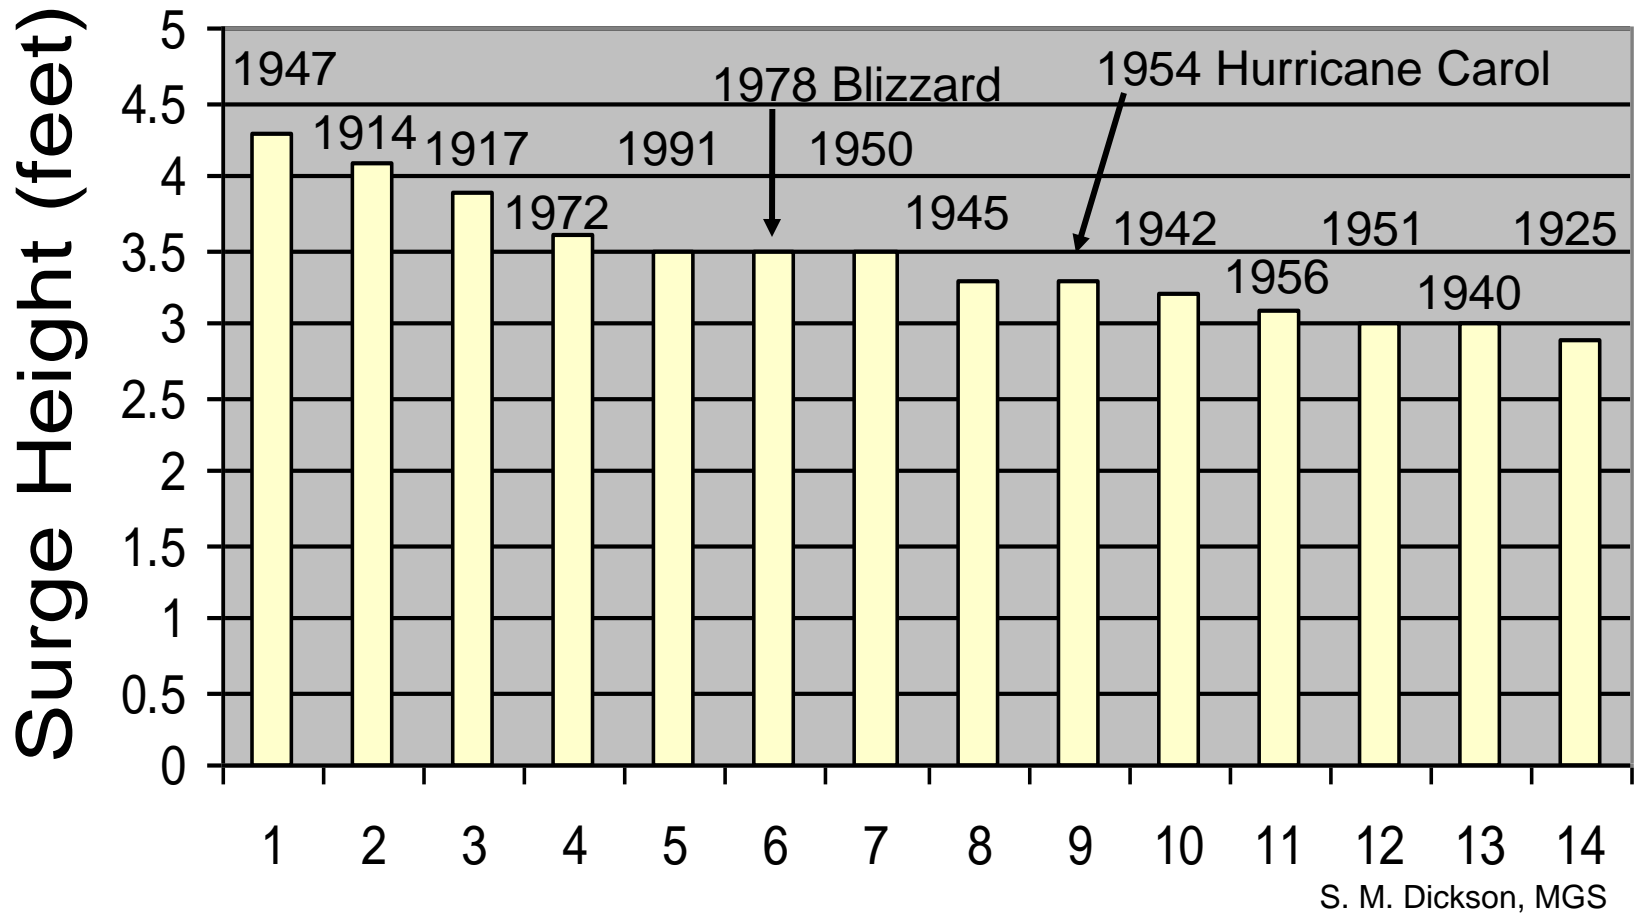
Top 14 Coastal Storm Surges

Storm Rank by Surge Amount

1. 4.3 feet March 3, 1947
2. 4.1 feet March 1, 1914
3. 3.9 feet Dec. 14, 1917
4. 3.6 feet Dec. 19, 1972
5. 3.5 feet Oct. 30, 1991 (Perfect Storm)
6. 3.5 feet Feb. 7, 1978 (Blizzard; 10-yr surge)
7. 3.5 feet Nov. 26, 1950
8. 3.3 feet Aug. 31, 1954 (Hurricane Carol)
9. 3.2 feet Dec. 2, 1942
10. 3.1 feet Mar. 16, 1956

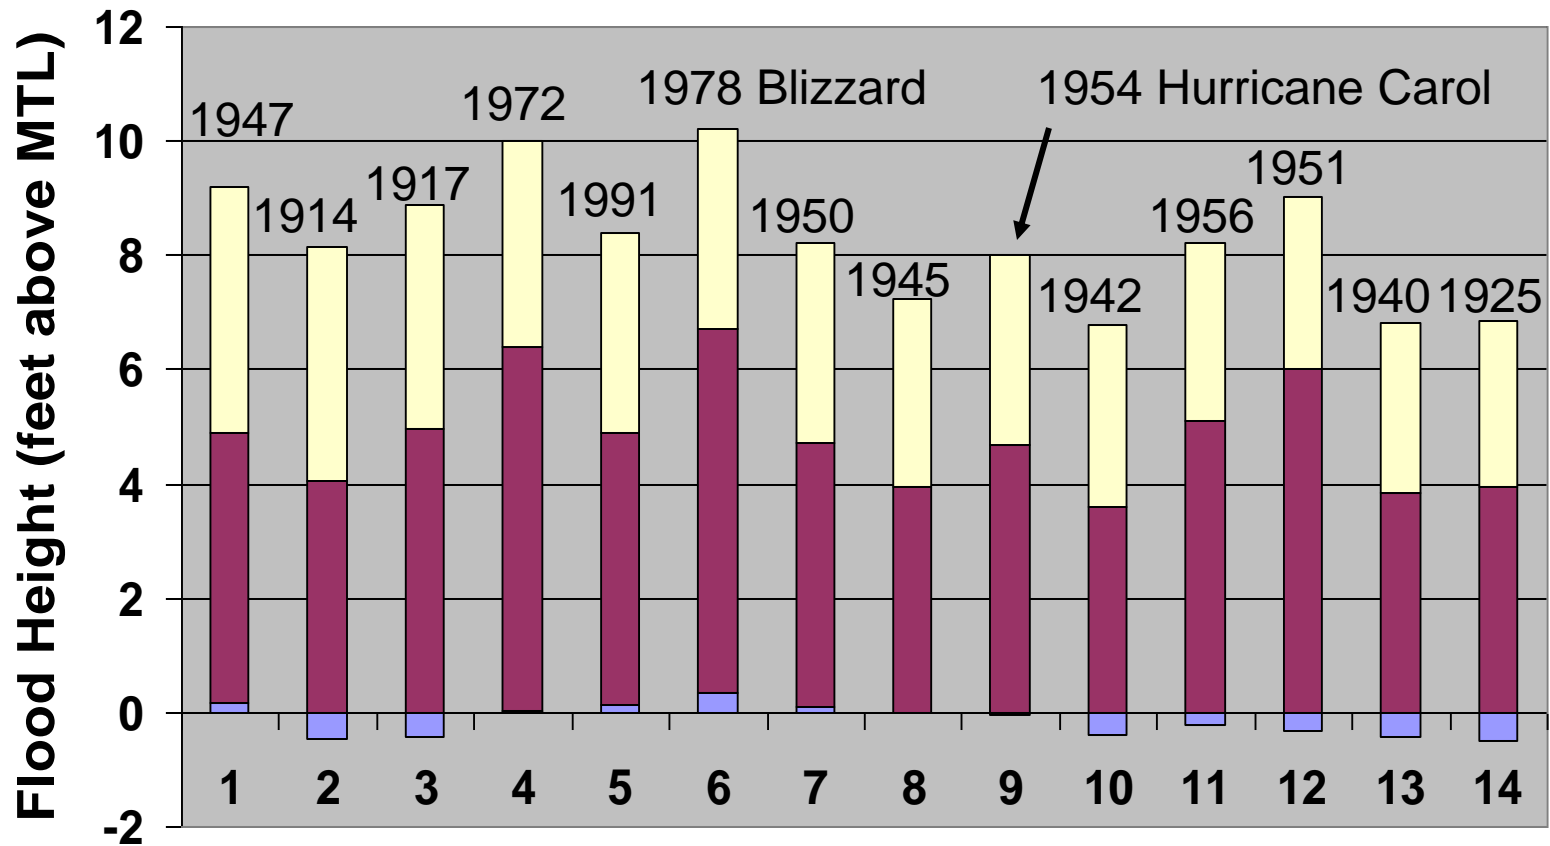
Coastal Flooding & Erosion Events

Storm Rank by Surge Amount

Surge
- MHW -
Tide
Mean
Sea
Level

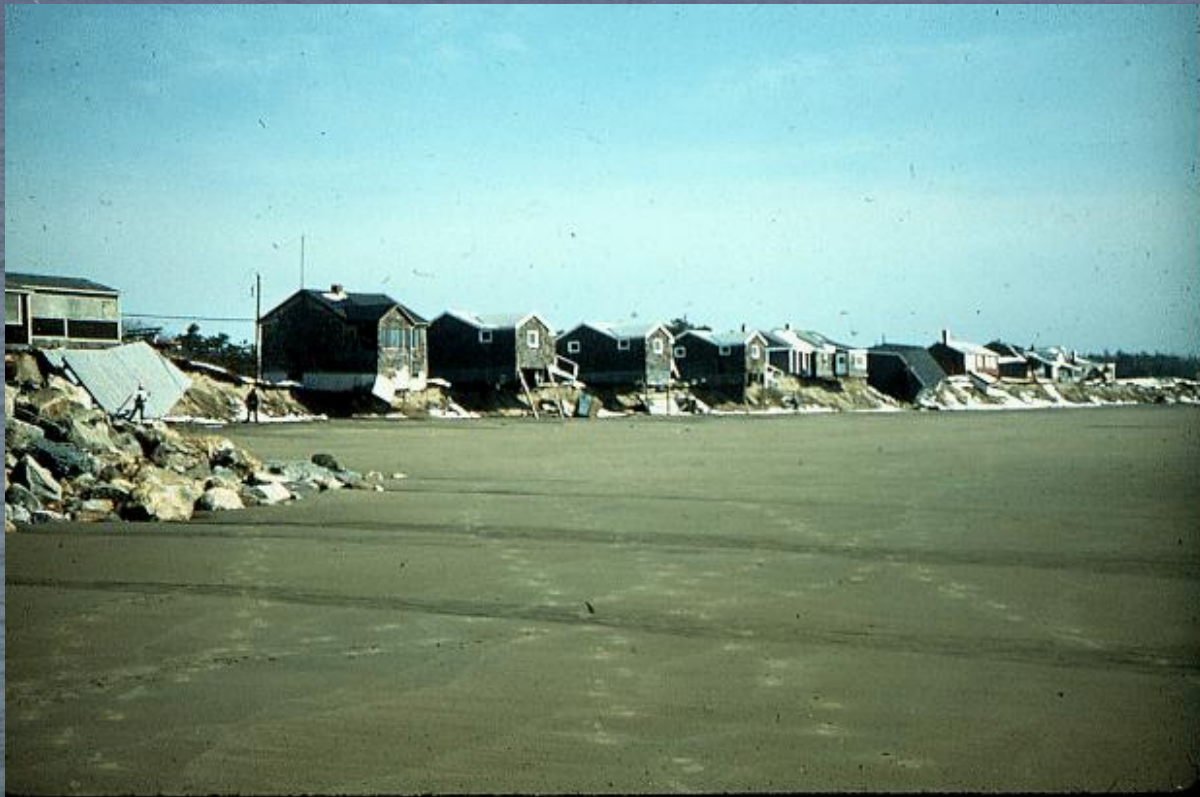
1976 beach erosion at
Hunnewell Beach,
Phippsburg

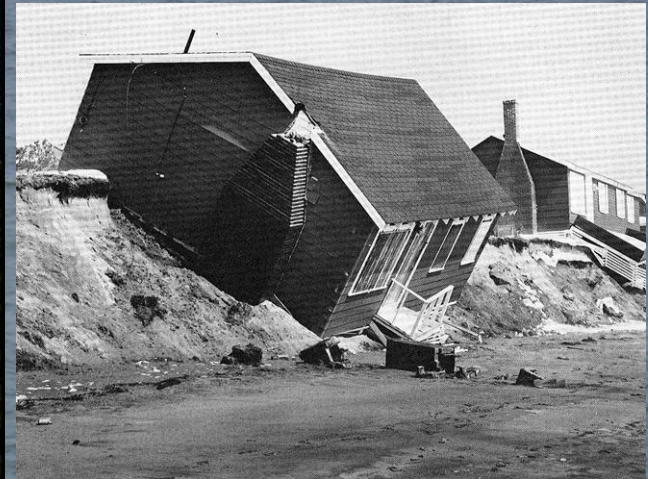
Erosion undermines homes at Hunnewell Beach, Phippsburg

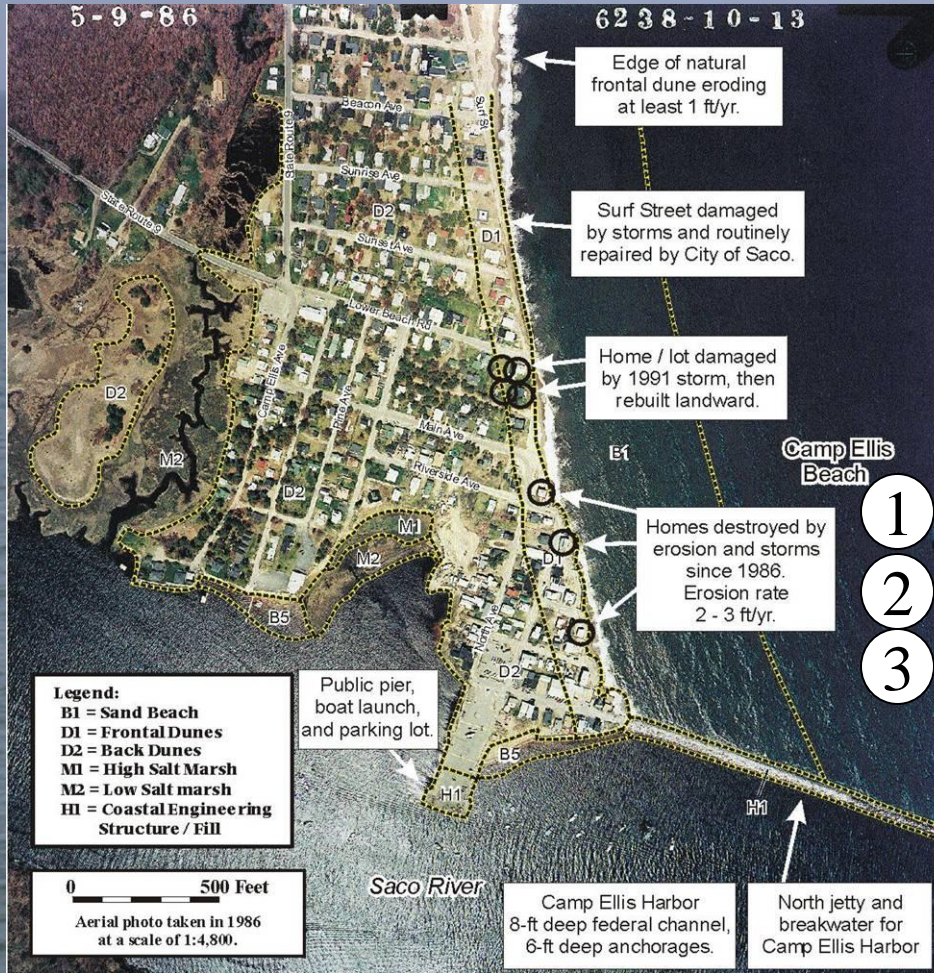
Erosion Damage - Saco

- 1
- 2
- 3

Since the 1983 Sand Dune Rules went into effect, 3 homes in Saco were the only ones in Maine damaged by >50%. They were not rebuilt nor were the rules challenged in court. Three other houses, one in Saco and two at Popham Beach, were damaged <50% by waves and each was rebuilt farther inland.

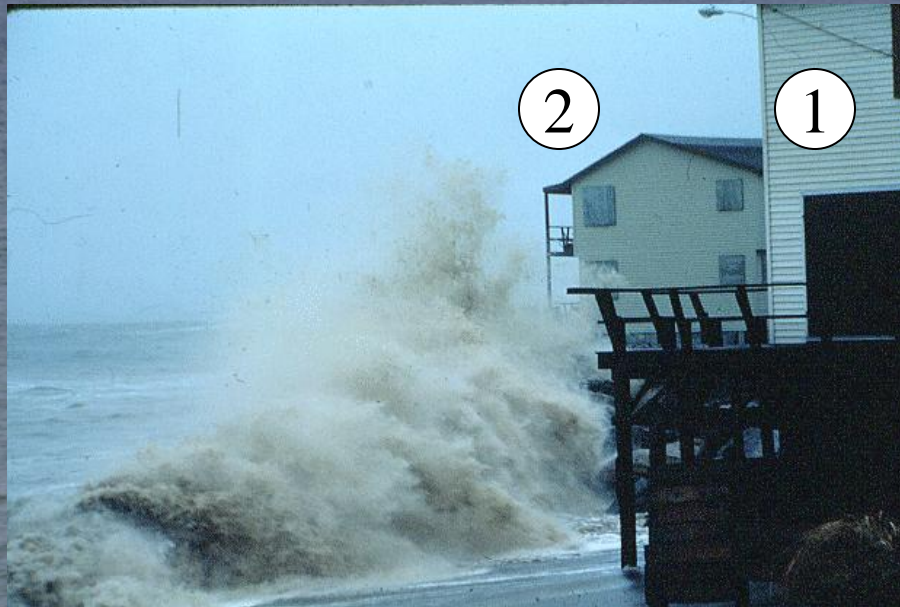
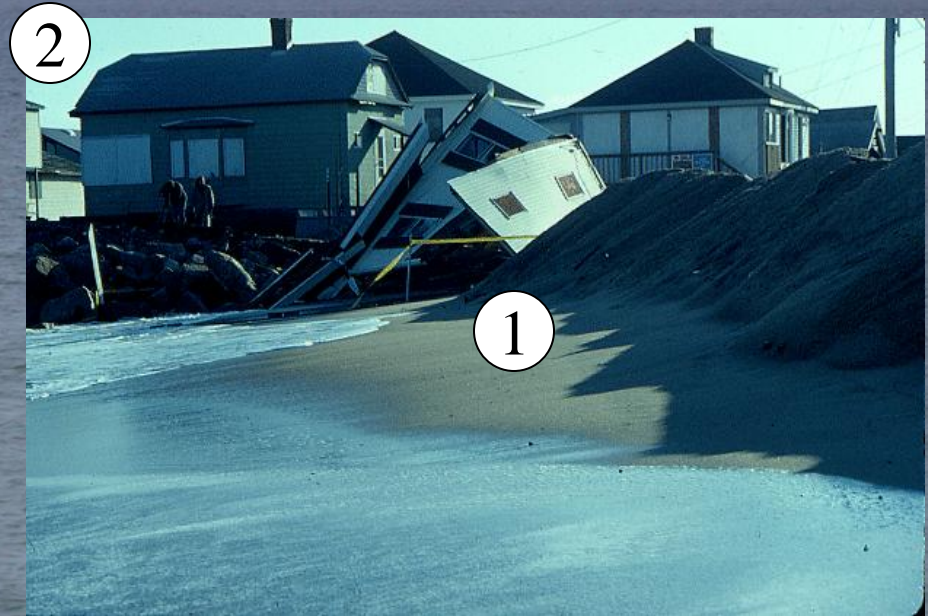
Erosion Damage – 1986 & 1990

Erosion undermines homes at Camp Ellis Beach in Saco

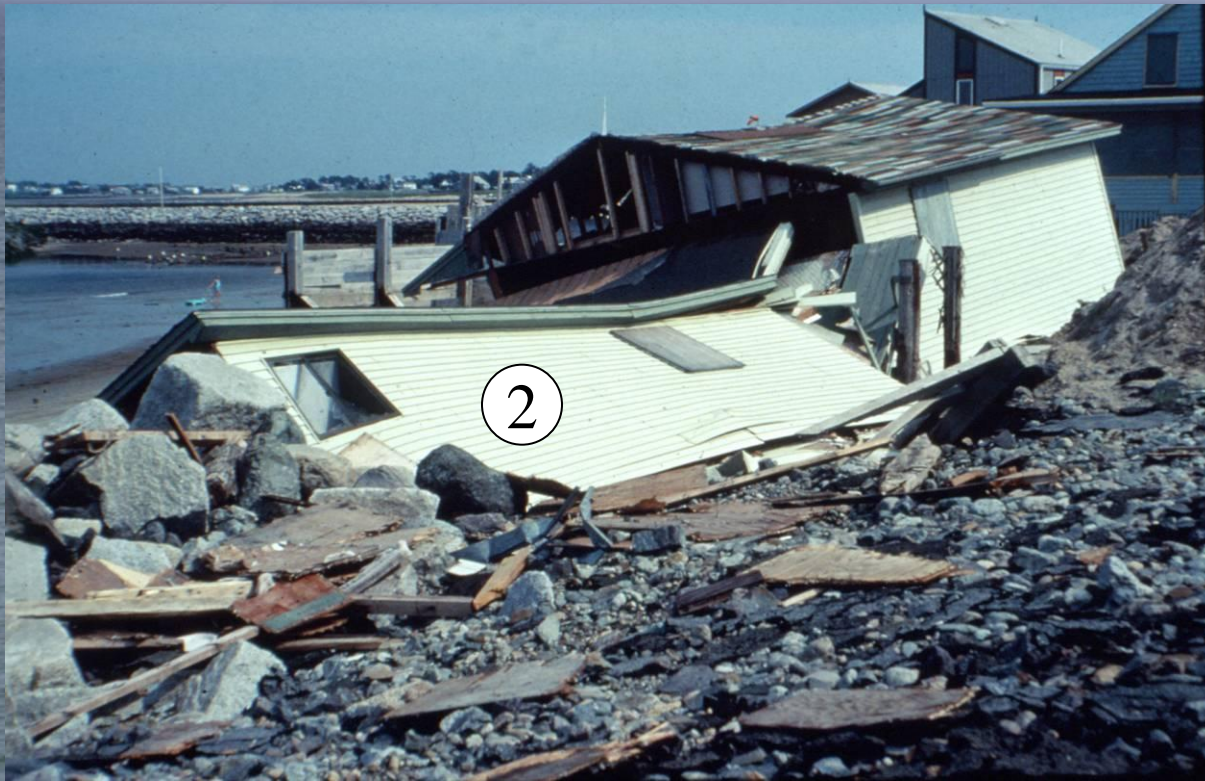
Erosion Damage – Camp Ellis

Erosion destroyed a seawall and house at Camp Ellis Beach in Saco (in the 1990s).

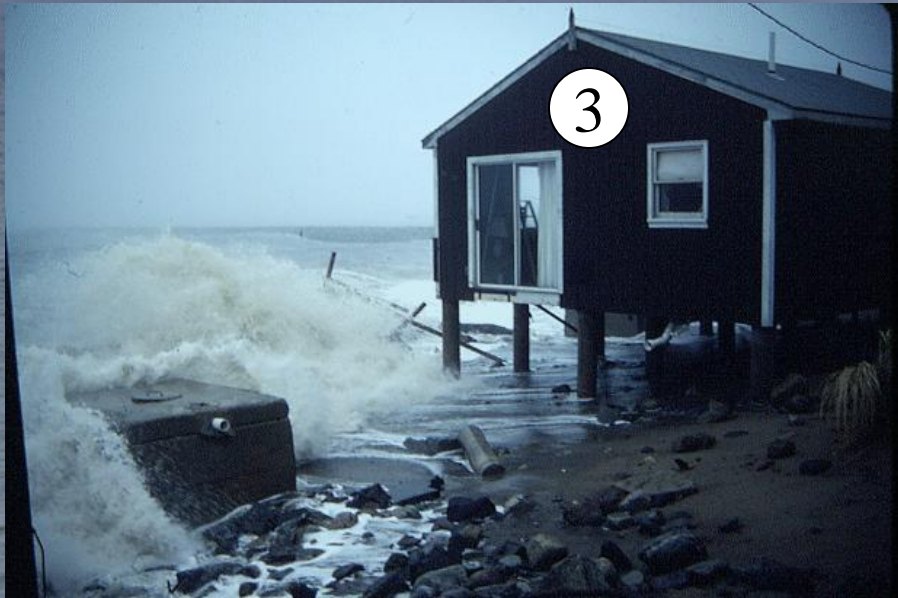
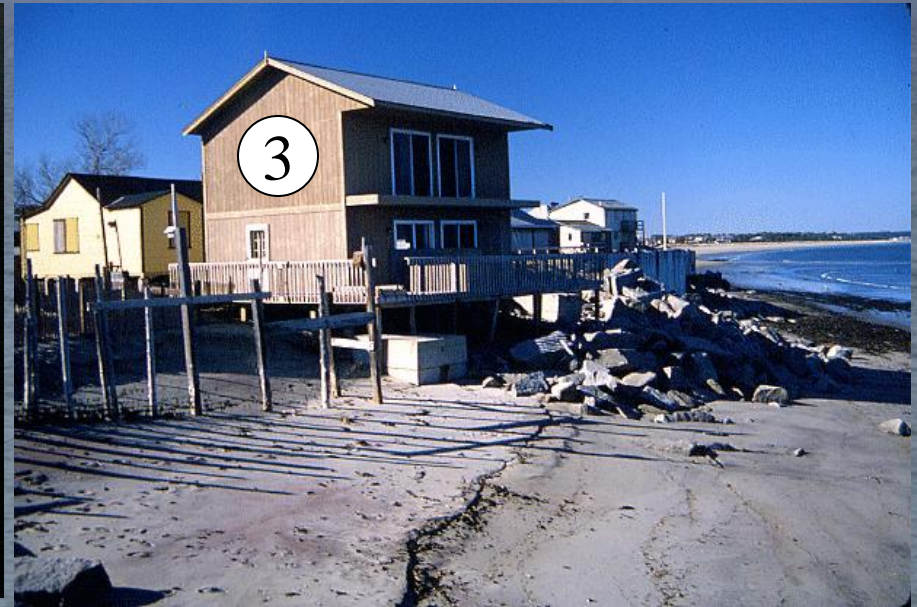
Erosion Damage & Redevelopment

Erosion undermines a home at Camp Ellis Beach prior to its expansion and subsequent total collapse in 1991.

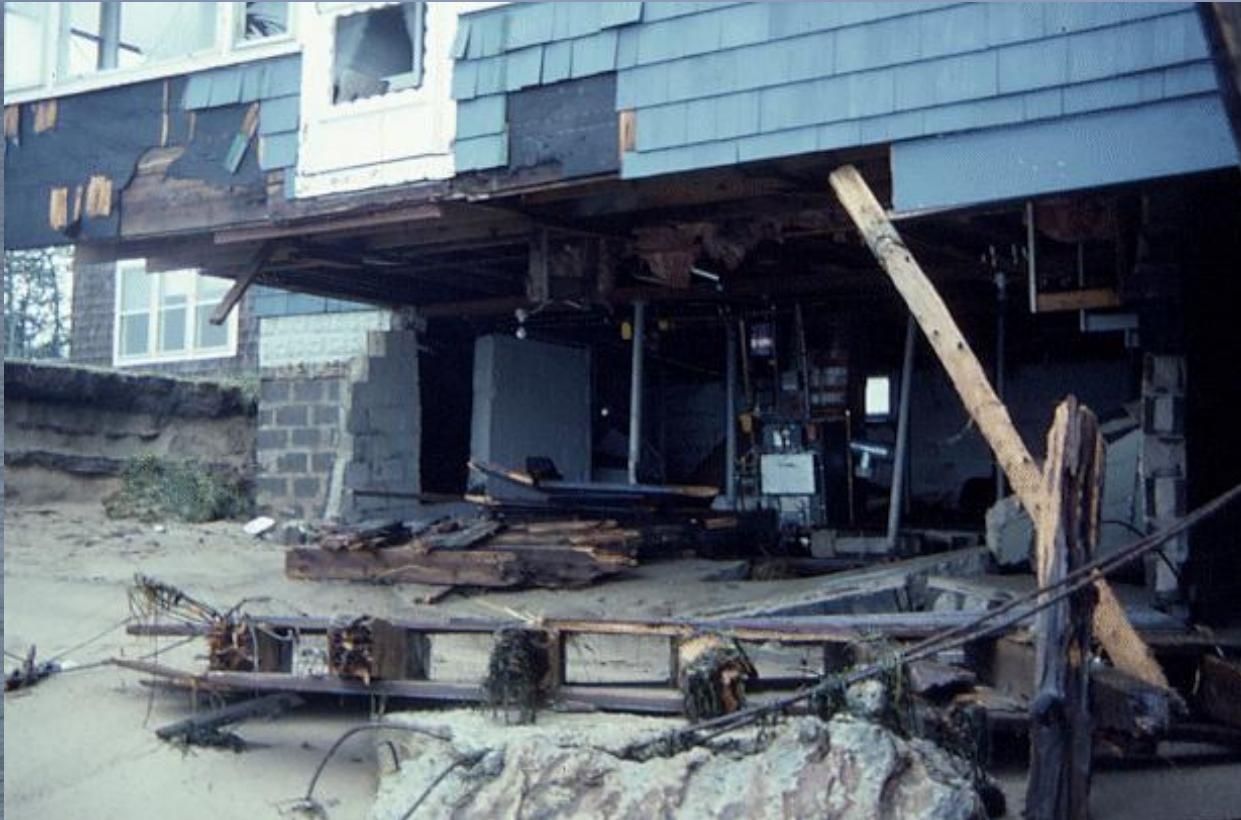
Erosion Damage - 1991

This building was relocated landward in a frontal dune after seawall failure and storm damage.

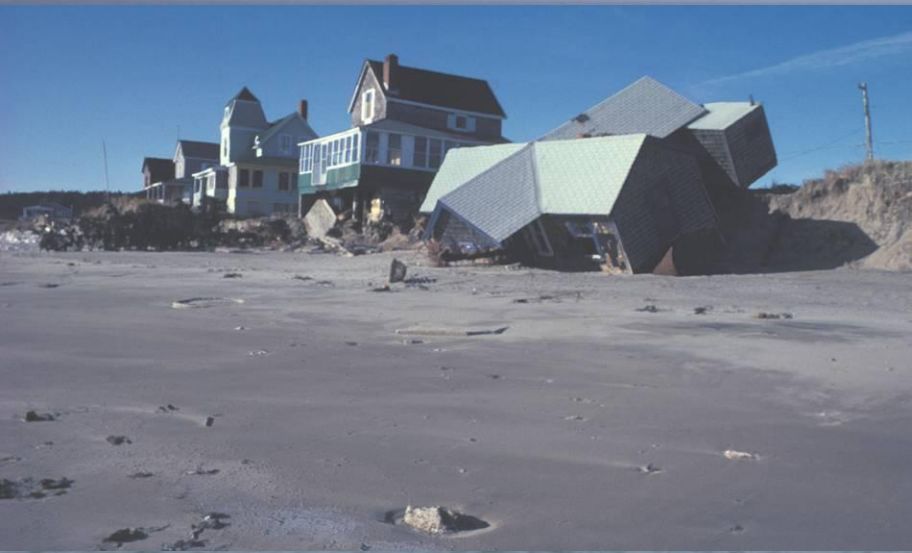
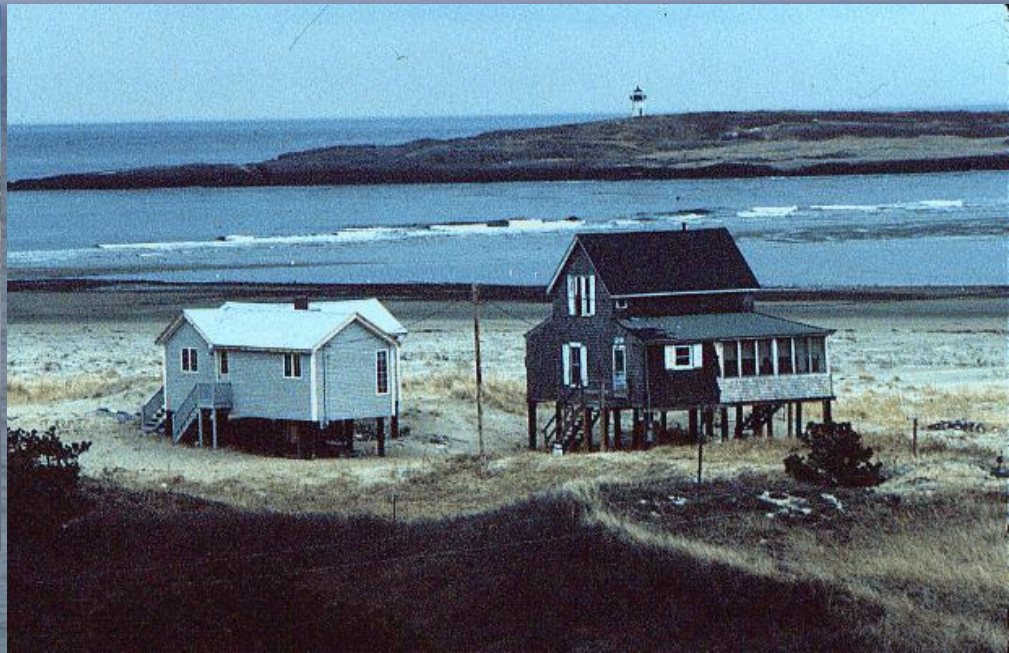
Erosion Damage – Popham 1983

Undermined and threatened by erosion, 2 homes retreat and elevate.
