**CONCEPTUAL SITE MODEL  
FOR  
FARWELL MILL OIL RECOVERY  
SITE  
LISBON, MAINE  
ANDROSCOGGIN COUNTY**

**PREPARED FOR:  
MILLER INDUSTRIES, INC.  
LISBON FALLS, MAINE**

**MARCH 2009**

**CONCEPTUAL SITE MODEL  
FARWELL MILL OIL RECOVERY SITE  
LISBON, MAINE**

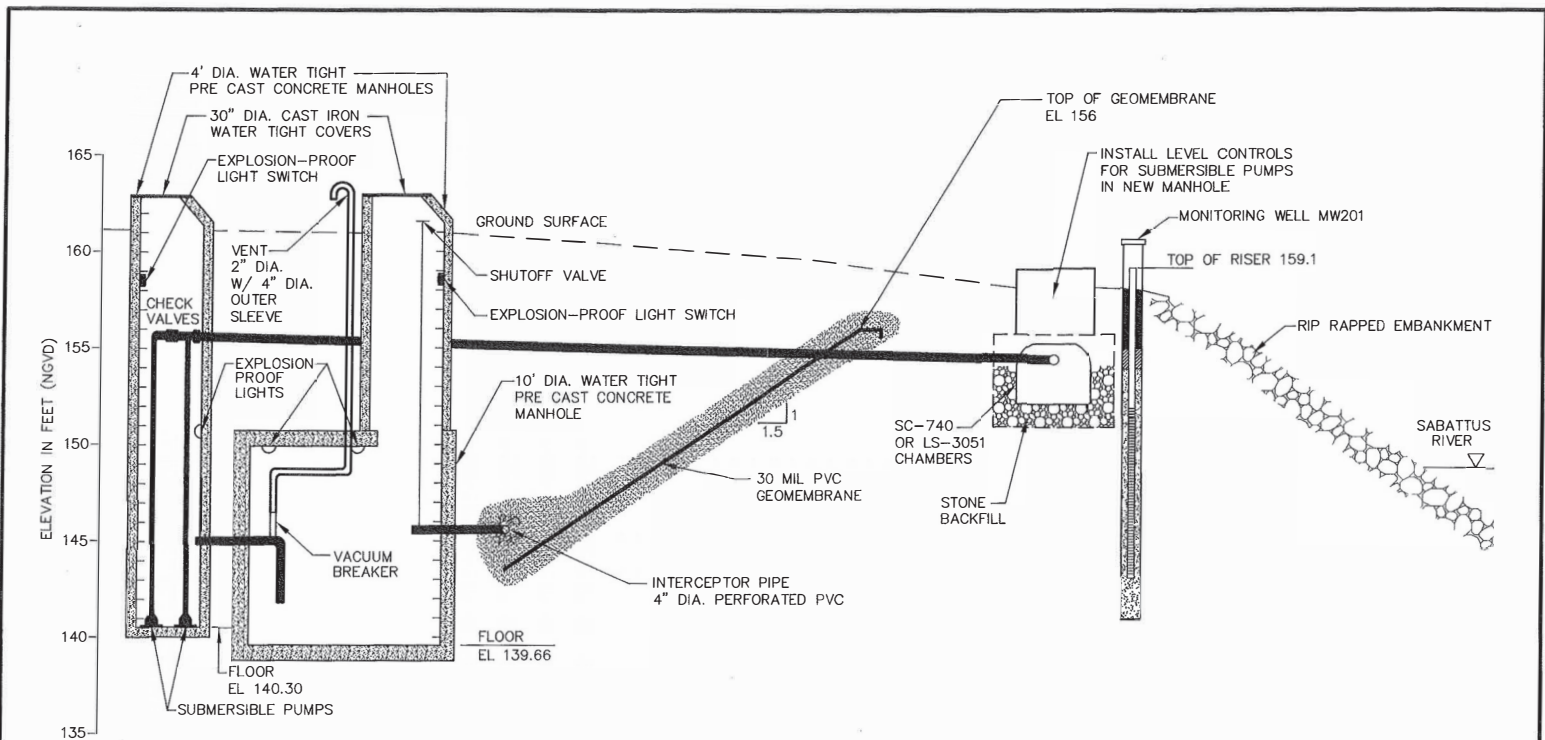
FIGURE 1  
 CROSS SECTION OF PROPOSED  
 RETROFIT 10 FOOT DIAMETER VAULT  
 FARWELL MILL OIL RECOVERY SYSTEM  
 MILLER INDUSTRIES, INC.  
 LISBON, MAINE

1. POSITION OF MANHOLES IS SCHEMATICALLY SHOWN.
2. WATER LEVEL INFORMATION FROM INVESTIGATIONS 1985 TO 1991.
3. HISTORIC HIGH WATER PRIOR TO 1990 151 FT MSL.
4. HISTORIC LOW WATER PRIOR TO 1990 147 FT MSL.
5. AVERAGE WATER TABLE PRIOR TO INSTALLATION OF LINER AND EXTRACTION SYSTEM 148-149 FT MSL.

Completing minor retrofitting of the existing vault for use as a simple oil/water separator (as shown in Figure 2) would likely be as effective as purchasing and installing a new oil water separator. Retrofitting the existing vault would provide significant capacity for oil storage, and minimize the potential for overflow into the clean water side of the system because the 10-foot diameter vault has a capacity of 600 gallons per vertical foot. This system would be more amenable overall to simple maintenance from the surface, avoiding the necessity for confined space entry.

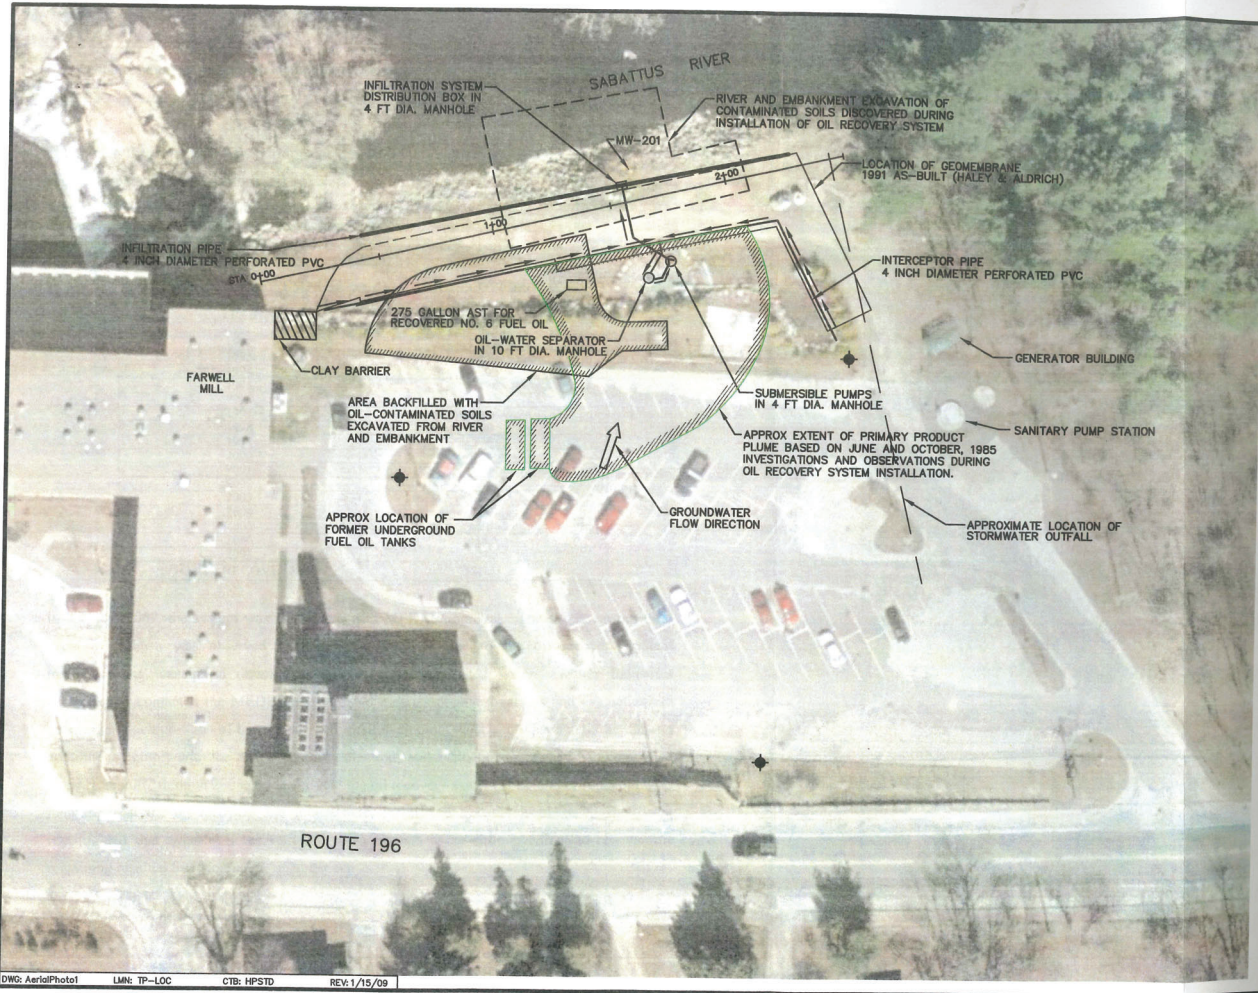
**FIGURE 2**  
 SITE PLAN  
 MILLER INDUSTRIES  
 FARWELL MILL  
 LISBON, MAINE

As noted in Subsection 2.2, the source of the No. 6 oil contamination was from one of two former USTs located in the southern parking lot. An estimated 7,000 gallons of No. 6 oil was released from the leaking USTs sometime between the time when they were installed in the 1950's or 1960's and 1987, when the tank were removed (Ref. Miller Industries and H&A). Historical oil seeps along the Sabattus riverbank indicated migration of the No. 6 oil over a distance of about 120 feet. The horizontal boundaries of the product plume in the 1980's were defined based on test trenches (E.C. Jordan Co., 1985), which identified a primary plume traveling from the source in an east-southeast direction to the Sabattus River (see Figure 2).

During installation of the oil recovery system in 1990, an extensive plume of heavy oil was observed within the Sabattus riverbed. The plume was excavated from the riverbed back toward the location of the former leaking USTs. Approximately 1,500 cubic yards of No. 6 oil-containing sediments from excavation of the Sabattus riverbed and embankment were backfilled in "lifts" just upgradient of the system's geomembrane barrier in the area shown on Figure 2. Each lift of oily soil was separated by clean sand to expedite the flow of oil into the collection pipe, and then into the system's oil-water separator. (Ref. H&A, As-built Configuration and Monitoring of Oil Recovery System, November 7 through 9, 1990). A three-foot thick sand cover was placed over the entire area backfilled with contaminated soils (See Figure 2 for backfill area).

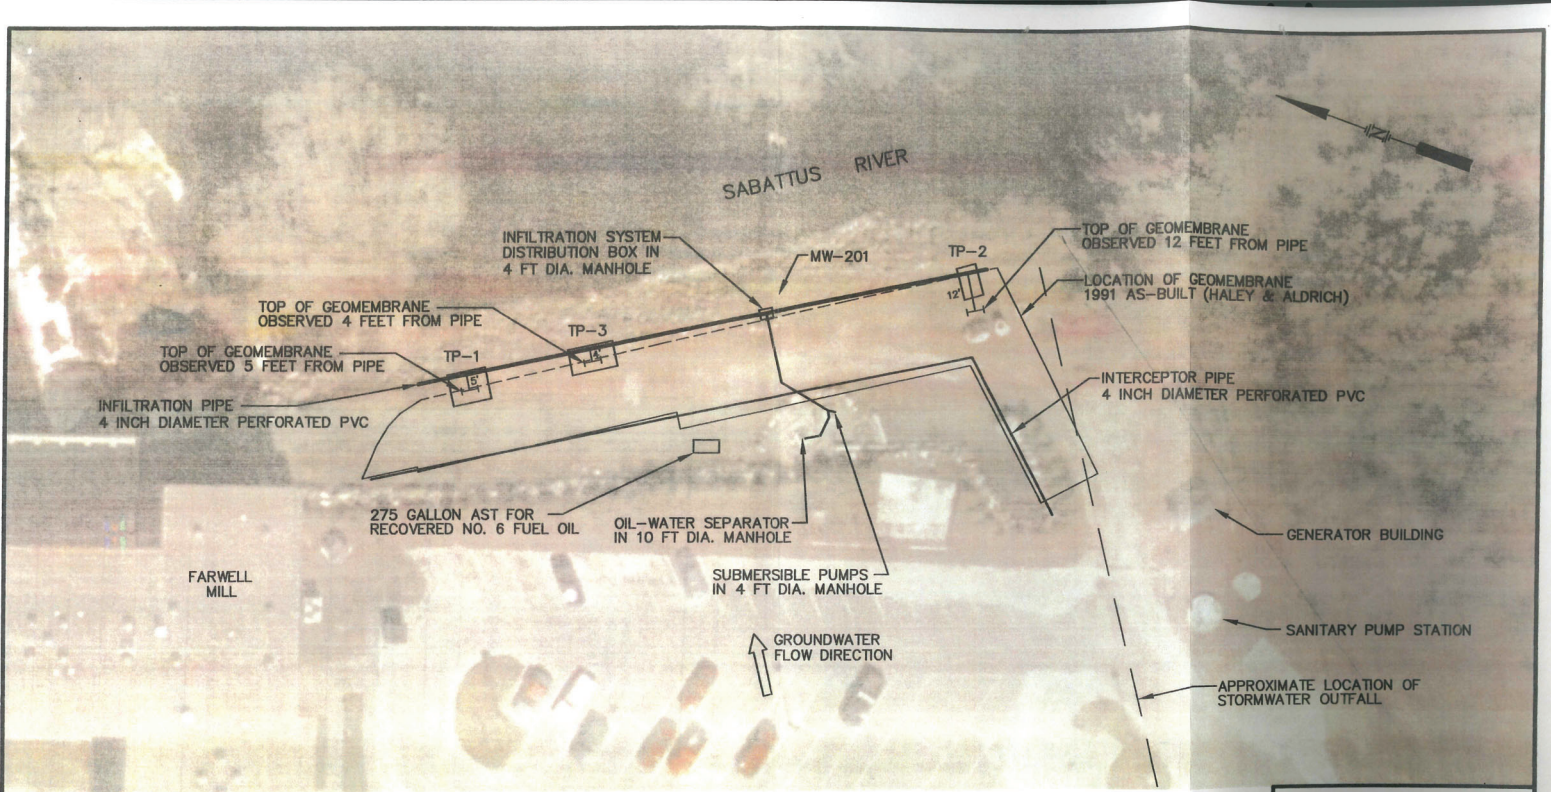
NOTE: AERIAL PHOTO FROM MAINE GIS AERIAL PHOTOGRAPHY  
 DATE OF PHOTO-APRIL 2001

- a. Figure 1 shows the locations of the three test pits completed on May 22, 2007. Test Pit 1 revealed that the northwest end of the infiltration pipe was filled with a silty sediment. Test Pits 2 and 3 showed no sediment in the infiltration pipe, and showed the perforations in the bottom were open. The coarse backfill under the infiltration trench contained visible No. 6 staining and concentrations of DRO above MEDEP Baseline 2 standards of 50 to 100 mg/kg. Observations of the fine silty sand under the coarse backfill did not contain any visible staining of No. 6 suggesting that the No. 6 fuel oil in the coarse backfill is not mobile and was not the cause of the sheen on the River on April 25, 2007.
