Feasibility/Alternatives Analysis Report Montgomery Dam, Megunticook River Camden, ME

May 3, 2019

Town of Camden,
Maine

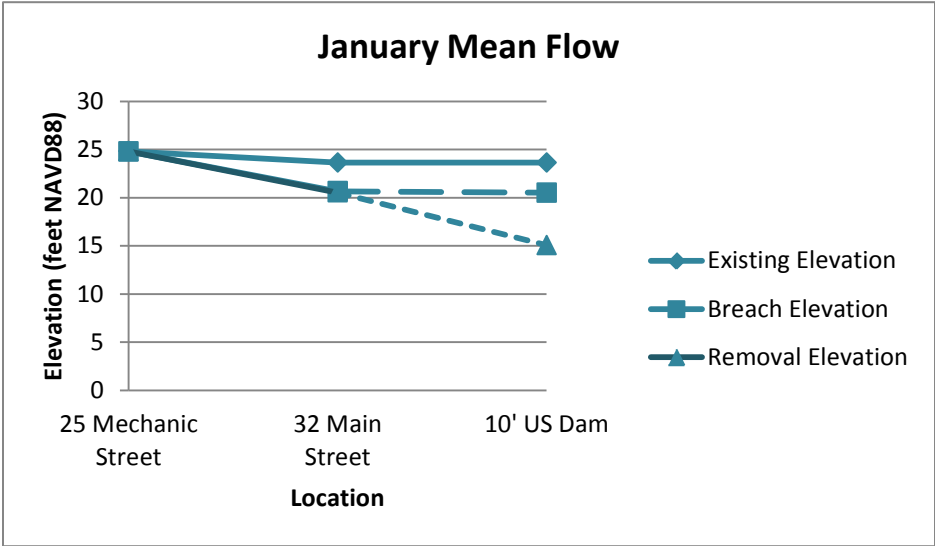
January mean flows for the alternatives are shown at left for three locations. Breaching results in an estimated water level drop of 4.13' at 32 Main Street and 4.26' at the dam. Removal results in an estimated water level drop of 4.28' at 32 Main Street and 9.73' at the dam. (Data: Inter-Fluve)

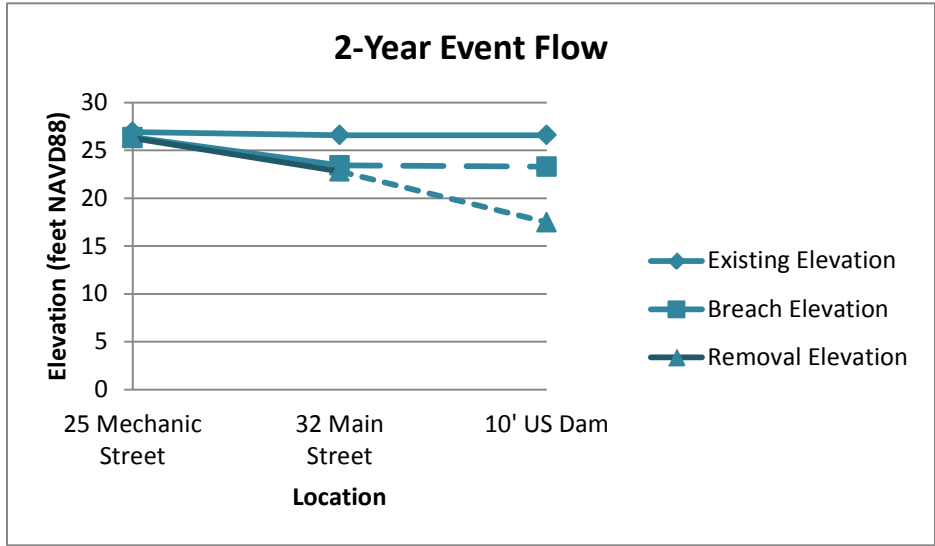
2-year event flows for the alternatives are shown at left for three locations. Breaching results in an estimated water level drop of 2.95' at 32 Main Street and 3.48' at the dam. Removal results in an estimated water level drop of 3.08' at 32 Main Street and 8.80' at the dam. (Data: Inter-Fluve)

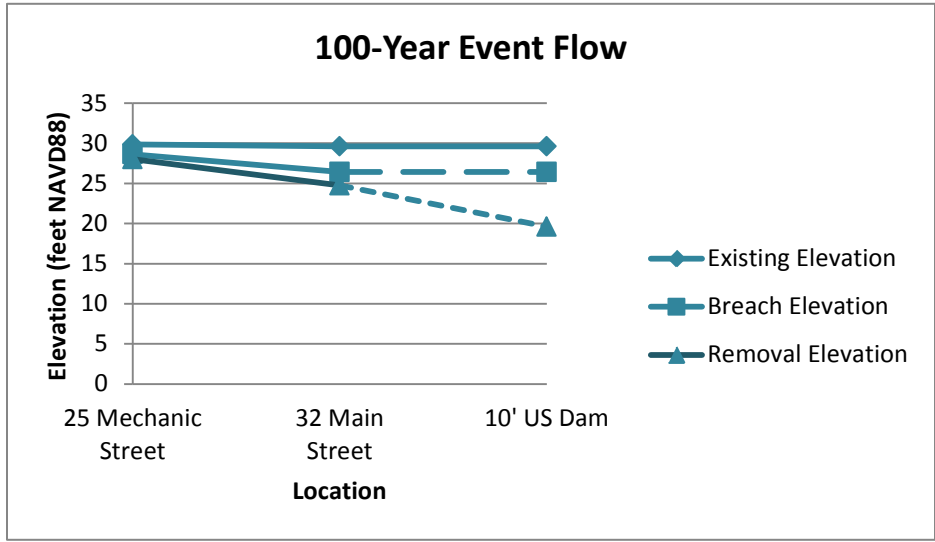
100-year event flows for the alternatives are shown at left for three locations. Breaching results in an estimated water level drop of 2.20' at 32 Main Street and 3.26' at the dam. Removal results in an estimated water level drop of 2.20' at 32 Main Street and 8.41' at the dam. (Data: Inter-Fluve)
