# *Maine Department of Transportation*

Pavement Condition Report

## **GREENVILLE MUNICIPAL AIRPORT (3B 1)**

Submitted To:  
Maine Department of Transportation  
16 State House Station  
Augusta, ME 04333

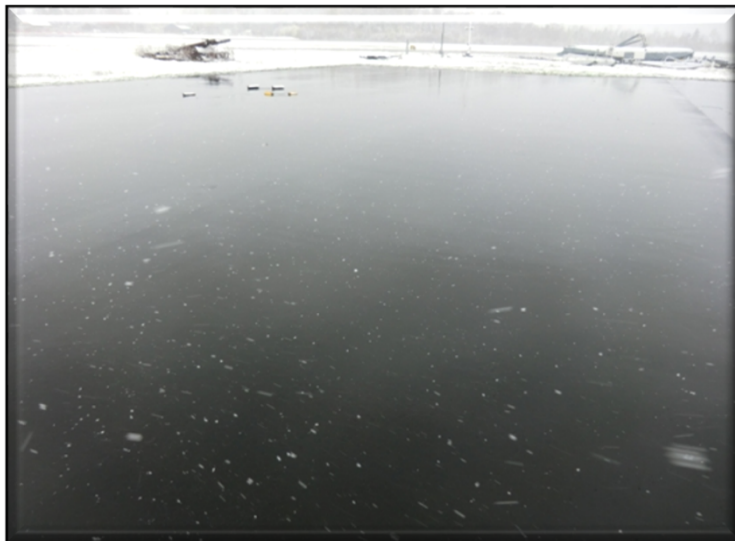
<b>Section:</b>	<b>3B1::APB::001</b>
<b>Description:</b>	Apron B
<b>PaveType:</b>	AC
<b>Area:</b>	20,300
<b>Built:</b>	1/15/2014
<b>Age:</b>	5yr

<sup>4</sup> Higher than average deterioration rate of 10.5 PCI/Yr for APB-001 is due to low-and medium-severity alligator cracking on a four year old pavement.

M&R	Action	Year / Quantity	Cost (\$)	Ending PCI
Major	Major M&R	2020	414,113	100
Minor	All Minor	2020	1,121	61
1	Patching - AC Deep	60 SqFt	1,121	-
2	-	-	-	-
3	-	-	-	-
4	-	-	-	-
5	-	-	-	-
6	-	-	-	-
7	-	-	-	-

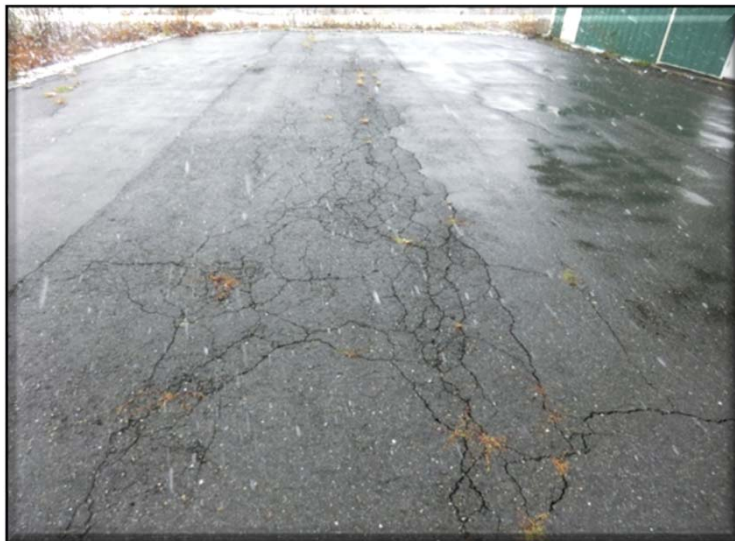
<b>Section:</b>	<b>3B1::APC::001</b>
<b>Description:</b>	Apron C
<b>PaveType:</b>	AC
<b>Area:</b>	6,600
<b>Built:</b>	1/15/2014
<b>Age:</b>	5yr

<sup>5</sup> Higher than average deterioration rate of 7.3 PCI/Yr for APC-001 is due to a significant amount of medium-severity L&T cracking on a four year old pavement.

M&R	Action	Year / Quantity	Cost (\$)	Ending PCI
Major	Major M&R	2020	18,150	100
Minor	All Minor	2020	436	81
1	Crack Sealing - AC	316 Ft	436	-
2	-	-	-	-
3	-	-	-	-
4	-	-	-	-
5	-	-	-	-
6	-	-	-	-
7	-	-	-	-

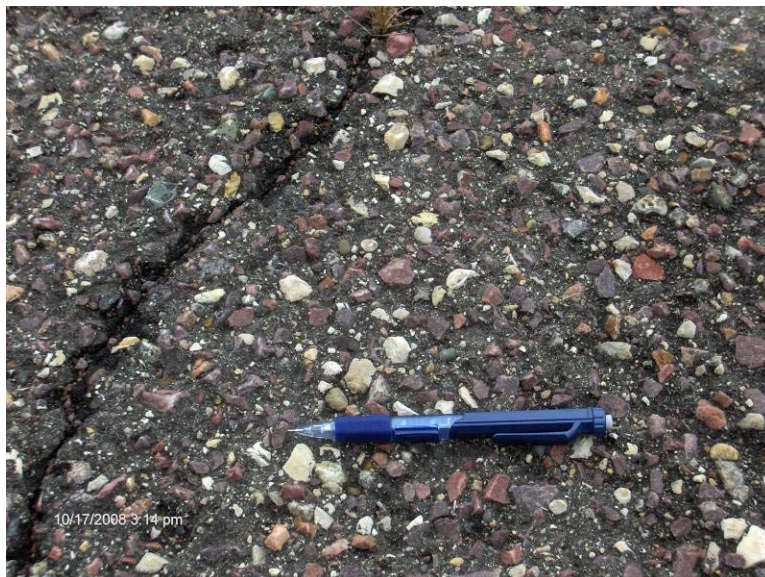
**Example of Raveling/Weathering**

Raveling and weathering are the wearing away of the pavement surface. Raveling is the condition where the mid- to large size aggregates are becoming dislodged; weathering is when the fine aggregate wears away exposing the edges of the larger aggregate. These distresses are usually evident over large areas and may occur together (pictured above) or separately. Raveling and weathering may indicate that the asphalt binder has hardened significantly.
