Pavement Condition Report

## **BIDDEFORD MUNICIPAL AIRPORT (KB19)**

To assist individual airports to effectively maintain their pavement infrastructure and help improve airport pavement conditions statewide, the Maine Department of Transportation (MaineDOT) contracted with DuBois & King, Inc. (D&K) to provide pavement evaluation surveys at local airports. Assisting D&K on this effort was Applied Research Associates, Inc. (ARA). This report documents the pavement condition at Biddeford Municipal Airport (B19) in November 2018.

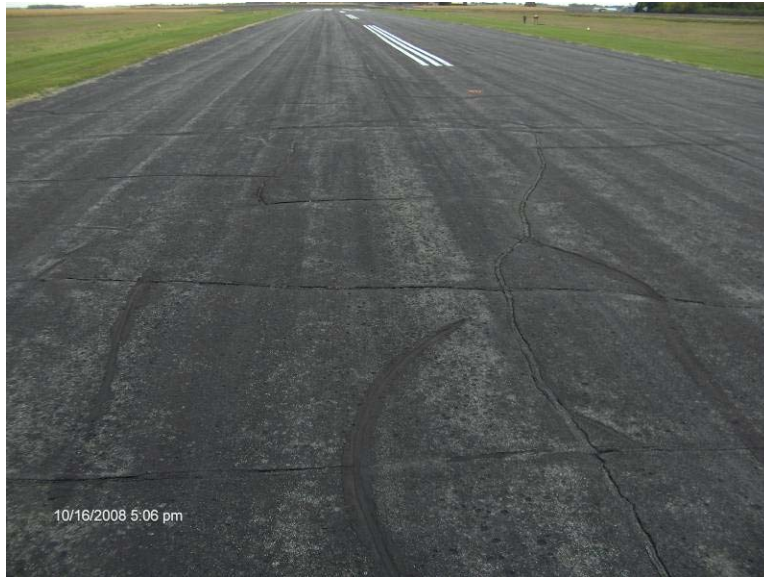
### *Example of Block Cracking*

Block cracking is longitudinal and transverse cracking that has established a pattern of blocks ranging in size from 1ft x 1ft to 10ft x 10ft. This distress typically happens in older asphalt pavements and is an indication that the bituminous binder has lost most of its flexibility. The severity determination is basically determined by the crack width criteria defined for longitudinal and transverse cracking. Crack sealing typically is used to repair block cracking; however, the amount of required sealant can be extensive due to the high density of cracks.

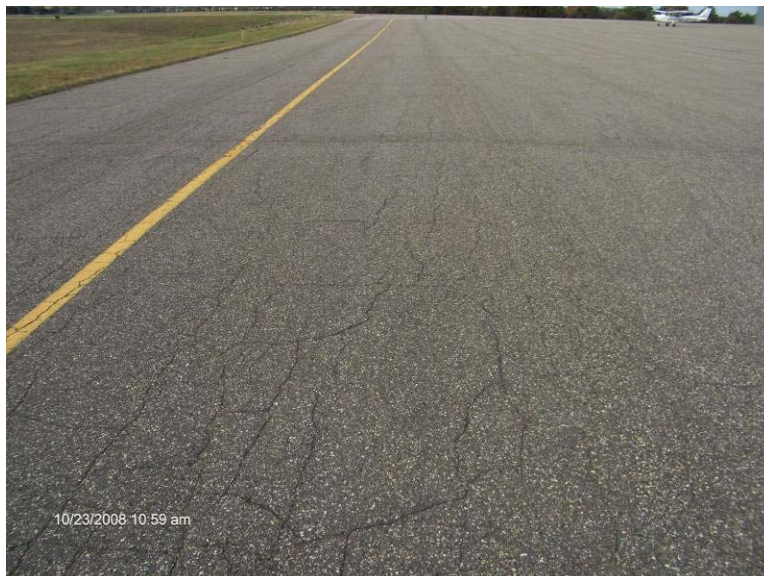
### *Example of Alligator Cracking*

Alligator (or fatigue) cracks are a series of interconnected load-related cracks caused by fatigue of the asphalt surface. Alligator cracking is a significant structural distress and develops only in places subject to traffic loads. These cracks typically initiate at the bottom of the asphalt layer (where tensile strains

are highest) and propagate upward - so once a fatigue crack is visible, significant damage has already occurred.

At low severity, alligator cracks are evidenced by a series of parallel hairline cracks (usually in a wheel path). Further traffic and deterioration leads to the interconnection of these cracks. Medium severity alligator cracking is a well-defined pattern of interconnected cracks, some spalling may be present. High severity alligator cracks have lost aggregate interlock between adjacent pieces, the cracks may be severely spalled with FOD potential, and most likely the pieces will move freely under traffic. Alligator cracking is a structural failure and cannot be repaired with sealant, the proper repair is full-depth patching.
