Highway and Bridge Barrier Rail Report

State of Maine Department
of Transportation, November
2016

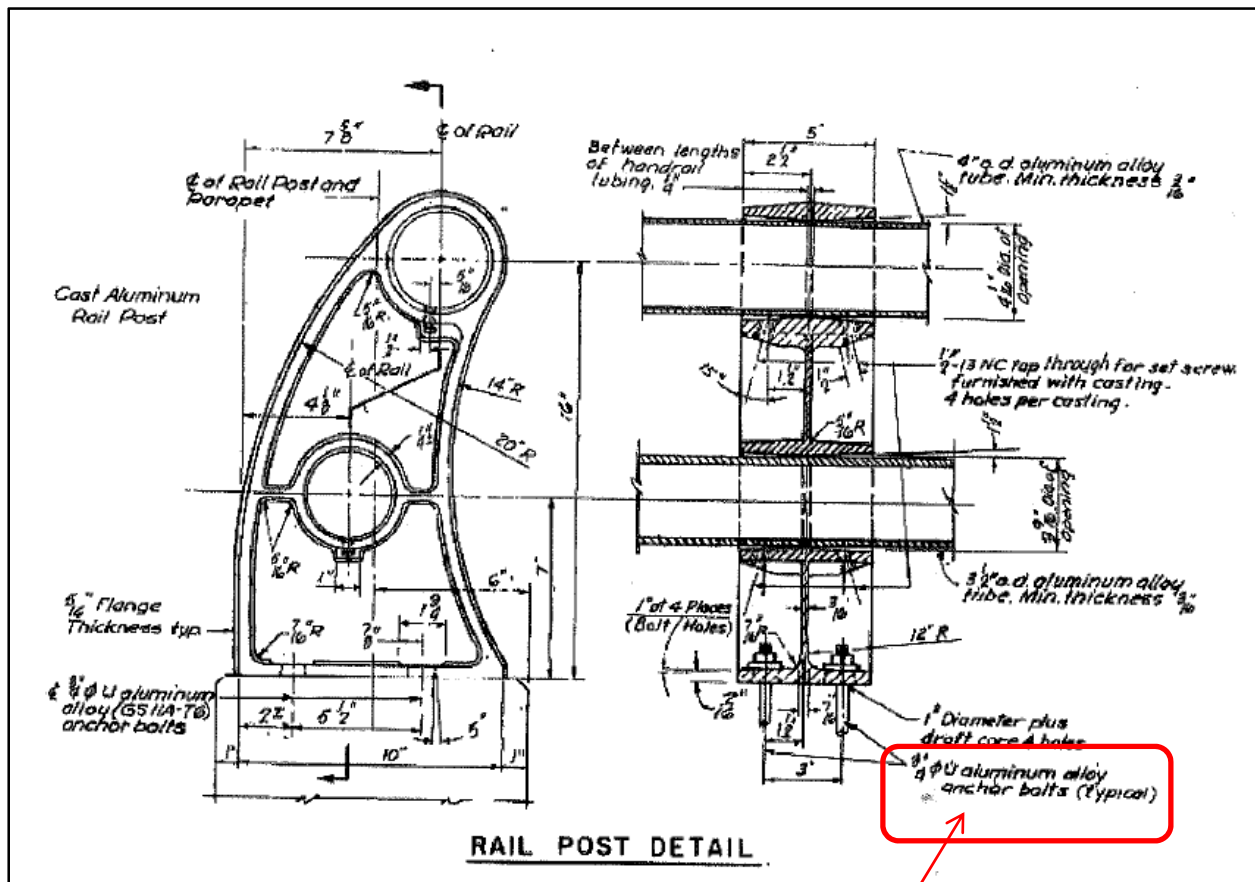
Figure 7 – Aluminum Rail Post For Non-Continuous Rail

- Aluminum Rail Components that are non-continuous (i.e. begin and end at each post). These round tubular parts fit inside a socket with little perimeter support. They are predicted to come entirely loose if a post is deflected enough. This rail is representative of the oldest aluminum bridge rail systems.
 - Higher probability of rails becoming dislodged.
 - Anchor Bolts appear to sometimes be made of Aluminum (see Figure 7).
 - Very difficult to maintain. Few suppliers of aluminum parts results in procurement issues.
 - The lower yield strength than steel results in higher probability of failure in shear and bending.
 - No Crash-testing in that era.
 - Height issues.

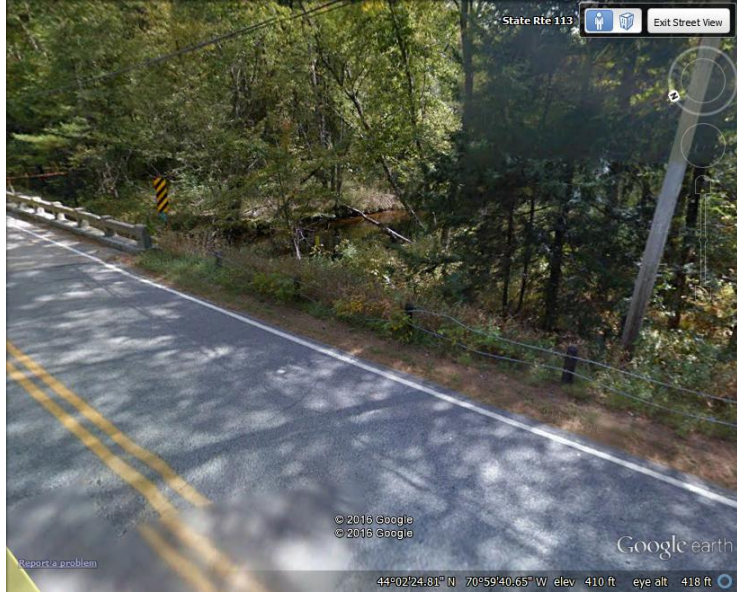
Weathered Steel w-beam rail sequence of level of corrosion at laps.
