I. Executive Summary

This study assesses the performance of the roof drainage systems at Historic New England's properties in Maine. This study was commissioned by Historic New England as current predictions for future weather suggest more frequent, intense storms and more rainfall in New England. As concerned stewards of multiple historic properties across New England, Historic New England seeks an evaluation of the current systems, including capacity and performance. As the properties are historic sites used as educational tools, ideally the systems are both functional and historically accurate.

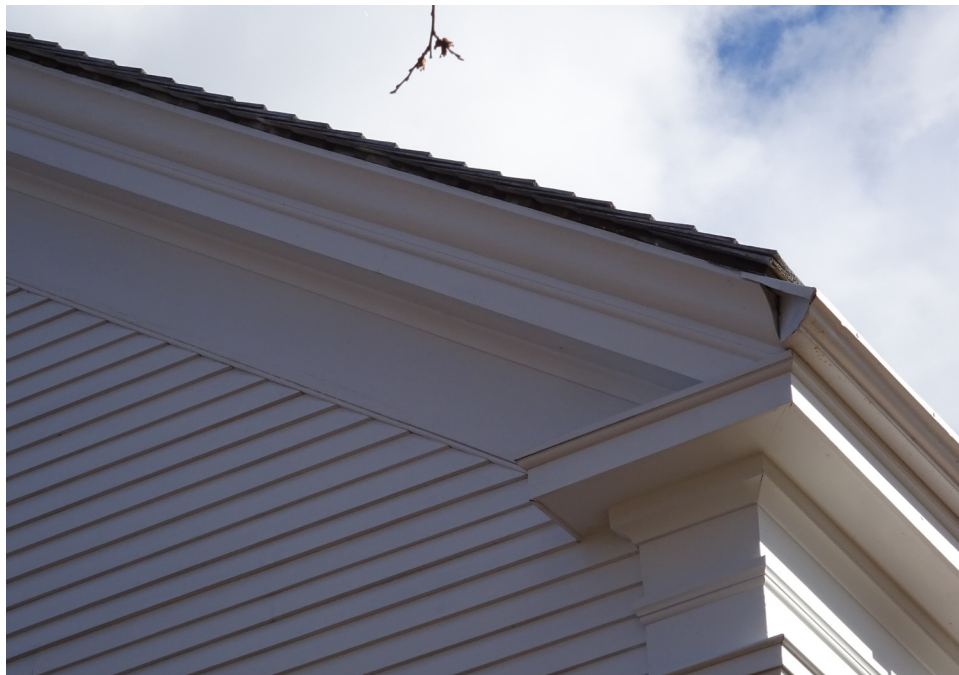
This wooden gutter at the Parson Smith House has an undersized outlet made of metal. It was found that most of the historic wooden gutters had undersized outlets. Photograph taken by Shawn Beckwith, April 18, 2018.
