MAINE stream crossings

new designs to restore stream continuity

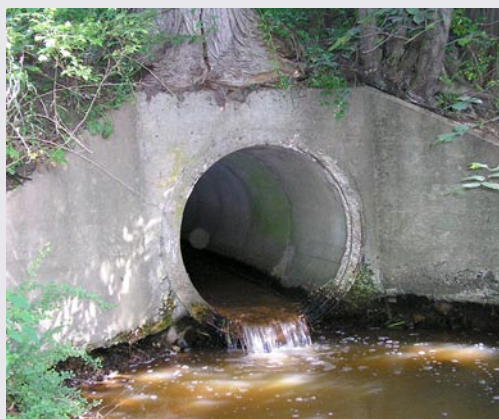
UNDERSIZED CROSSINGS restrict natural stream flow, causing several problems, including scouring and erosion, high flow velocity, clogging, and ponding. Crossings should be large enough to retain natural substrates and to pass fish, wildlife, floods, and debris.

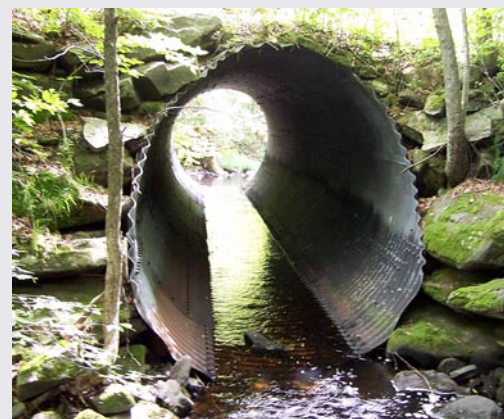
SHALLOW CROSSINGS have water depths too low for many organisms to move through them and may lack appropriate bed material. Crossings should have an open bottom or should be sunk into the streambed to allow for natural substrate and water depths.

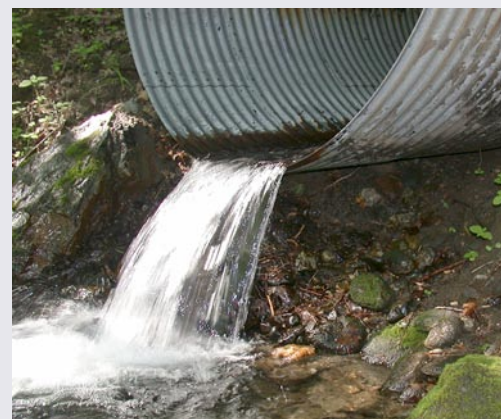
PERCHED CROSSINGS are above the level of the stream bottom at the downstream end. Perching can result from either improper installation or from years of downstream bed erosion. Crossings should be open-bottomed or sunk in the bed to prevent perching.
